November 18, 2016

Mr. Dan Tadic, PE
City and Borough of Sitka
100 Lincoln Street
Sitka, AK 99835

**RE: GARY PAXTON INDUSTRIAL PARK DEBRIS FLOW ANALYSIS,
SITKA, ALASKA**

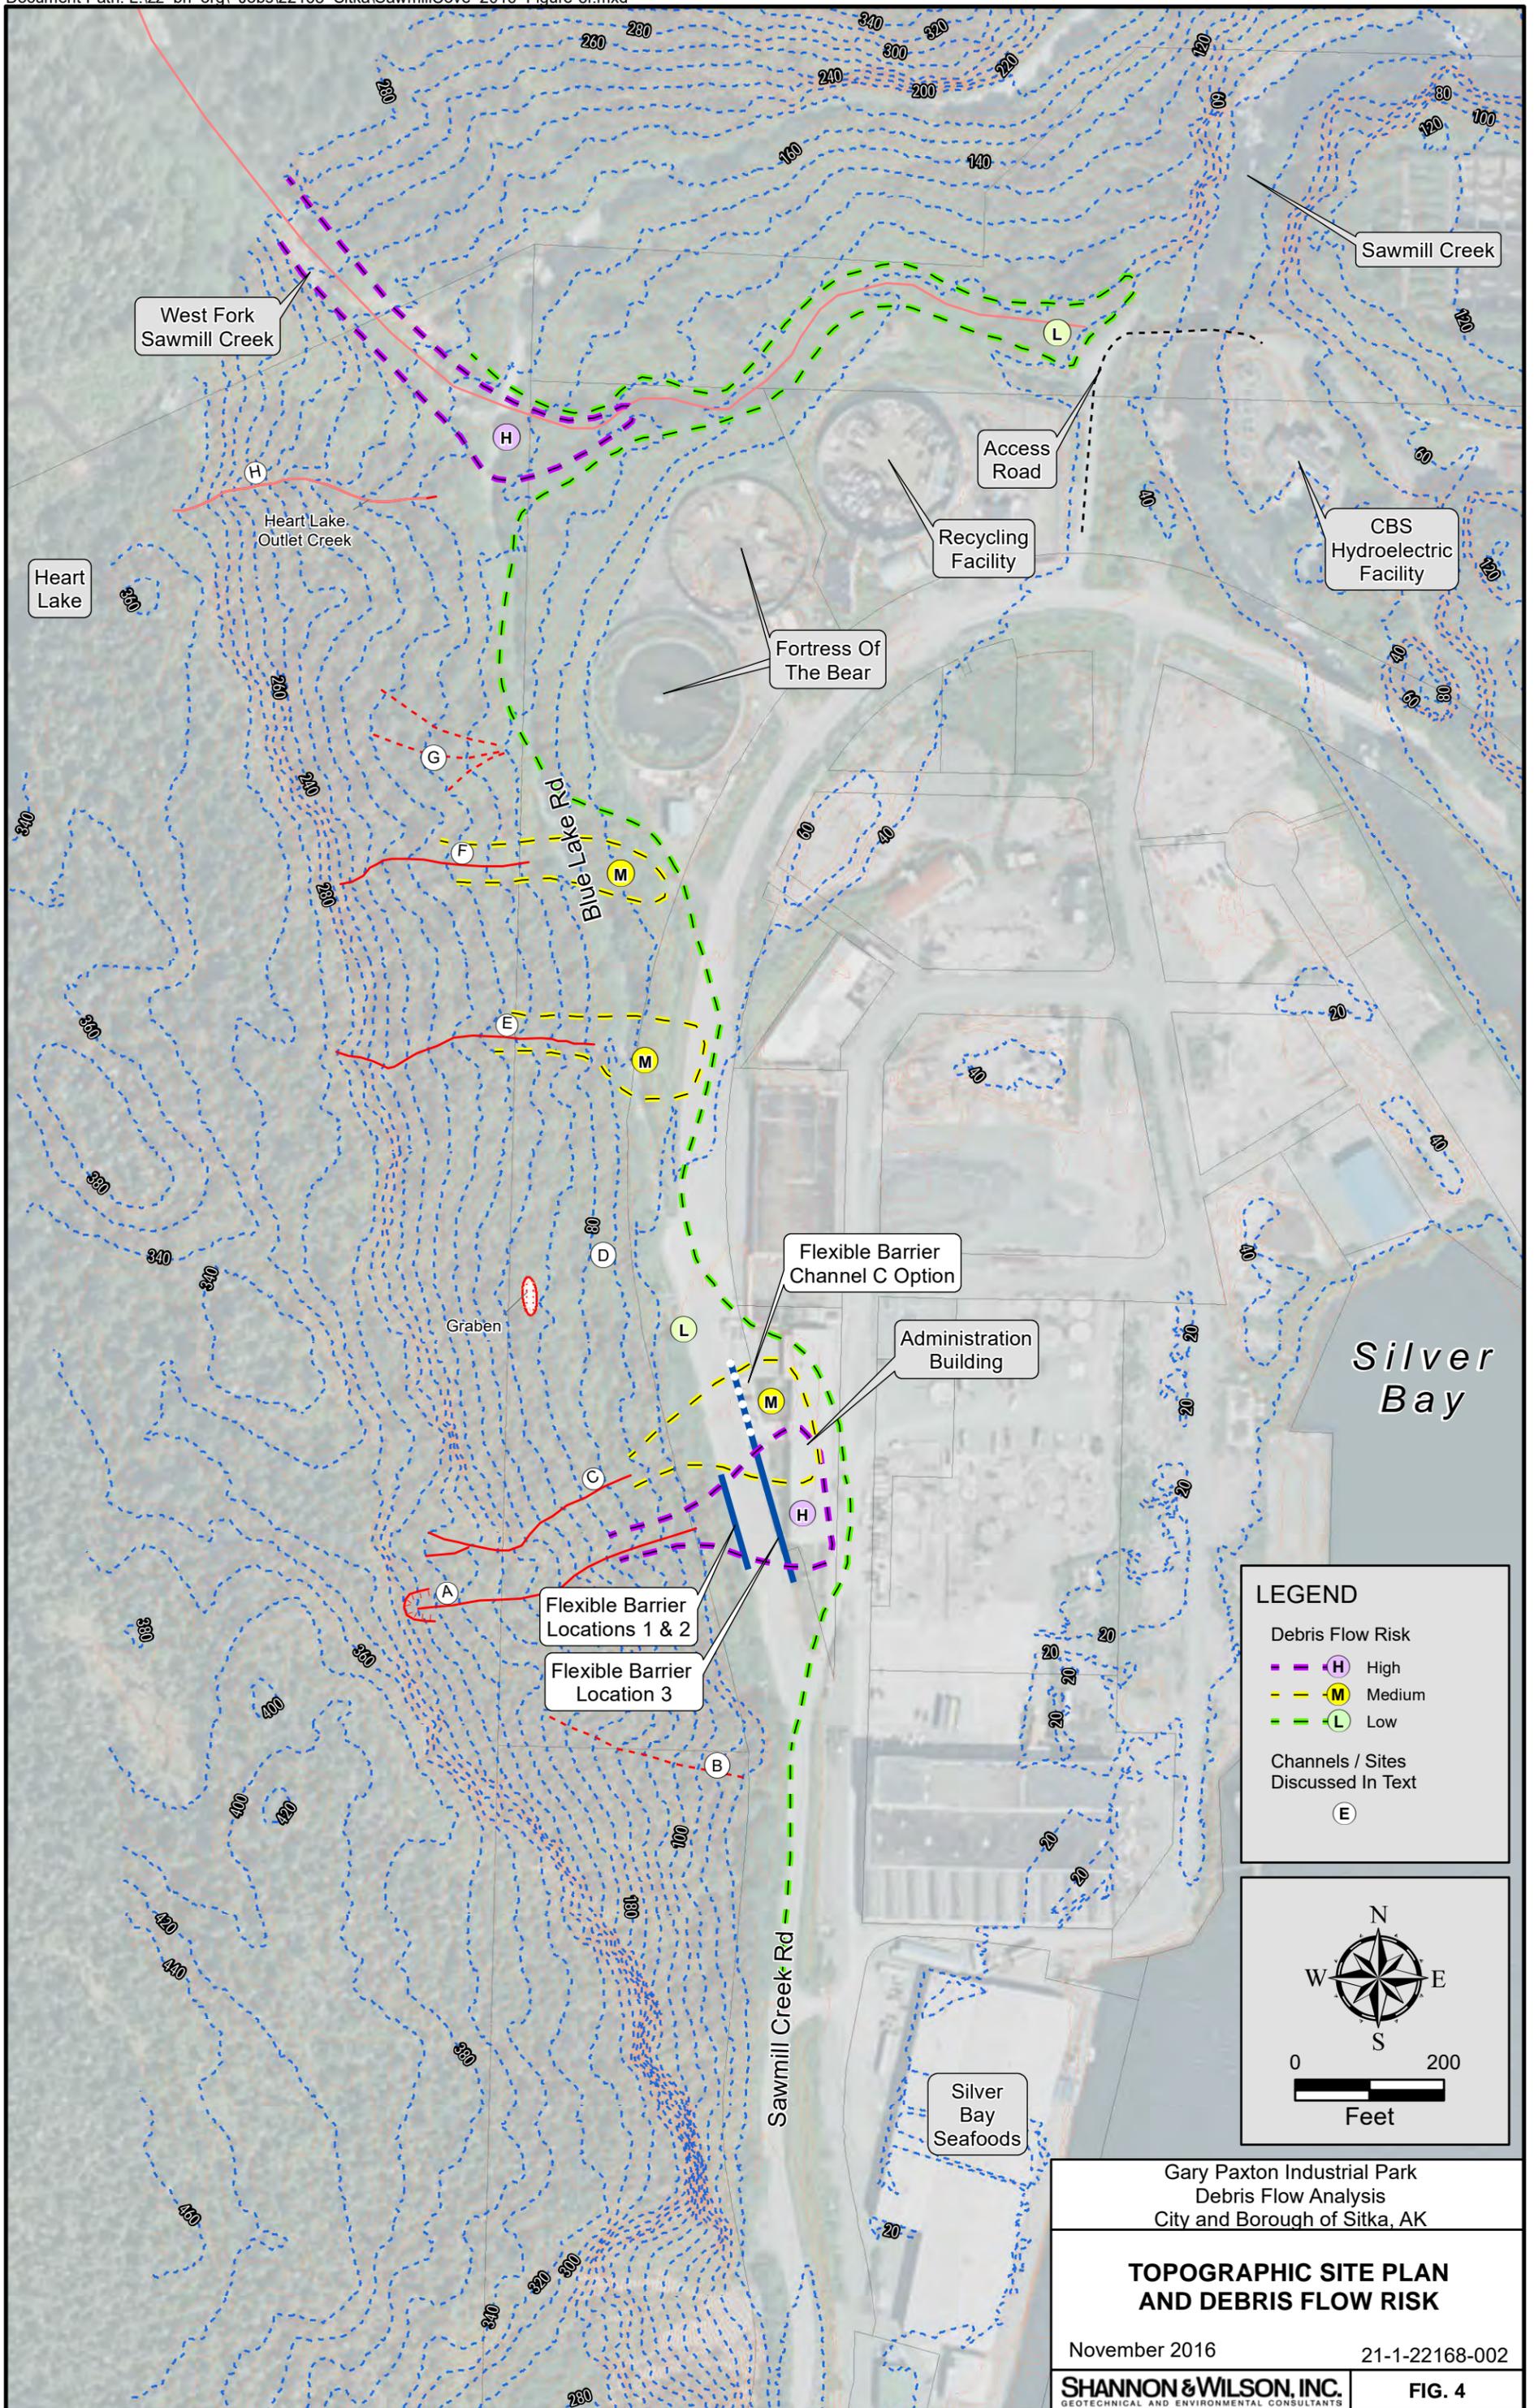
FIG. 4

Six small ephemeral creeks are located on Sawmill Creek Road Slope. All are unnamed; therefore, we used alphabetical designations for purposes of this letter report, as shown in Figure 4. As discussed in more detail below, many of these creeks flow in broad bowls, but the channel that failed in 2015 (Channel A) is incised into the hillside, as shown in Figure 2. Likewise, the northernmost channel on this slope that drains Heart Lake (Channel H) is deeply incised. This channel joins West Fork Sawmill Creek just below the Blue Lake Road.

Channel	Likelihood	Consequences
A	High	Additional landslides could occur near the existing headscarp and trigger debris flows. We recommend assuming a debris flow would be similar to the August 18, 2015, event.
B	Low	Small landslides could occur, but debris likely would not reach Sawmill Creek Road.
C	Moderate	A landslide occurring below the rocky escarpment could trigger a debris flow of similar size to the August 18, 2015, event. Because of the channel position, a debris flow could impact the Administration Building.
D	Low	If a deep-seated landslide occurred, it likely would affect the Blue Lake Road. We do not believe it would affect the Sawmill Creek Road.
E	Moderate	A debris flow likely would deposit most debris on the Blue Lake Road. Some debris could cross the road and deposit on the slopes below and on the Sawmill Creek Road. We do not believe a debris flow would cross the Sawmill Creek Road and impact buildings.

We recommend considering three flexible debris flow barrier alternatives at the locations shown on Figure 4:

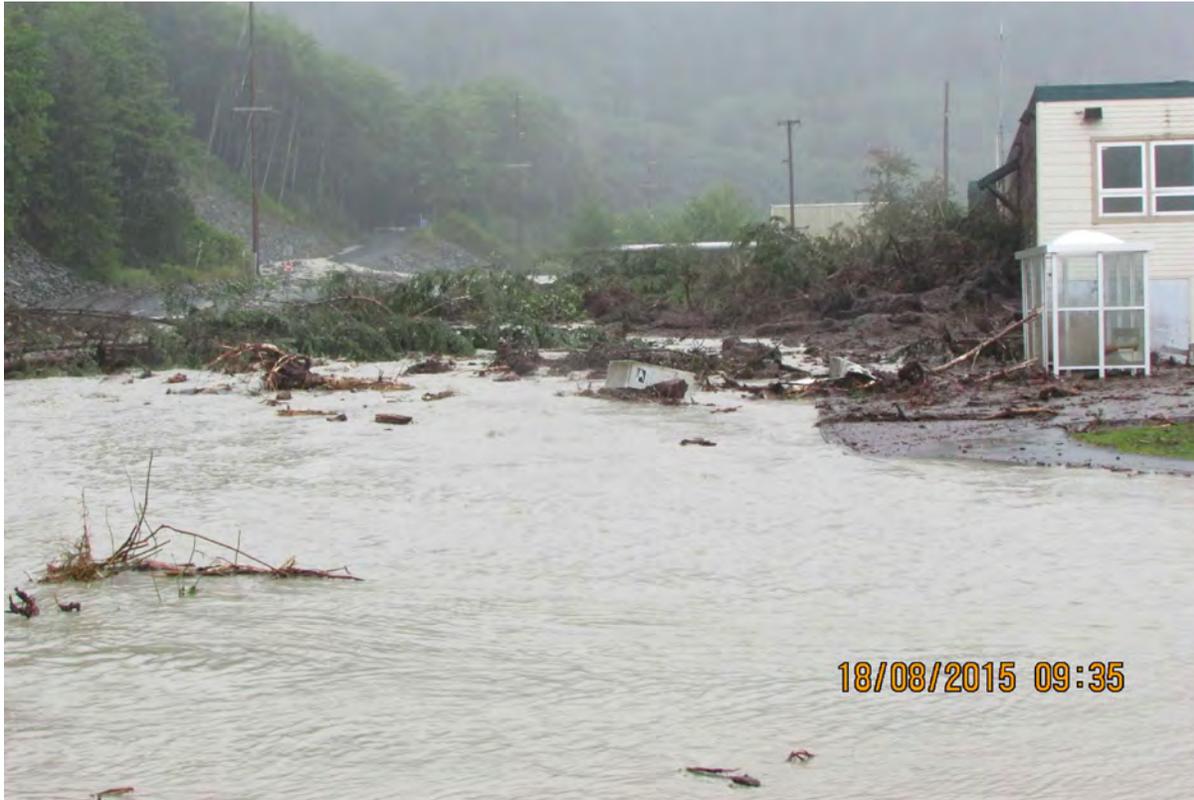
- The debris consisted of soil, riprap, and quarry spalls that had been placed on a cut-slope above Sawmill Creek Road, and trees, root wads, and bushes. Photograph 1 shows the debris against the Administration Building.

- The debris crossed Sawmill Creek Road and hit the Administration Building. Debris piled against the Administration Building to a depth of about 5 feet. Some debris flowed about 10 feet past the southwest corner of the building.

Photograph 1. Debris against administration building on August 18, 2015.
Photograph provided by CBS

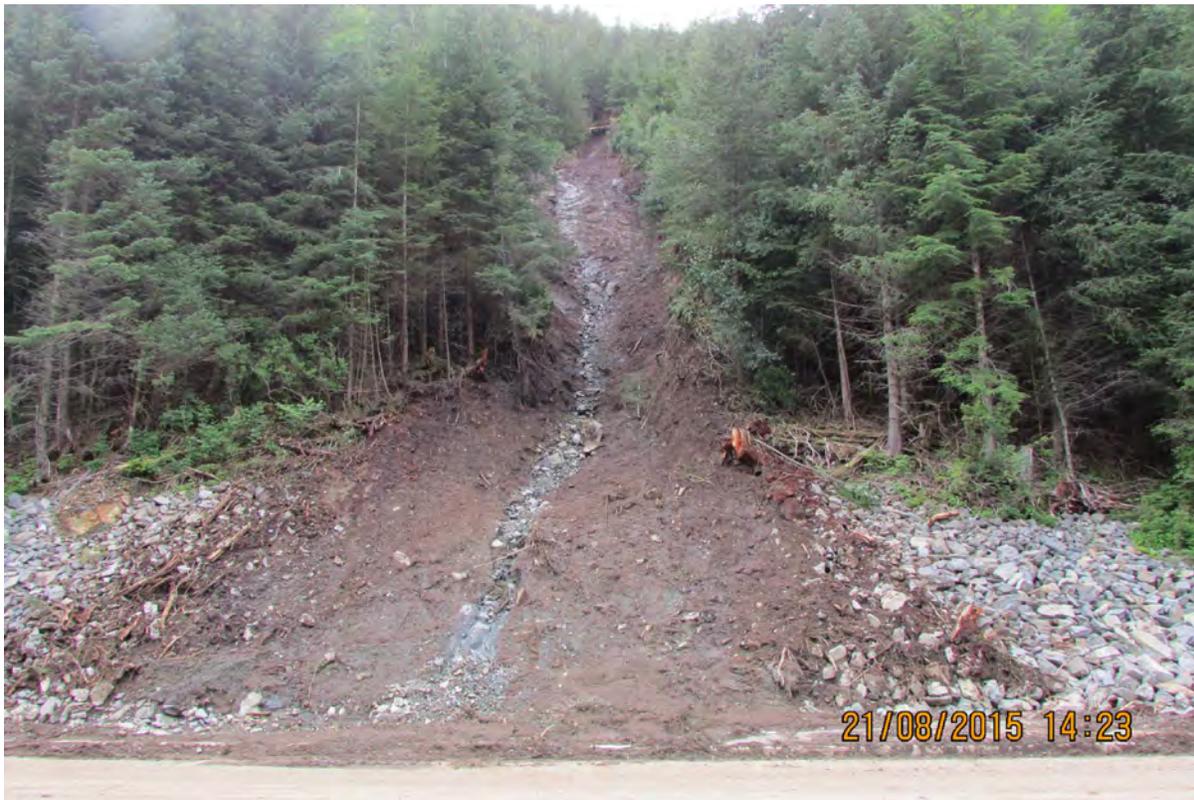
- The triggering landslide and debris flow occurred in the morning on August 18, 2015. The debris flow scoured a channel down to bedrock in the slopes above Sawmill Creek Road. Deposition occurred mainly between the toe of the slope and the Administration Building. Photograph 2 shows the channel scoured above Sawmill Creek Road.

Photograph 2. Sawmill Creek Road debris flow on August 21, 2015.
Photograph provided by CBS

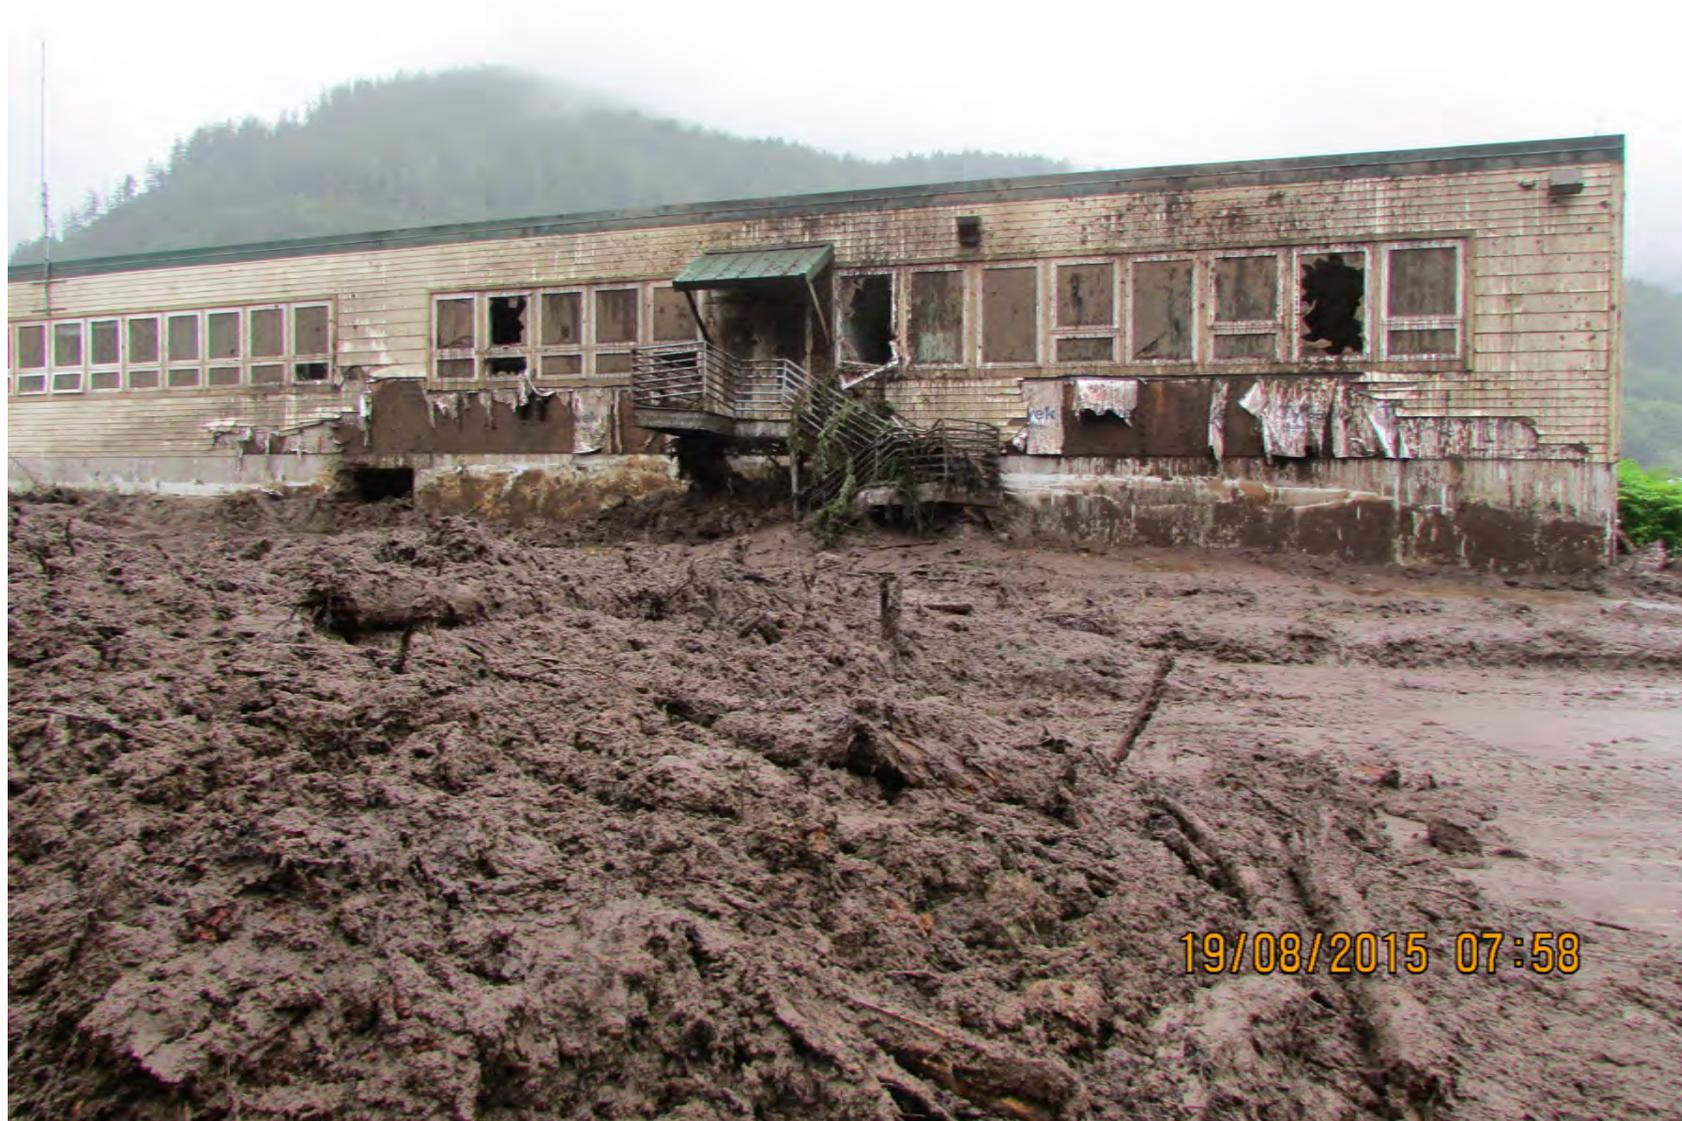
- The debris caused architectural damage to the Administration Building, including several broken windows and broken siding. Much of the building above the debris was spattered with mud. A mailbox in front of the building was ripped from its foundations. Photograph 3 shows damage to the Administration Building.
- CBS removed about 2,050 cubic yards of debris from Sawmill Creek Road and the parking and landscape areas in front of the Administration Building.

Photograph 3. Damage to Administration Building from Sawmill Creek Road debris flow. Photograph provided by CBS

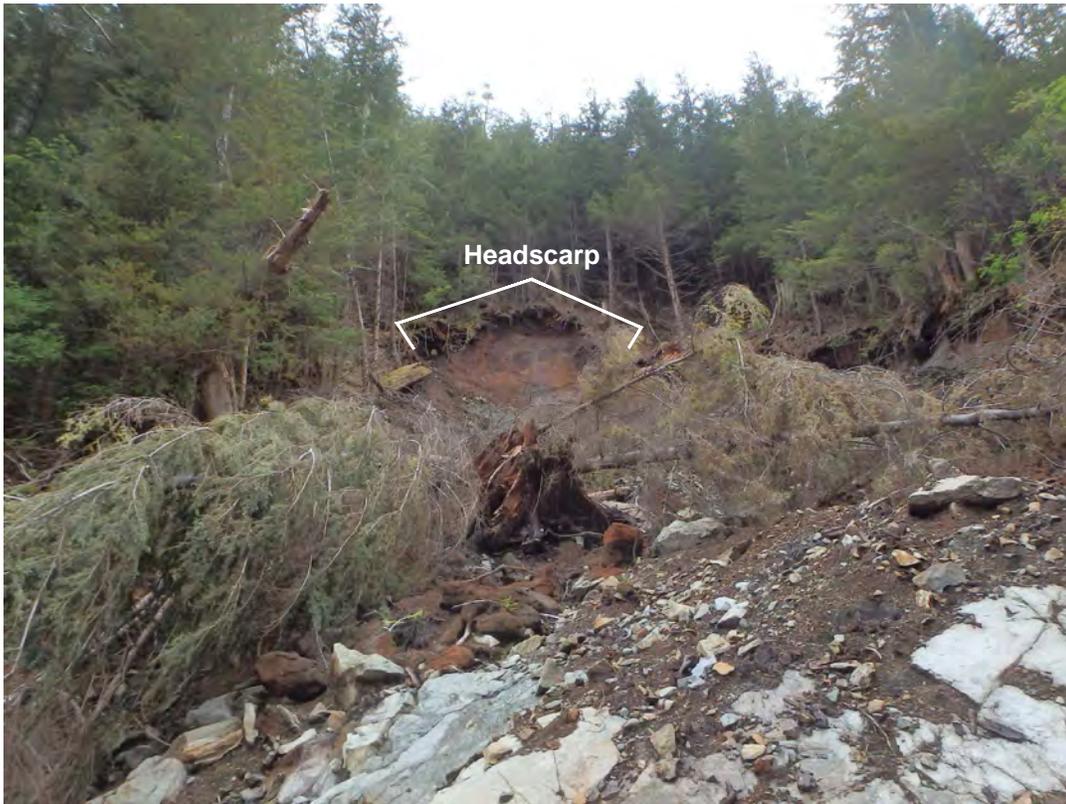
The debris flow likely began with a landslide near the base of the rocky escarpment, which is between about Elevation 260 to 300 feet. The triggering landslide occurred mostly in volcanic ash and colluvial soil that formed below the rocky escarpment. Glacial till underlies the volcanic ash and colluvial soil. The landslide was mostly about 5 feet thick, with a maximum headscarp height of about 15 feet. We believe the triggering landslide or landslides occurred between about Elevations 220 and 260 feet. The maximum width of the landslide initiation area at its base is about 45 feet. Photograph 5 shows the triggering landslide area, which is partially obscured by downed trees in the foreground. The accompanying profile shows the slopes along the bottom of the debris flow channel. Above the landslide area shown on the profile, the slope continues up to the rocky escarpment for about 10 to 30 feet. As shown in Table 1 above, we estimate the triggering landslide volume was about 500 to 600 cubic yards.

Photograph 5. Sawmill Creek Road debris flow initiation area.
Photograph taken May 31, 2016

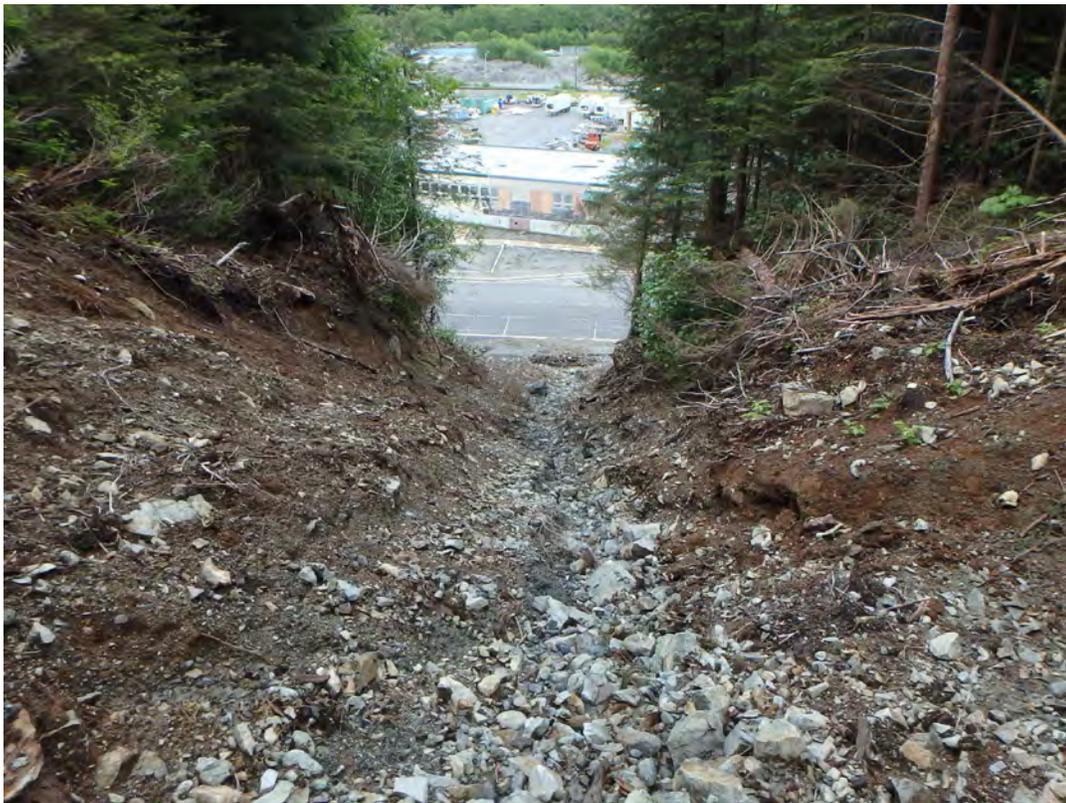
Most of the channel scoured downslope from the triggering landslides contained colluvium and glacial till. In two areas, the debris flow scoured down to bedrock, as shown in the profile above. The higher bedrock area shown in the profile above is visible in the foreground of Photograph 5. The scoured channel shown in Photograph 6 is underlain by glacial till. The glacial till and bedrock are resistant to erosion, and the debris flow had a relatively short runout before reaching flat ground. Therefore, the total debris flow volume was about 2,000 cubic yards, which was on the order of four times the triggering landslide volume.

Photograph 6. Sawmill Creek Road debris flow path, looking east.
Photograph taken May 31, 2016

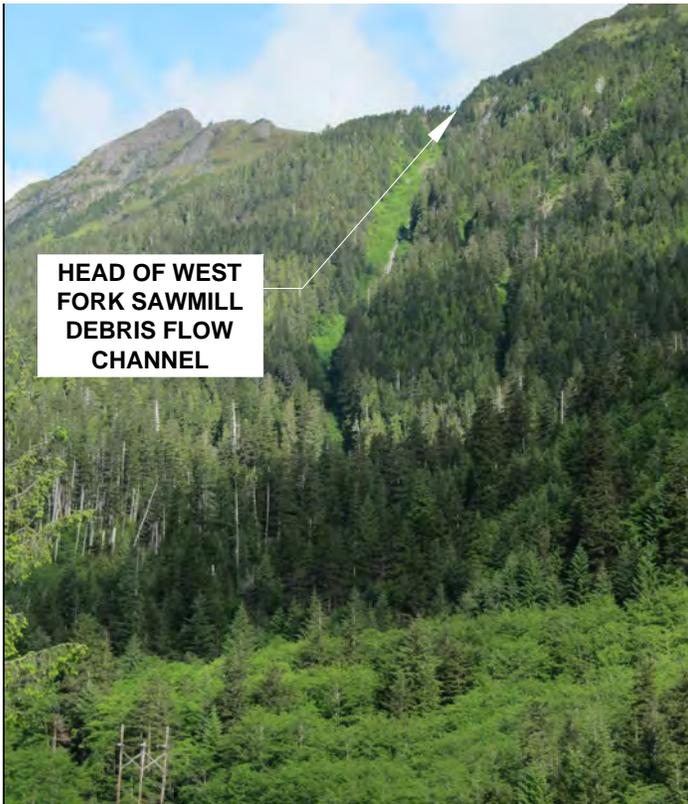
HEAD OF WEST
FORK SAWMILL
DEBRIS FLOW
CHANNEL

Photograph 7.
Head of West Fork Sawmill
Creek debris flow channel.

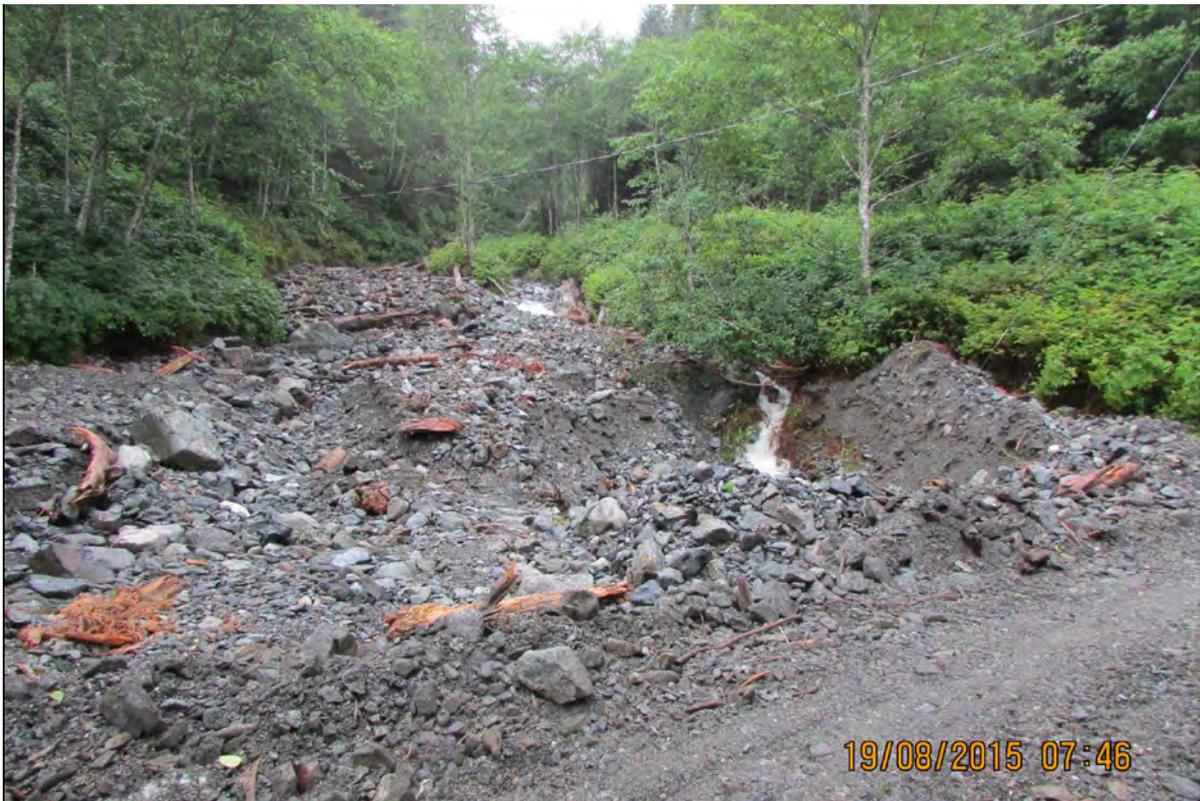
Photograph 8. West Fork Sawmill Creek channel, upstream from Blue Lake Road on August 19, 2015. Photograph provided by CBS

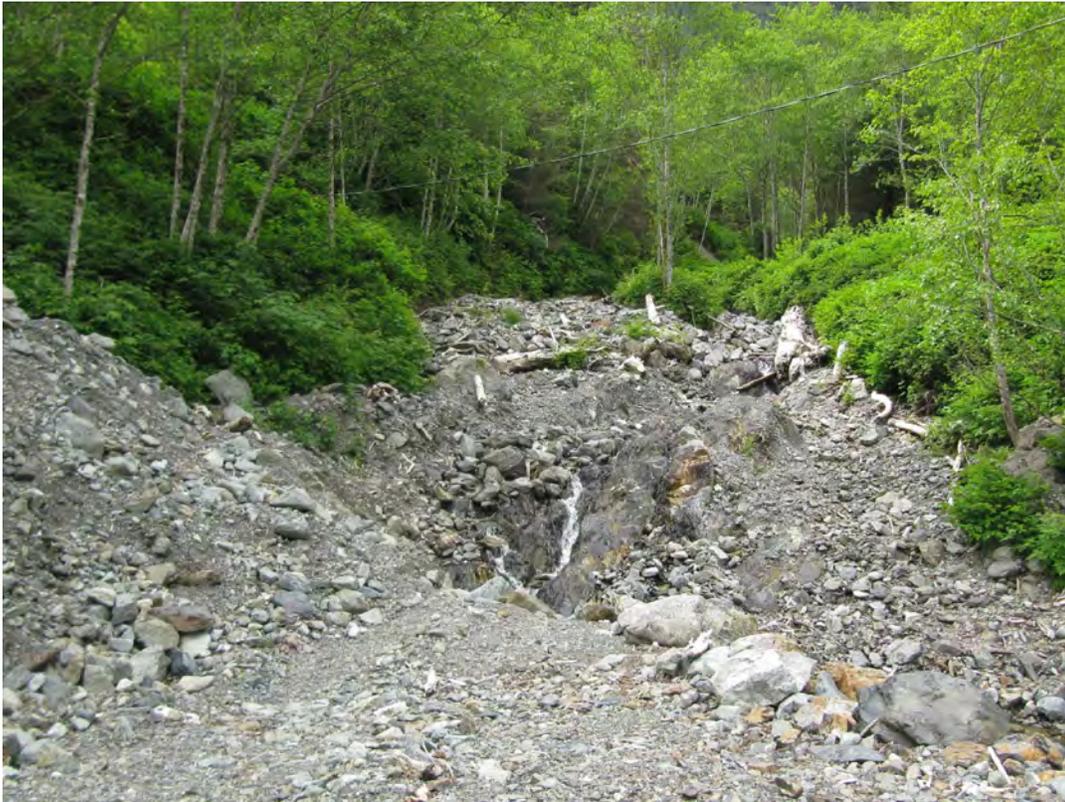
Photograph 9. West Fork Sawmill Creek channel, upstream of Blue Creek Road crossing on June 2, 2016. Note rock outcrop in creek channel.

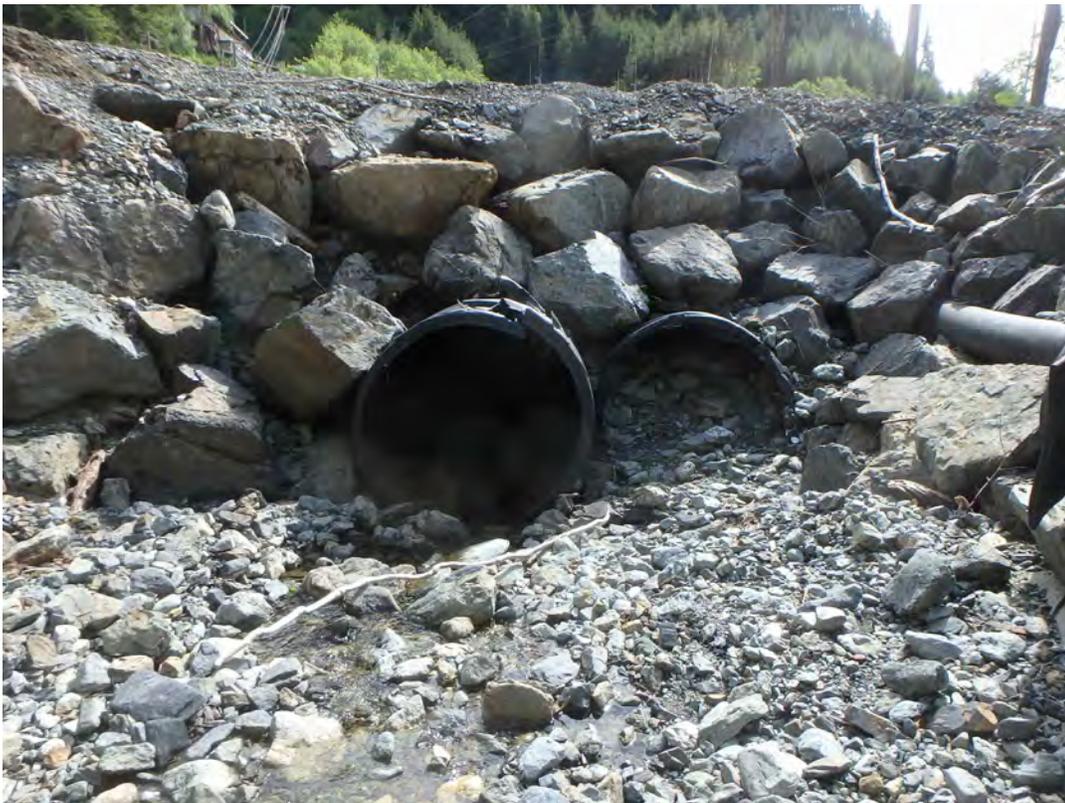
Photograph 10. West Fork Sawmill Creek twin culvert beneath hydroelectric facility access road. Note right culvert is filled with debris. Photograph taken May 31, 2016.

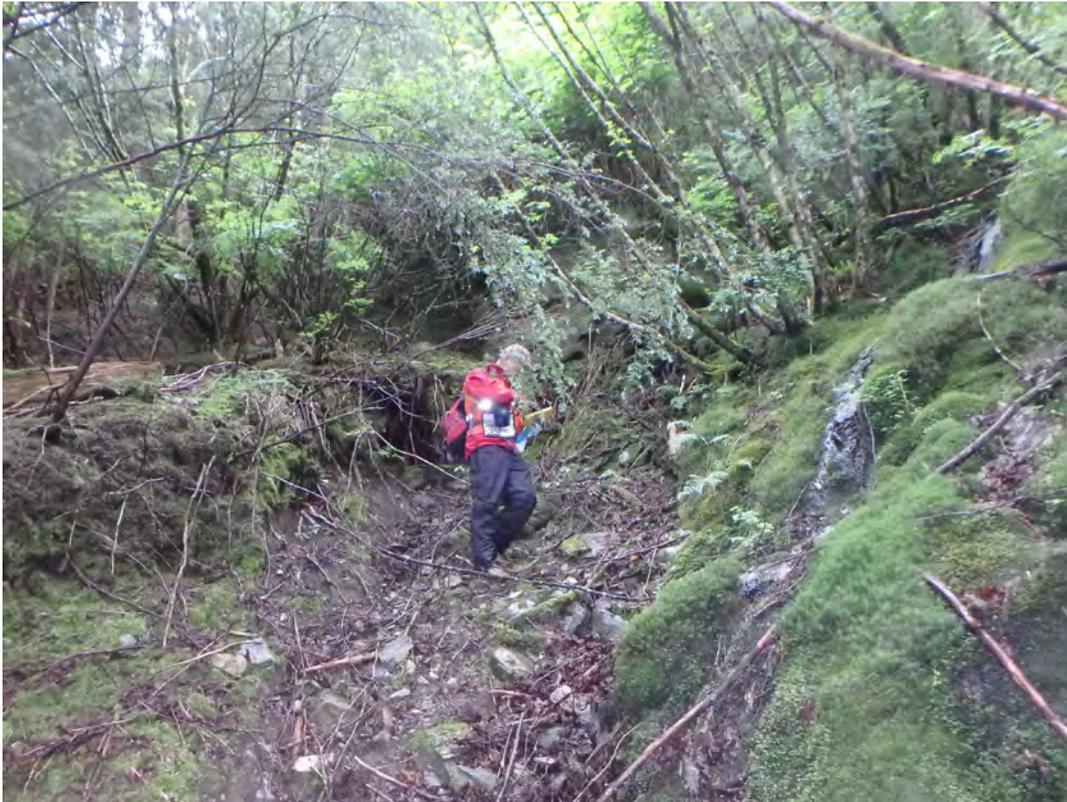
We observed two small landslide and/or erosion areas. Photograph 11 shows a small landslide near Elevation 80 feet. The landslide is 3 to 4 feet deep, up to 10 feet wide, and about 30 feet long. It is bounded by bedrock above and to the north. A small debris fan was visible below the landslide. It did not extend to the more gentle slopes next to Sawmill Creek Road.

Photograph 11. Small landslide at the top of channel B. Note bedrock above and to the right of the landslide scar. Photograph taken June 1, 2016.

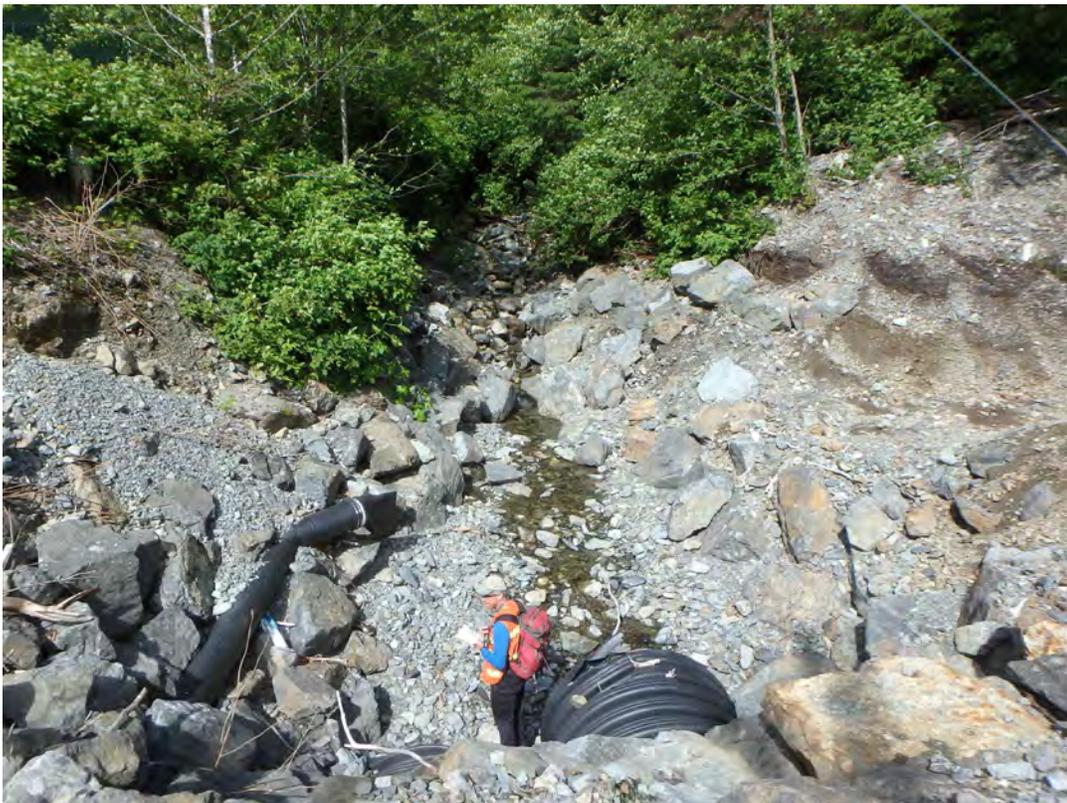
Photograph 12. West Fork Sawmill Creek, looking upstream from hydro electric facility access road. Overflow channel is to the right.

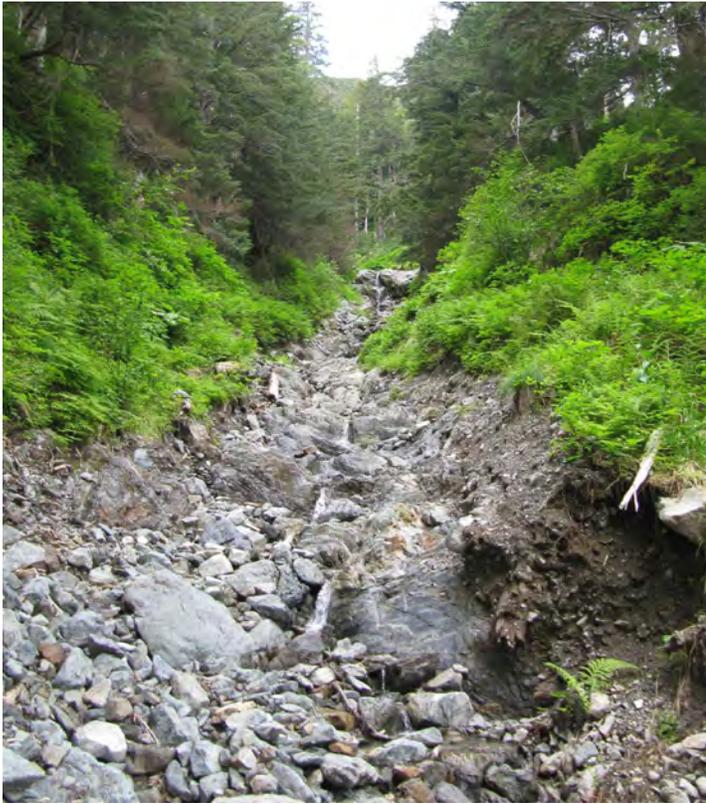
Photograph 13. West Fork Sawmill Creek below bedrock step. Note steep side, recent vegetation and mostly bedrock outcrop in channel bottom.

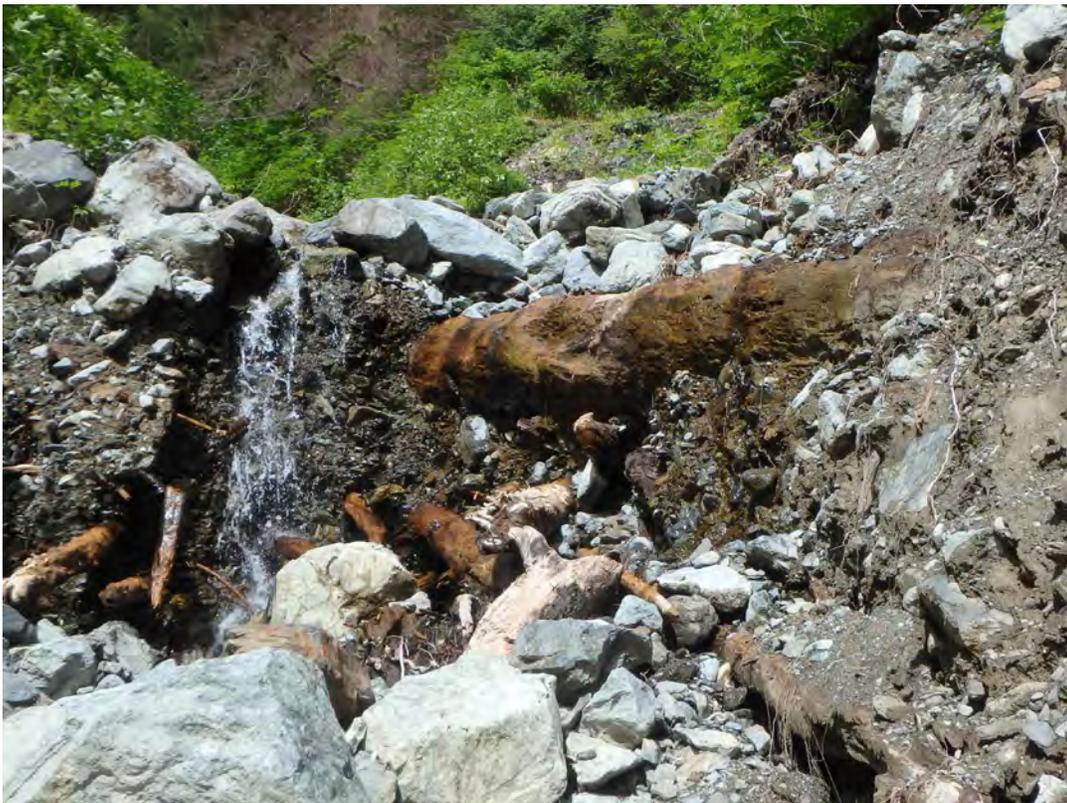
Photograph 14. West Fork Sawmill Creek just upstream from confluence with Tributary 2. Note large wood in previous unsorted debris flow deposits.

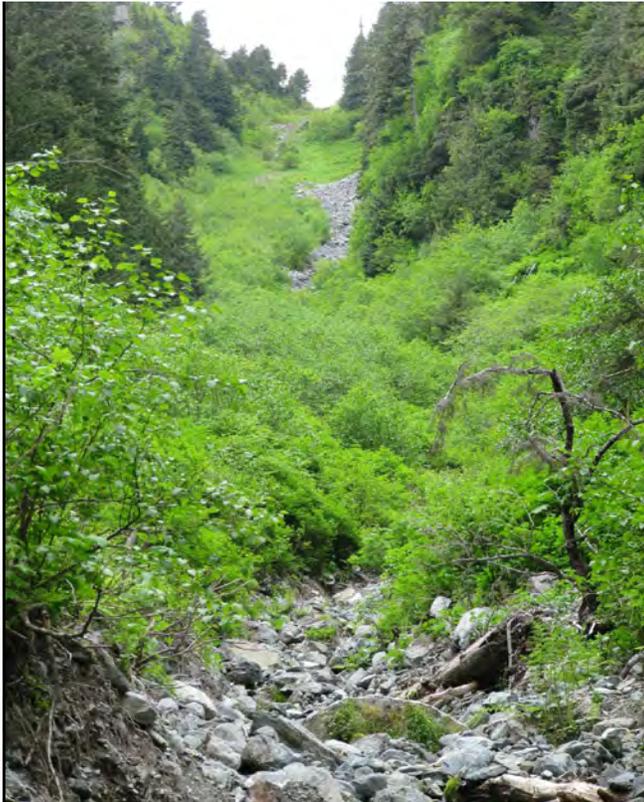
Photograph 15.
Upper, steep segments of
West Fork Sawmill Creek.
