21-1-22168-001

February 2, 2016

**RE: SOUTH KRAMER AVENUE LANDSLIDE: JACOBS CIRCLE TO  
EMMONS STREET, SITKA, ALASKA**

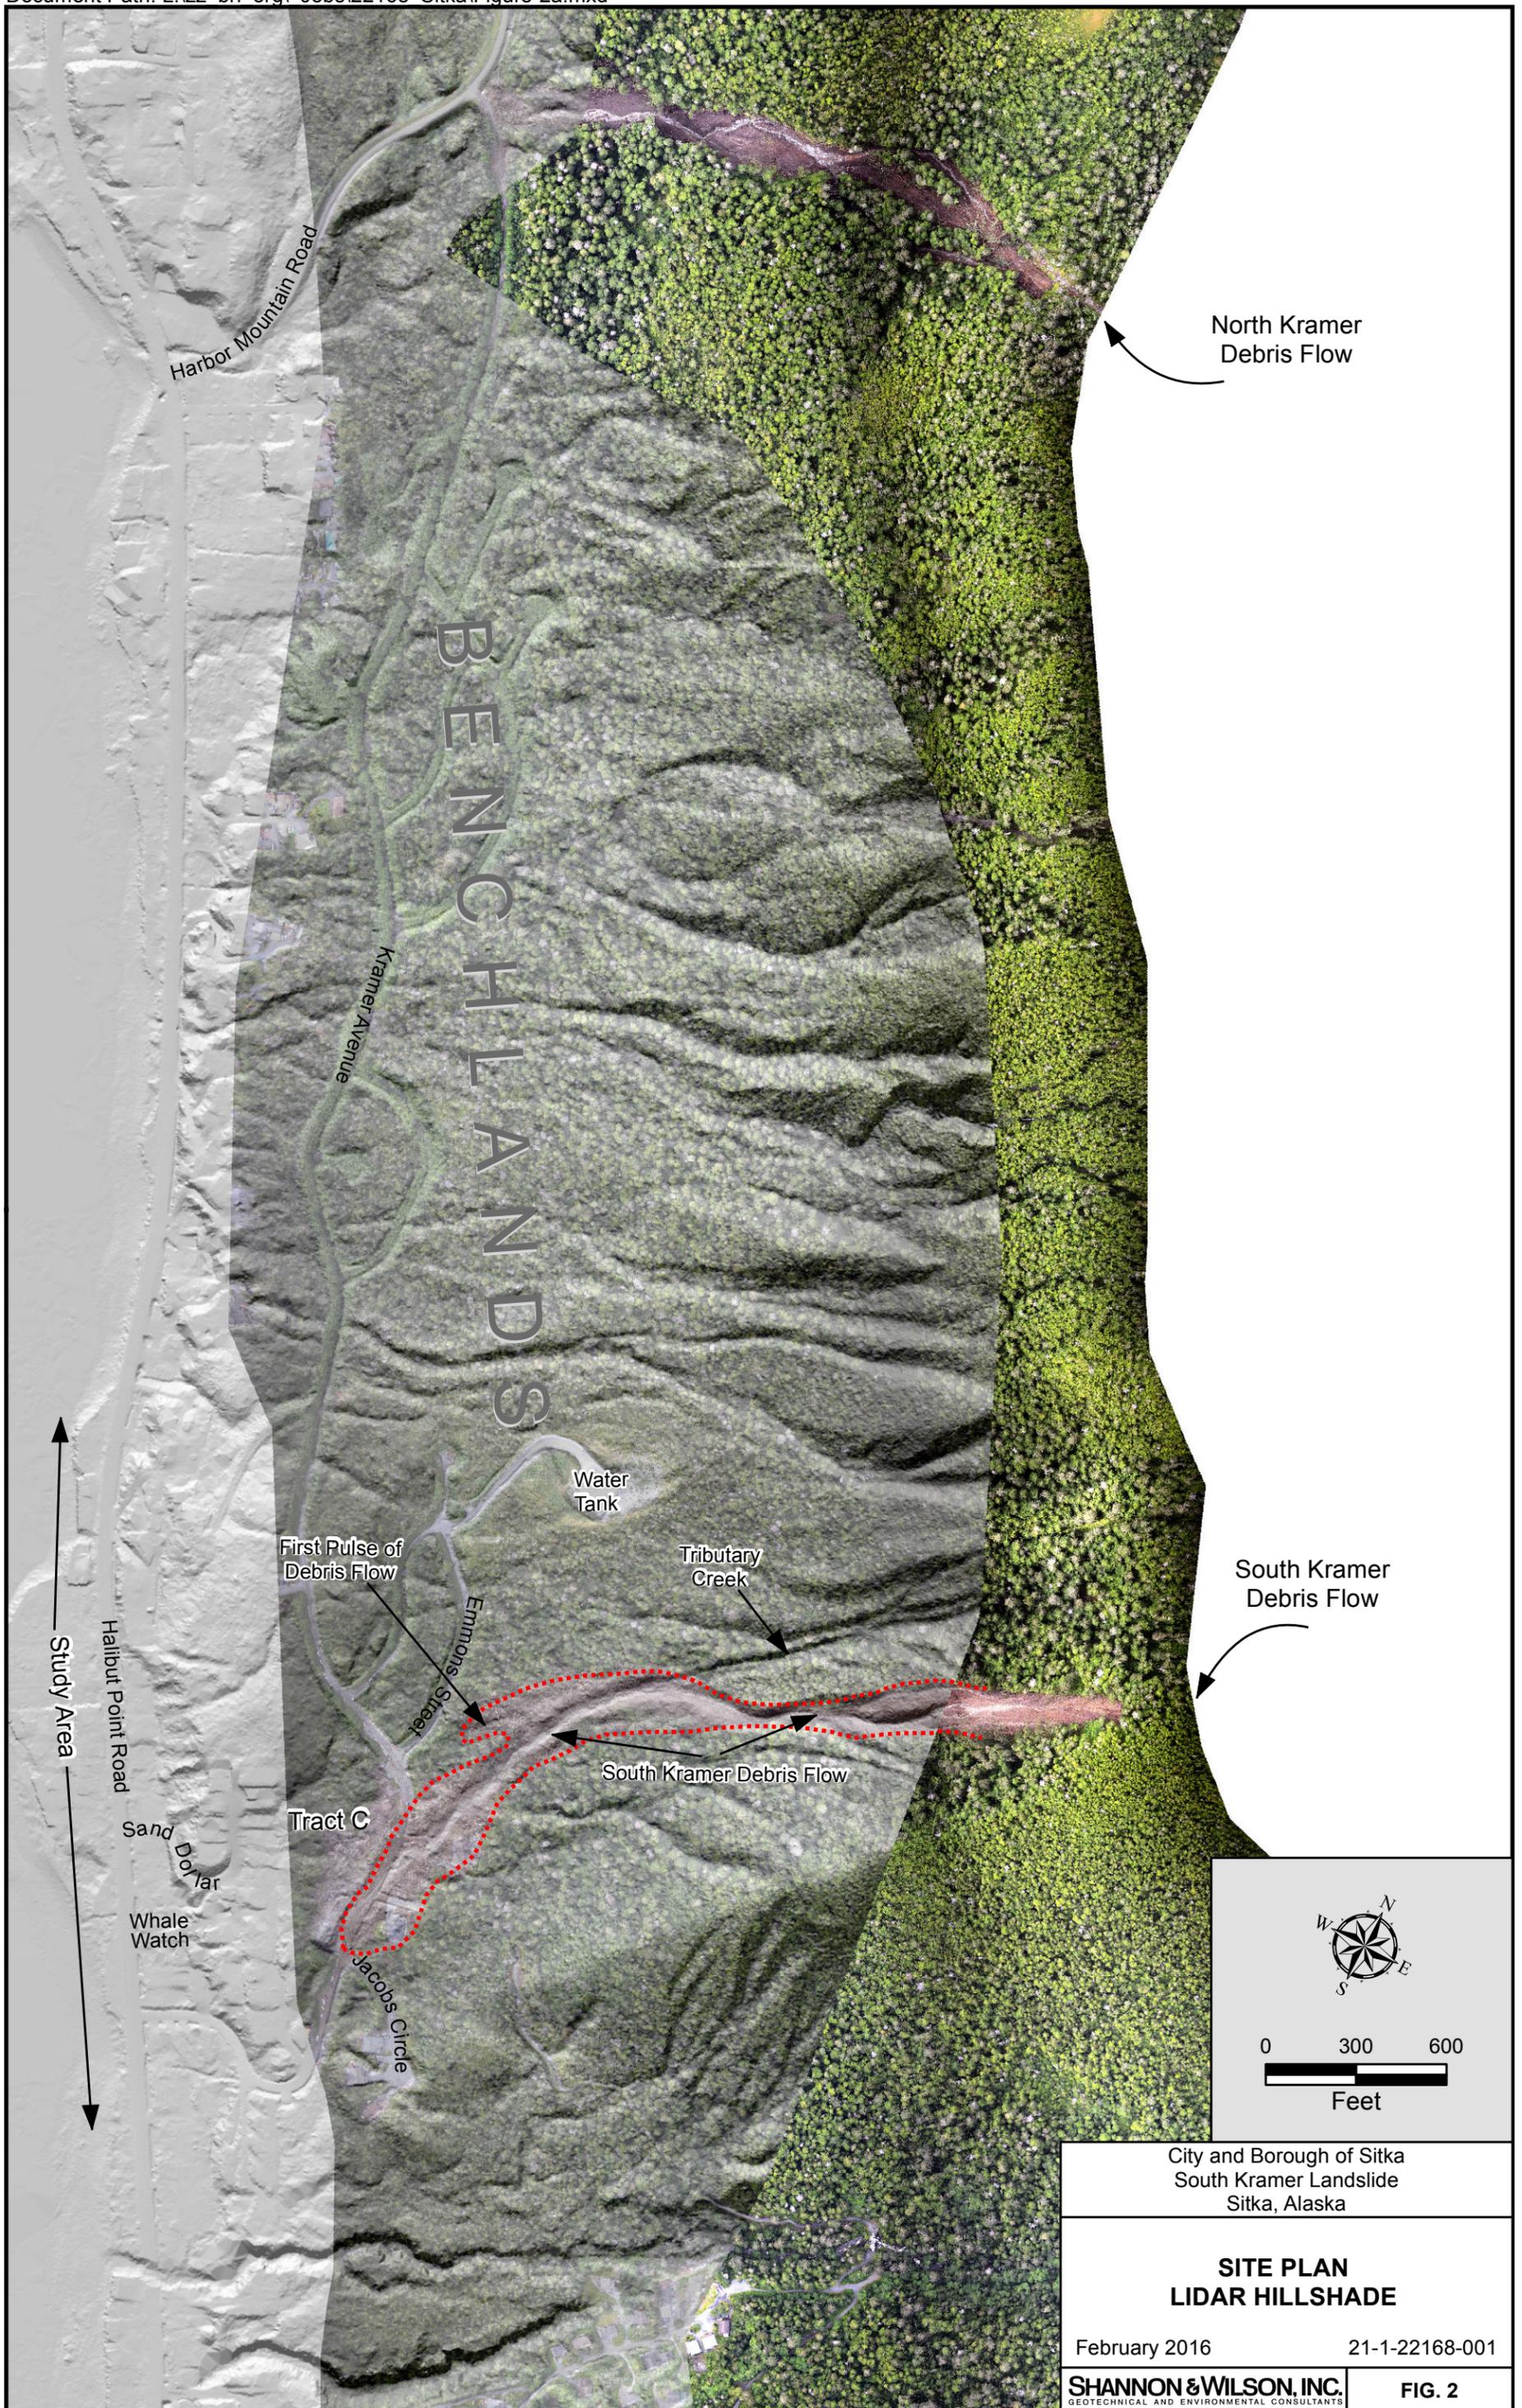
**FIG. 2**

From aerial photographs and from field observations, it appears that the first pulse of the debris flow left the channel and plowed into the woods near elevation 240 feet, as indicated in Figures 2 and 3. This was likely the result of an upslope, straight segment of the channel and the debris wanting to maintain a straight line. After the first pulse, the bulk of the debris followed the existing channel that was directed toward the residence at 430 Kramer Avenue. The debris killed three people, and destroyed one residence and damaged another. Upon reaching Kramer Avenue, the debris encountered a low berm on the south side of the road that appears from photographs to have been 2 to 3 feet higher than Kramer Avenue. Farther south along the western side of Kramer Avenue, fill was mounded 8 to 10 feet high in an earthfill berm. When the debris flow encountered these berms, it turned southward down the road. It came to a stop about 400 feet from the point at which it reached Kramer Avenue, as shown in Figures 2, 3, and 6.

The Light Detection and Ranging (LiDAR) hillshade image (Figure 2) of the study area is informative but enigmatic. On a very broad scale, it has been suggested by others that the west-facing slope of Harbor Mountain collapsed in ancient times, spreading landslide debris into the ocean, one remnant of which is a shoreline protrusion. There is no evidence in outcrop or exposure of debris of such a widespread event, and the LiDAR image does not unequivocally support such a hypothesis.

The LiDAR image does support the hypothesis that the Benchlands is, in part, constructed of landslide materials supplied by repeated debris flows along several discrete chutes that originate on Harbor Mountain. The depositional distribution of the landslide debris also supports this idea. No landslide debris is observed or reported to the west of Kramer Avenue.

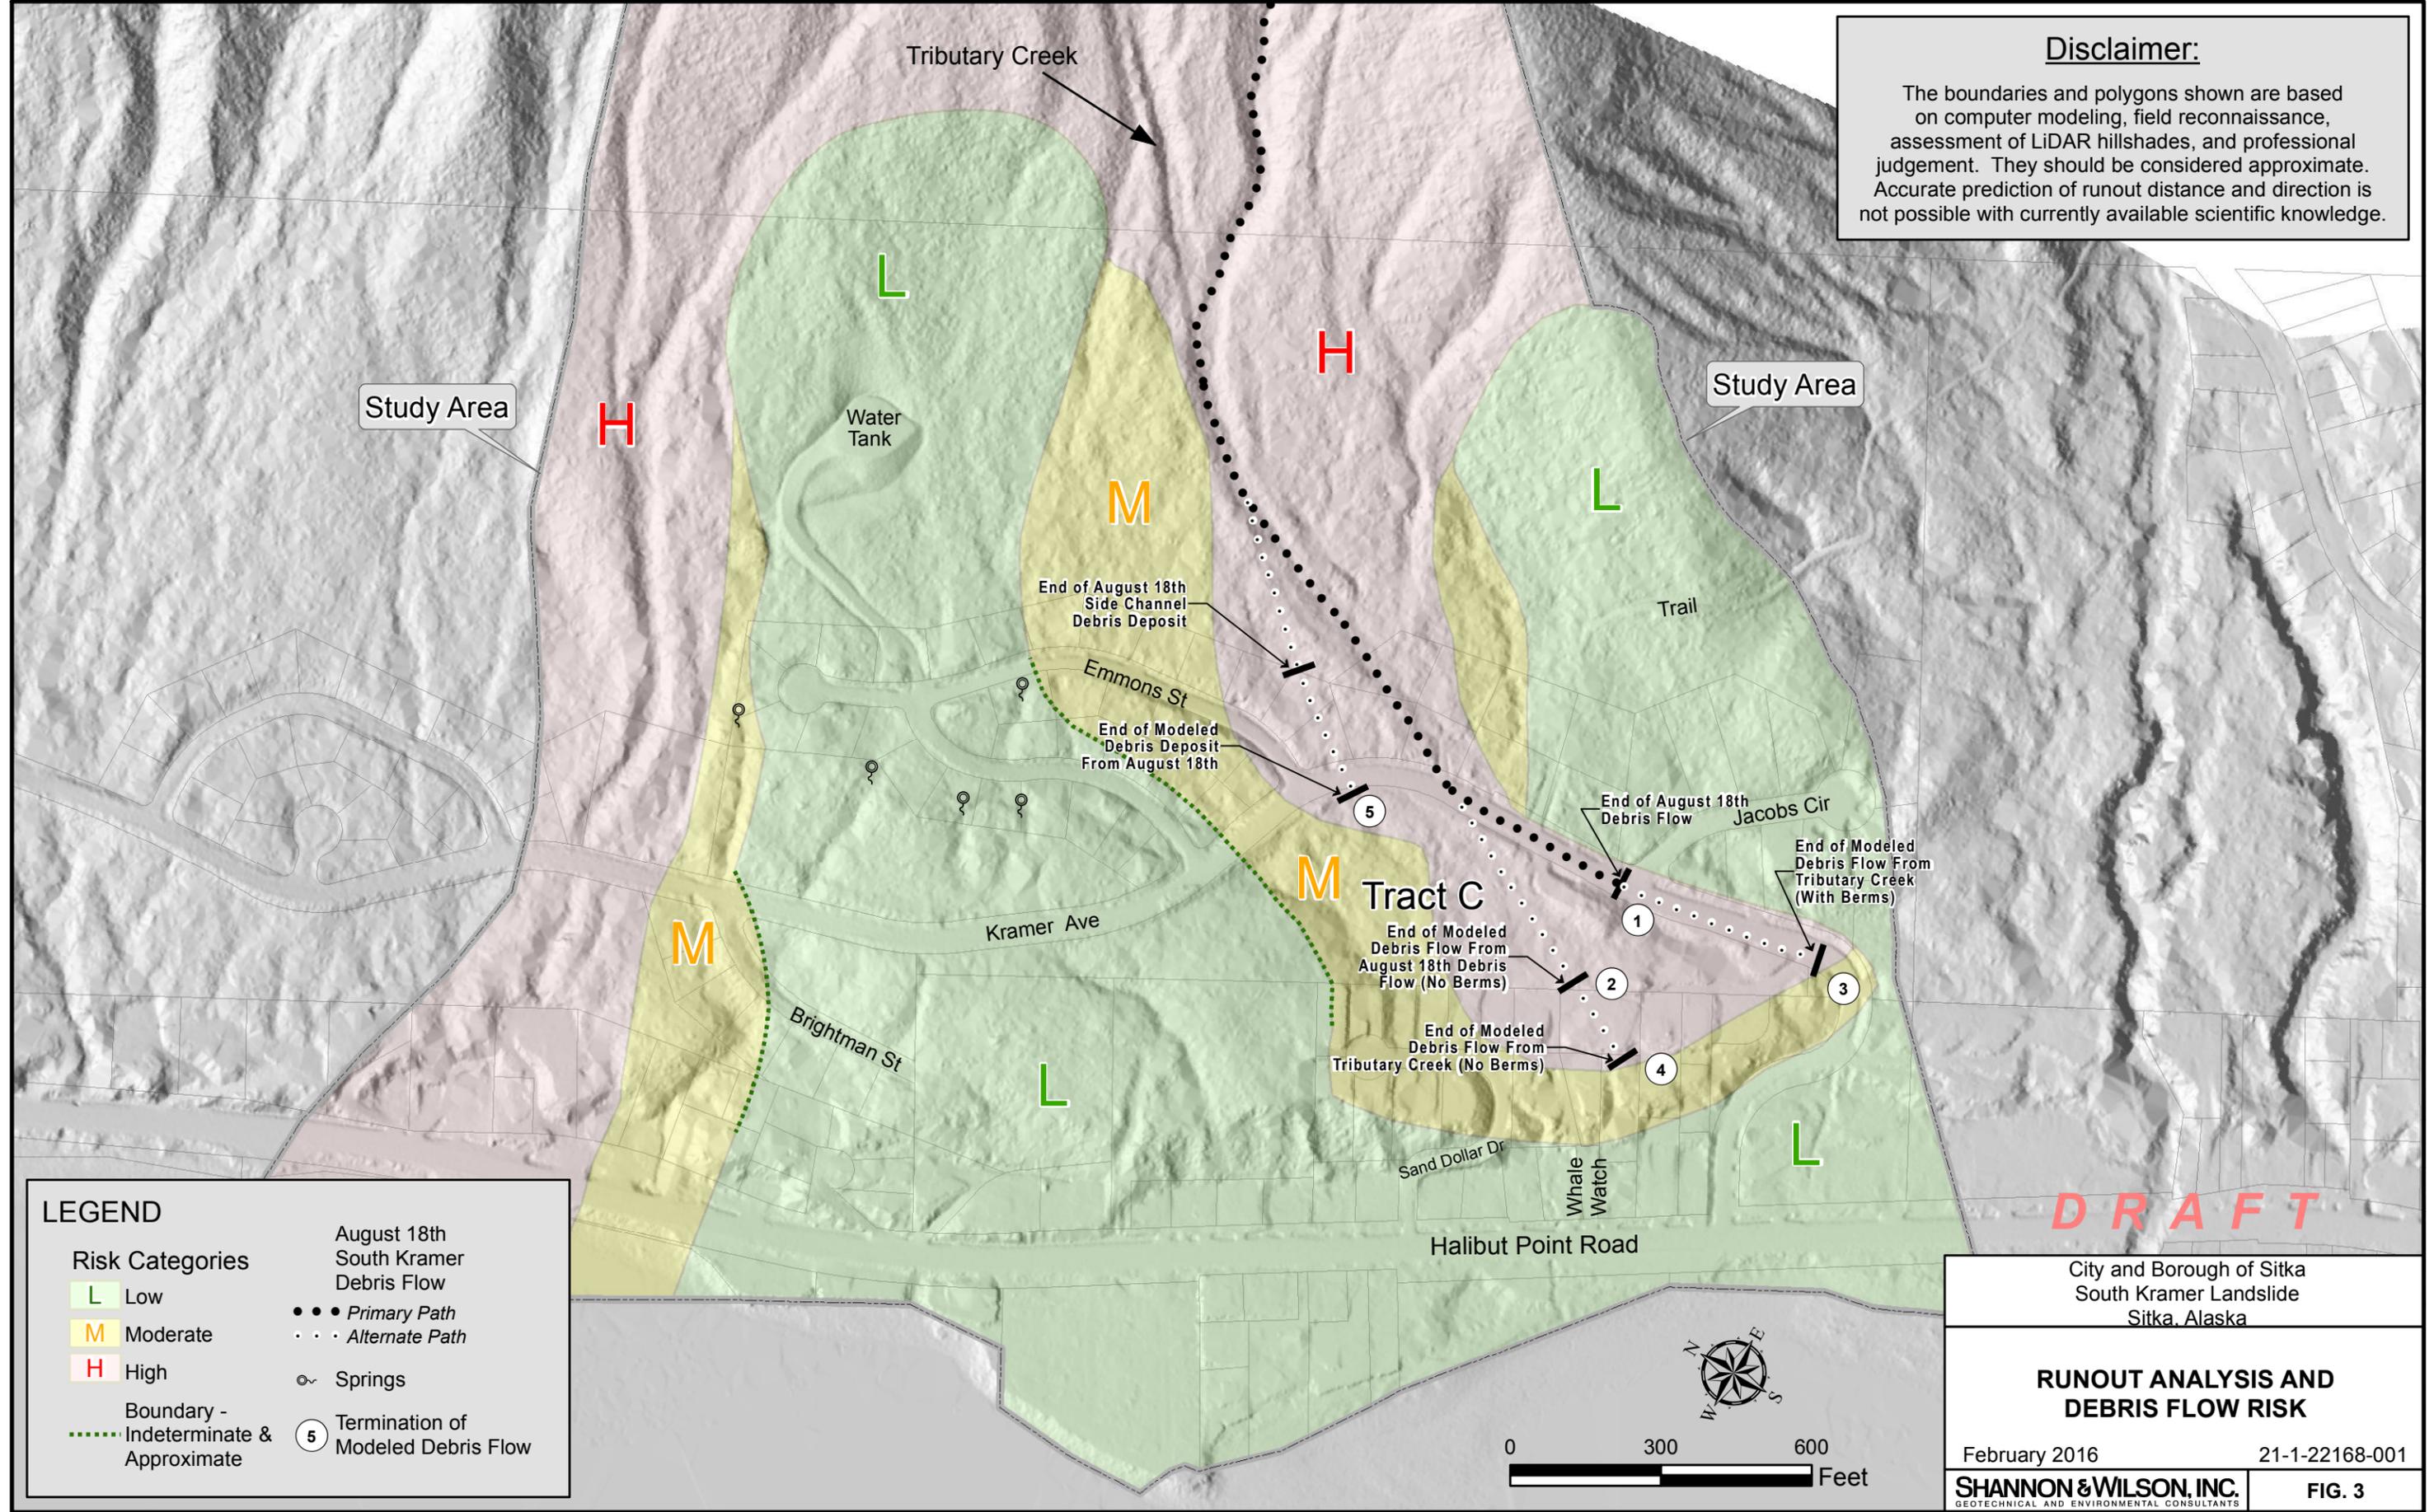
**FIG. 3**

Groundwater is perched in this area. In the Golder report, groundwater levels ranged from 1.5 to 8.5 feet below ground surface. Numerous springs, as noted in Figure 3, emerge from the hillside. In some cases, they form the heads of through-going surface streams. In other cases, they infiltrate back into the ground and pop out farther downslope. In some areas, such as Tract C, most of the ground is covered with standing water, likely perched on ash or till.

The locations of the distal ends of the modeled runouts are presented in Figure 3. Modeling indicated that another debris flow along the August 18 alignment would end up in the same place as before, assuming that the berms on the west side of Kramer Avenue were left in place. If the berms were not in place on August 18, the debris could potentially have runout into Tract C about 400 feet southwest of Kramer Avenue. If the August 18 debris flow deposit had continued straight westward through the woods, as shown in Figures 2 and 3, it could have reached Kramer Avenue. Modeling of this side branch of the debris flow showed that once the debris flow material leaves the channelized section of the creek and becomes a uniform unchannelized slope, the debris slows and deposits relatively quickly, as shown in Figure 3. The modeling does not

If this higher bedrock hollow failed in a manner similar to the August 18 debris flow, the model predicts that it would flow down Kramer Avenue about 400 feet beyond the Kramer Avenue debris deposit, assuming the berms were in place. Without the berms in place, this modeled debris flow would move about 580 feet southwest of Kramer Avenue, reaching residences on the eastern side of Whale Watch Drive and Sand Dollar Drive.

Three moderate risk zones were identified, as shown in Figure 3. They are either buffer areas between high- and low-risk zones, or areas that offer slightly higher risk than low, as discussed below. One is the buffer zone adjacent to the debris chute high-risk zone on the northern edge of the study area. Another buffer zone is located downhill (west) of Tract C. Another moderate zone is located uphill of Emmons Street where there appear to be deposits of ancient, relict debris flows. The channel that originally supplied debris to this area is presently incapable of delivering debris to this same area, in our opinion; however, if the adjacent incised creek/swale should become blocked during a debris flow, the relict channel could potentially deliver debris to this area again. If any new development or redevelopment is contemplated for these areas, a geotechnical evaluation should be performed and reviewed in the same manner as recommended above for high-risk zones.

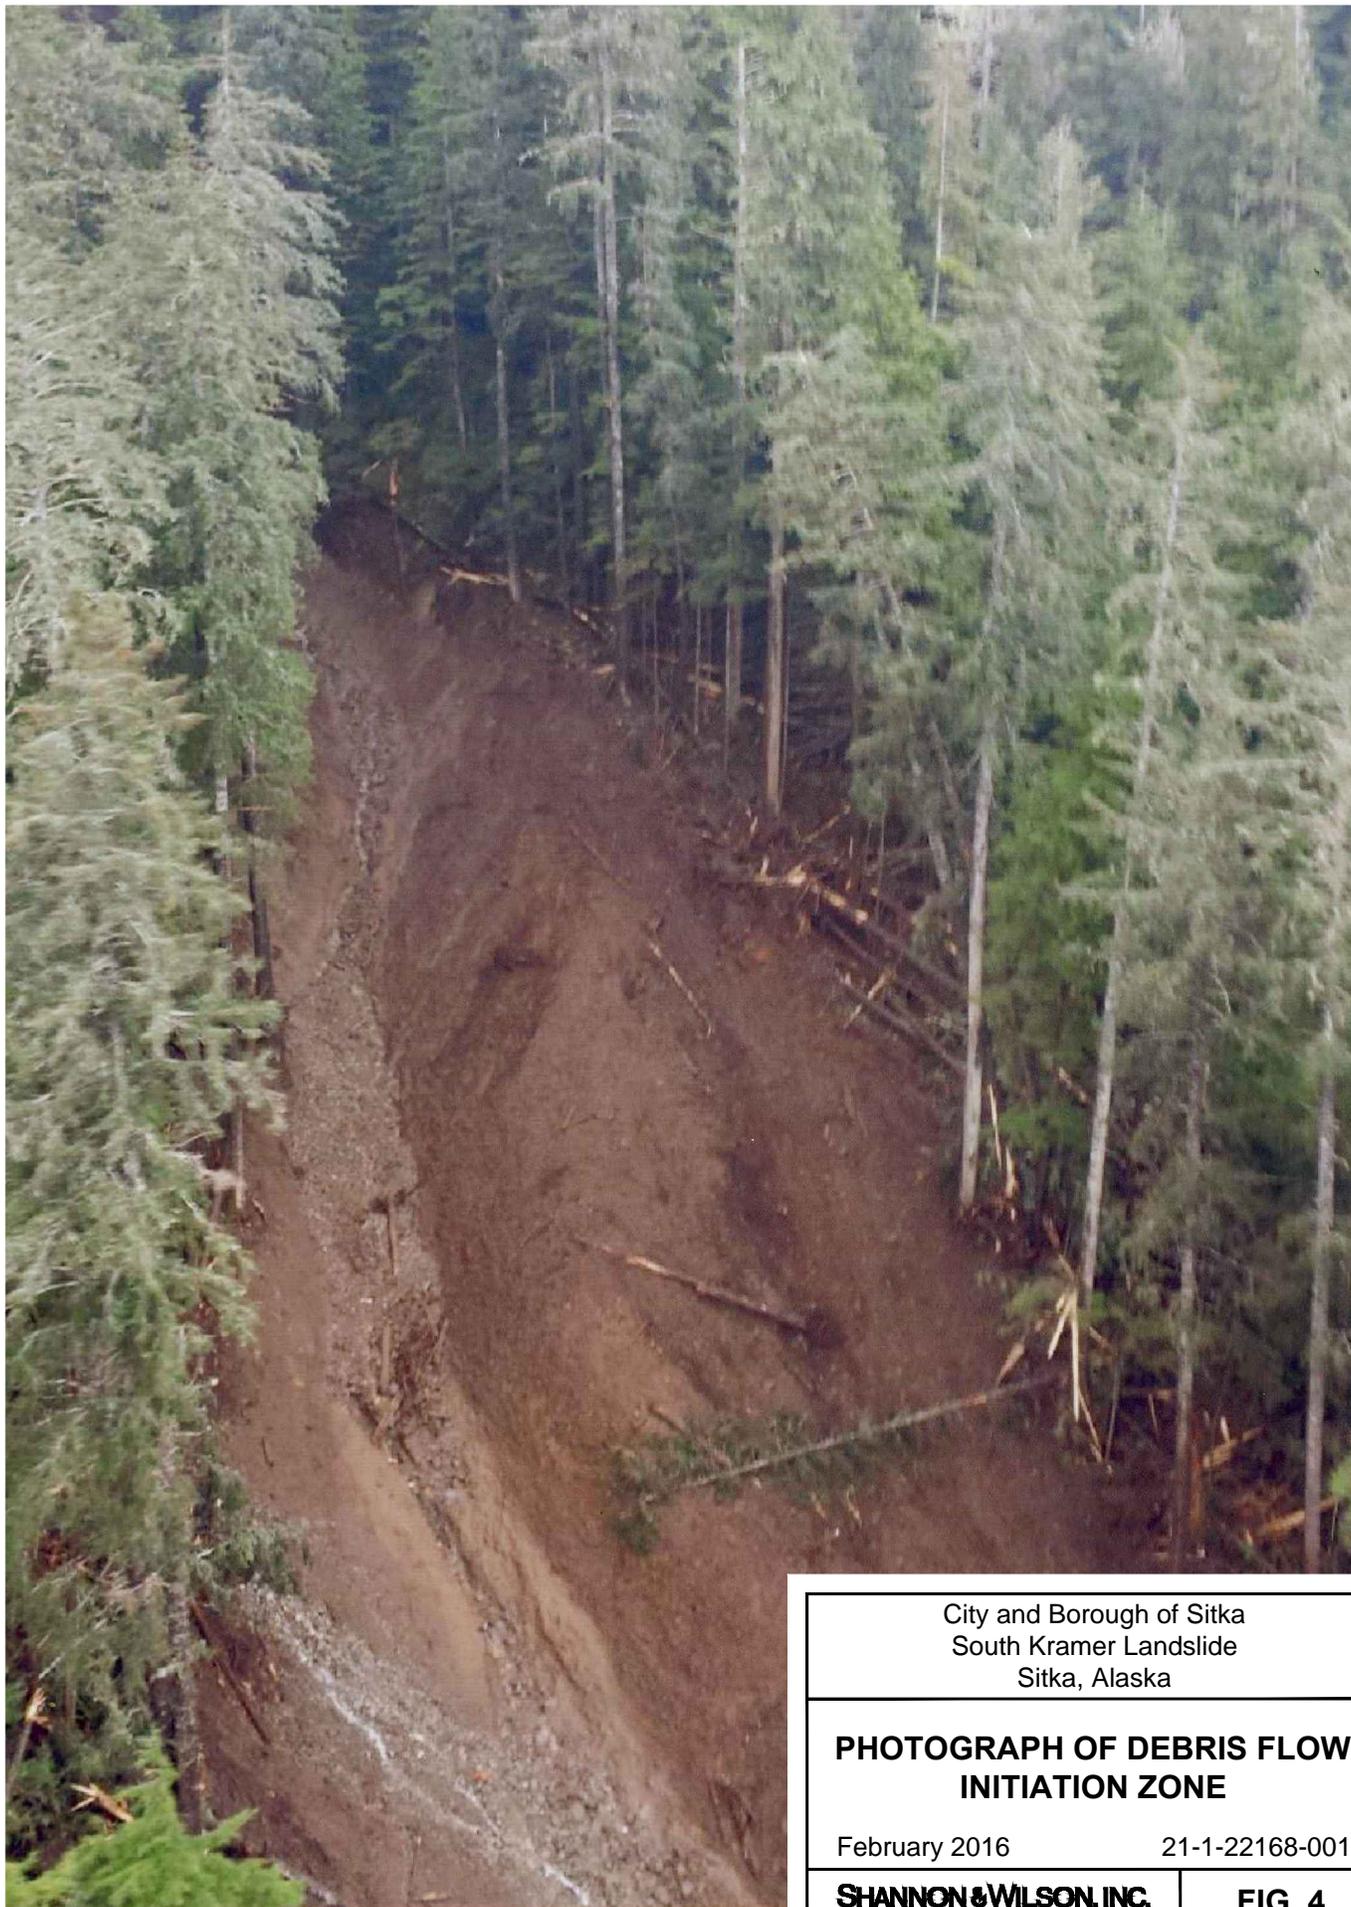
**FIG. 4**

**PHOTOGRAPH OF DEBRIS FLOW  
INITIATION ZONE**

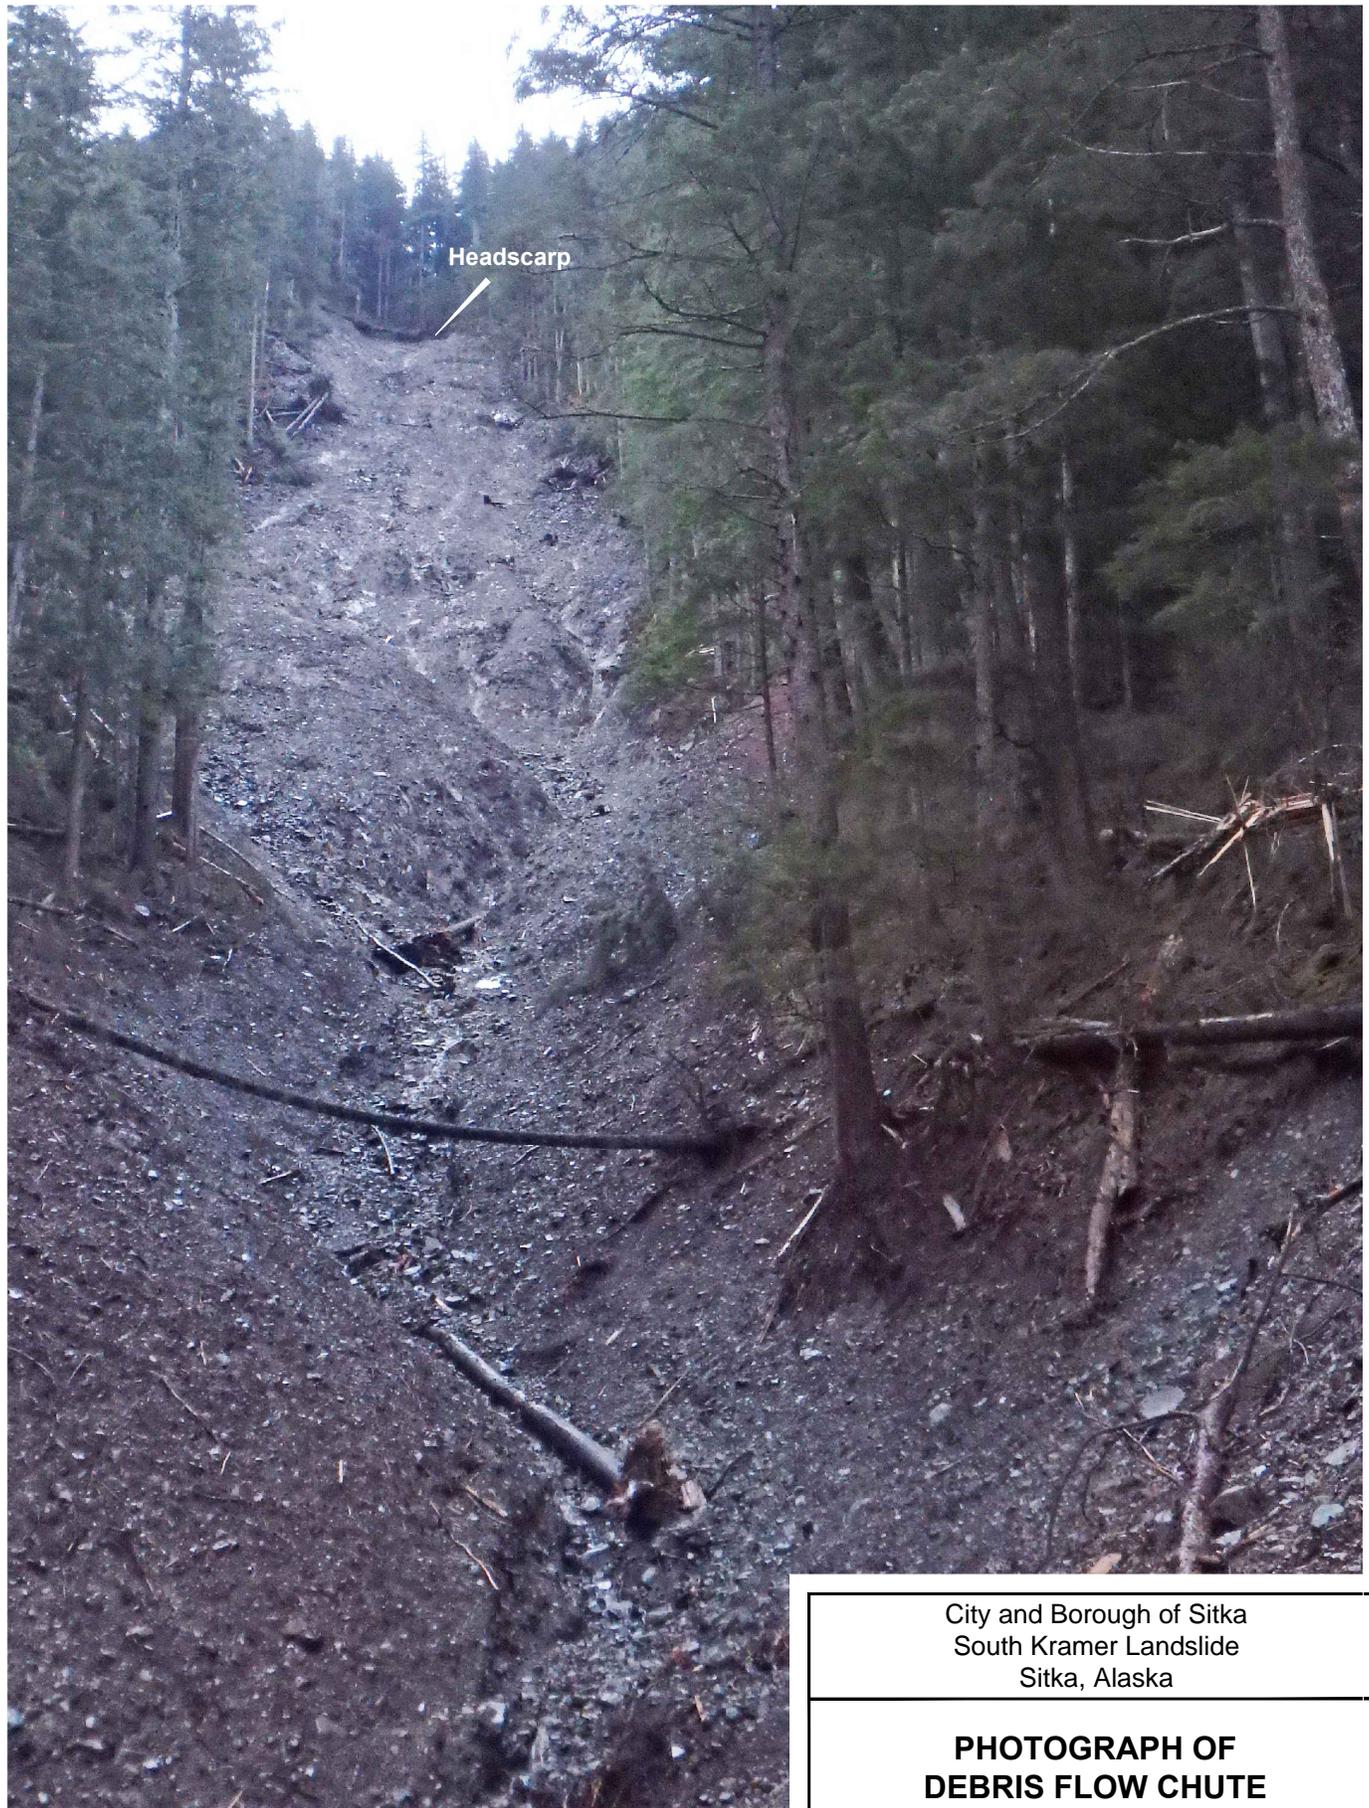
**FIG. 5**

**PHOTOGRAPH OF  
DEBRIS FLOW CHUTE**

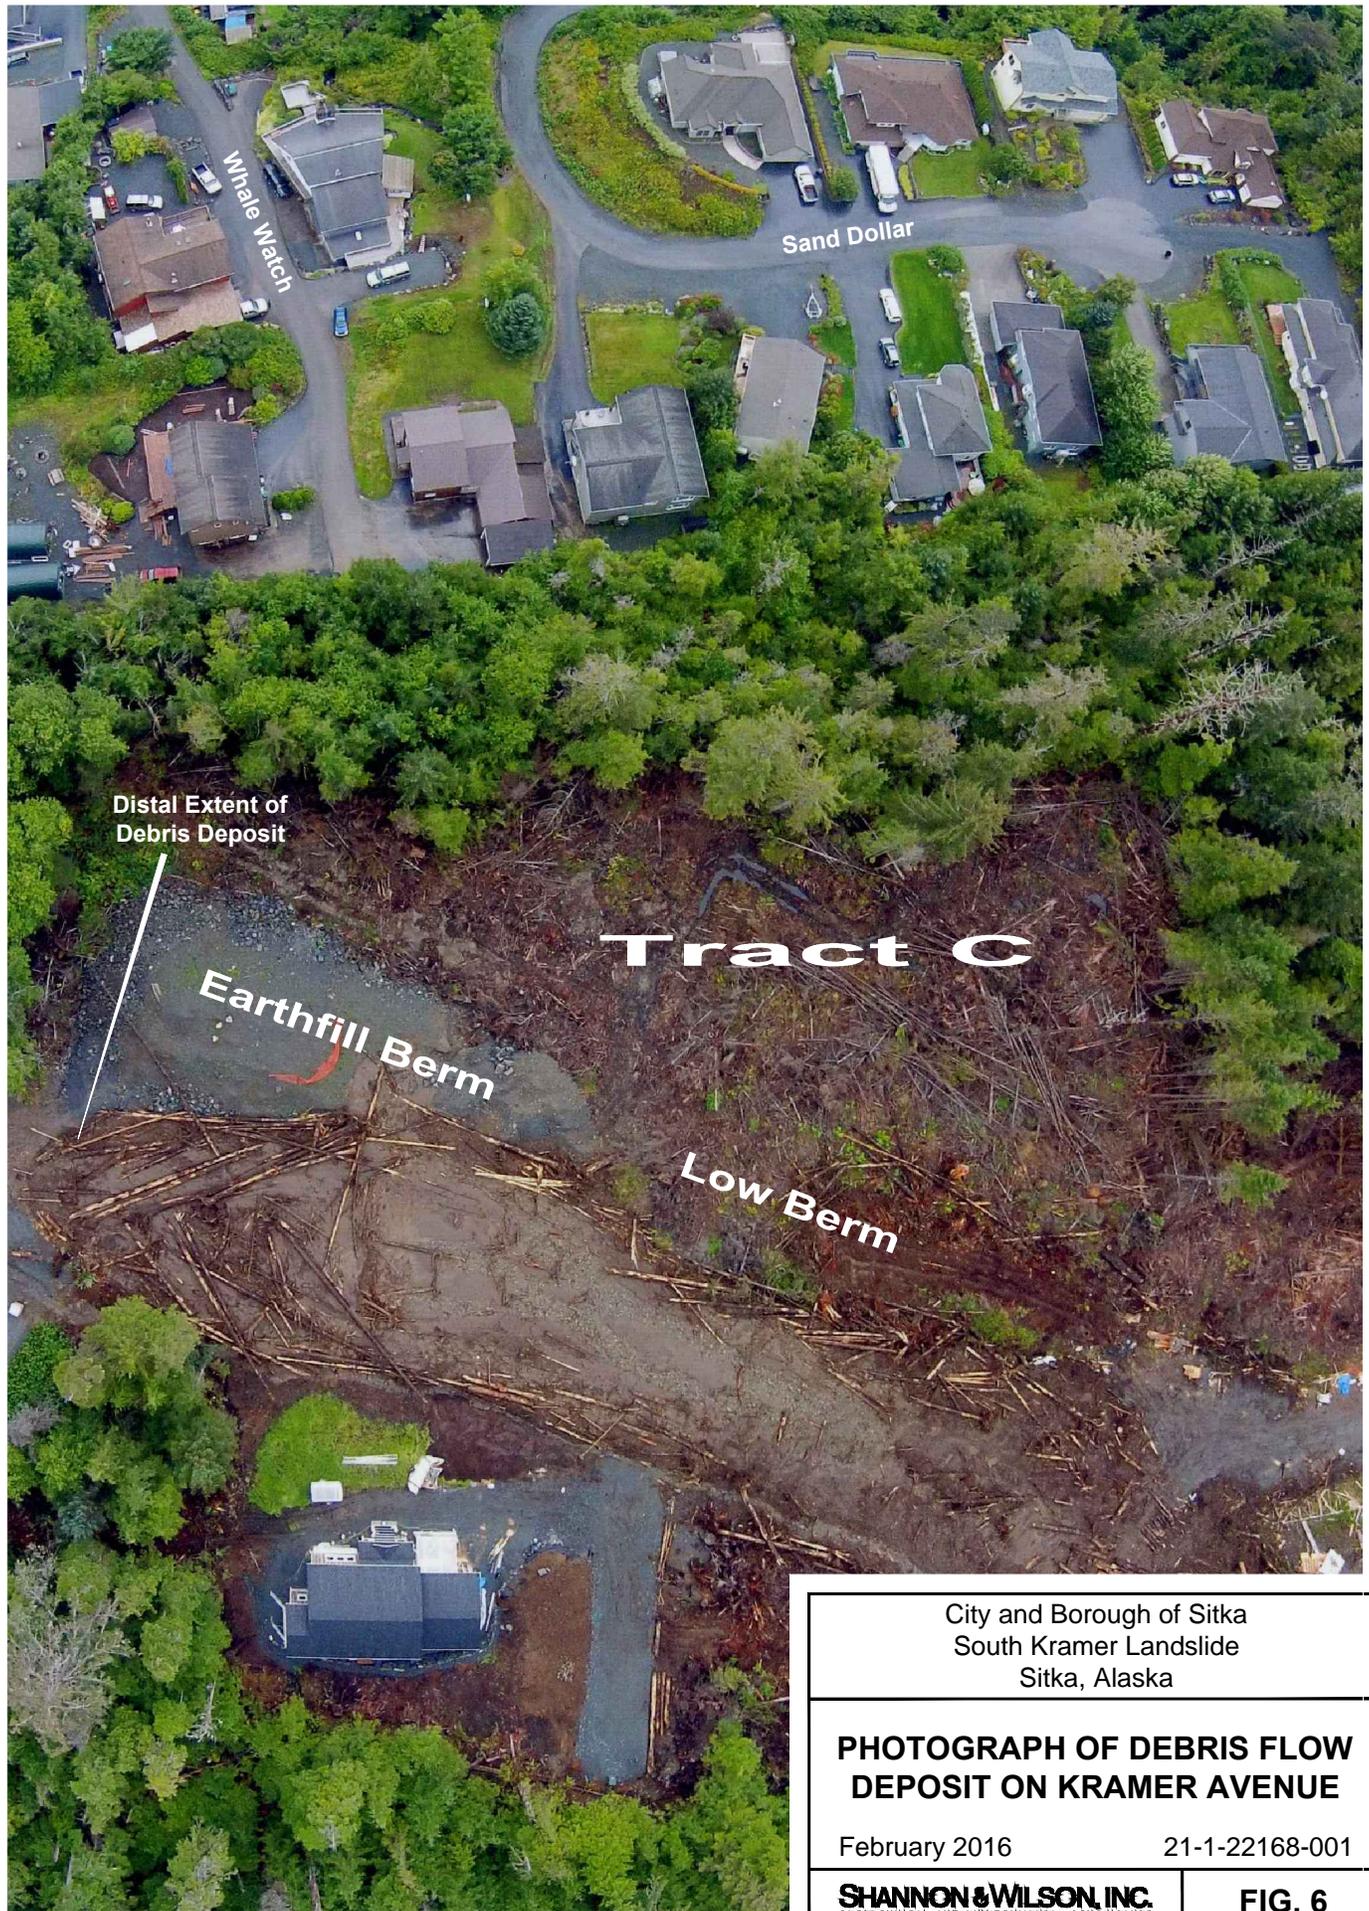
**FIG. 6**

We understand that the more southerly earthfill berm (Figure 6) is a temporary stockpile of soil that was placed by the development contractor for future site grading in Tract C.

**PHOTOGRAPH OF DEBRIS FLOW  
DEPOSIT ON KRAMER AVENUE**
