Wetland Delineation & Functions & Values Report

Sitka SPB Wetland Delineation

CITY AND BOROUGH OF SITKA  
**New Sitka Seaplane Base**

## **Wetland Delineation/Functions and Values Report**

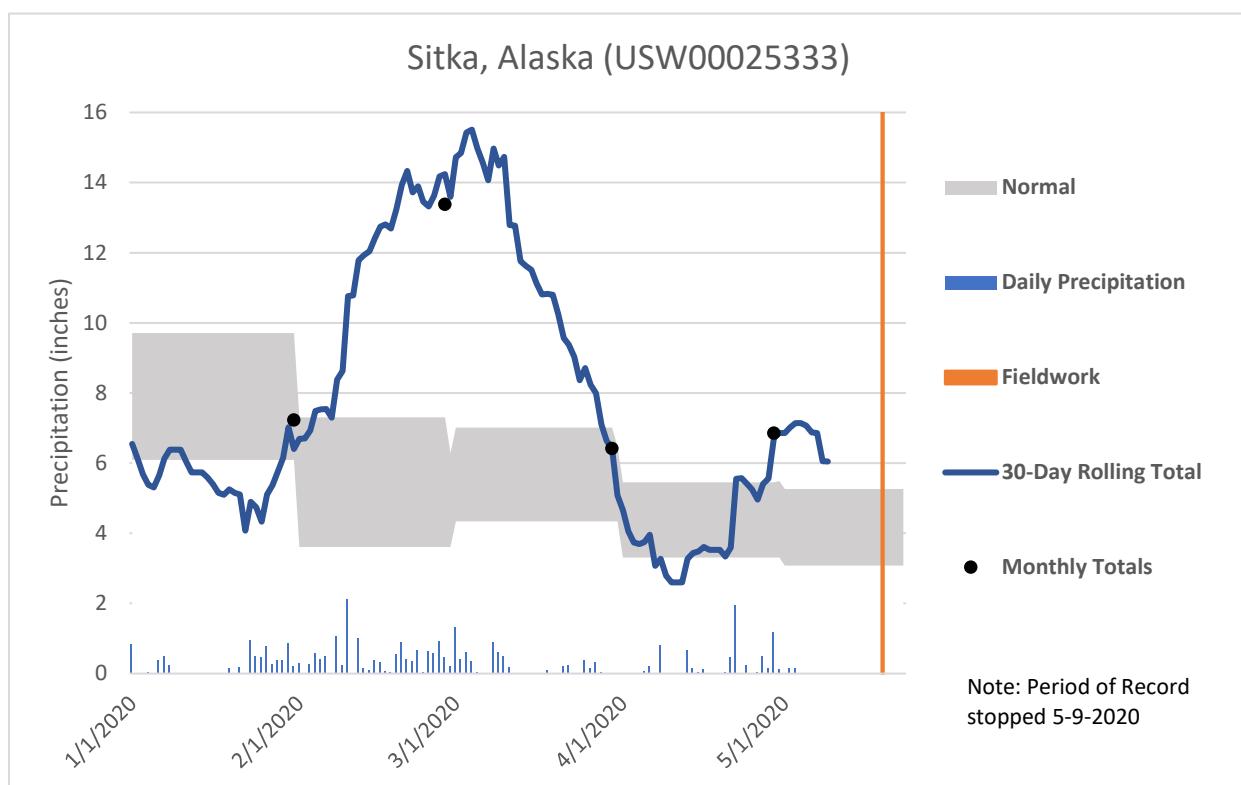
Graphic 1: Sitka Airport (USW00025333) 2020 Precipitation Data.

The closest global historical climatology network (GHCN) weather station is the Sitka Airport. The Sitka Airport GHCN weather station is located approximately 0.5 miles south of the project area. Precipitation data (Utah Climate Center 2020; Western Regional Climate Center 2020) from May 2000 to May 2020 was used to analyze antecedent conditions preceding the May 2020 data collection (Graphic 1). Daily precipitation values over a 30-day period were accumulated in order to examine the three-month period preceding data collection activities to determine if surface hydrology or soil moisture conditions observed were drier than normal, or wetter than normal (Natural Resource Conservation Service 2018). The period of record was stopped 5/9/2020 possibly due to COVID-19 impacts to data collection. Surface hydrology or soil moisture conditions observed were wetter than normal according to the precipitation analysis.

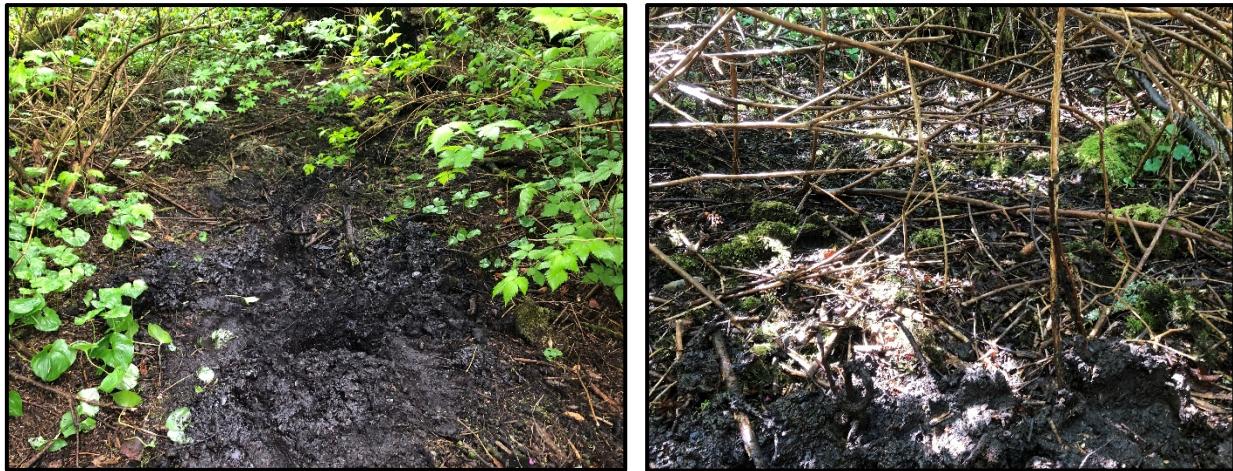
**Photo Set 1: Typical Scrub-Shrub Wetland**

Scrub-shrub wetlands (Cowardin classifications: PSS1B) are characterized by greater than 30% percent aerial cover in the shrub layer (Photo Set 1). These wetlands have a robust scrub shrub layer of stink currant (*Ribes bracteosum*) and salmonberry (*Rubus spectabilis*) with an herbaceous layer of false lily of the valley (*Maianthemum dilatatum*). All wetlands in the study area are classified as PSS1B. Characteristically, these wetlands are depressional, concave (two-to-three percent slopes) features that form as seeps.

These wetlands are located beneath the forest canopy but are small in size and have either scrub shrub vegetation or a sparsely vegetated concave surface. Both wetlands start as seeps flowing downhill. One wetland forms a swale while the other flows to a downhill point, forming a

The triangle-shaped seep wetland at TH 5 has problematic hydrophytic vegetation due to having a hydric soil, primary wetland hydrology, being a concave seep forming at a toeslope, and having a sparsely vegetated concave surface. The shrub stratum is growing over top of the wetland to maximize sunlight with few individuals rooted in the seep, and the herb stratum is growing at the downslope point of the triangle on a slight rise in elevation. The shrub stratum is dominantly salmonberry, which is most common on moist to wet, water-receiving sites in forested or wooded areas (Zouhar 2015). The Salmonberry aerial stems can be seen in Photo Set 1 on the right photo, growing laterally over top of the seep.

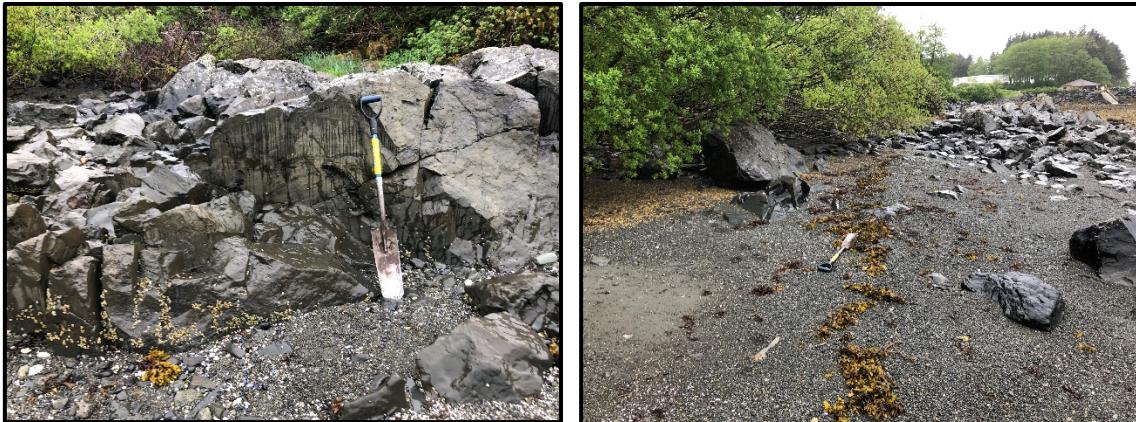
**Photo Set 2: Mean High Water**

Marine waters are found in tidal areas in Sitka Harbor below MHW. Waterbody consists of a tidally influenced coastline of Sitka Harbor. The MHW elevation of 9.16 feet was confirmed using a submeter accuracy GPS with visual observations of barnacles, saltwater vegetation growing on boulders, and debris deposits.

Marine waters below MHW are composed of gravel, cobble, boulder, and bedrock substrate with barnacles and marine vegetation growing along the rocks. A low tide survey was conducted with photos for various substrate types and is attached as Appendix C. Table 6 is a summary of marine waterbody data collected.

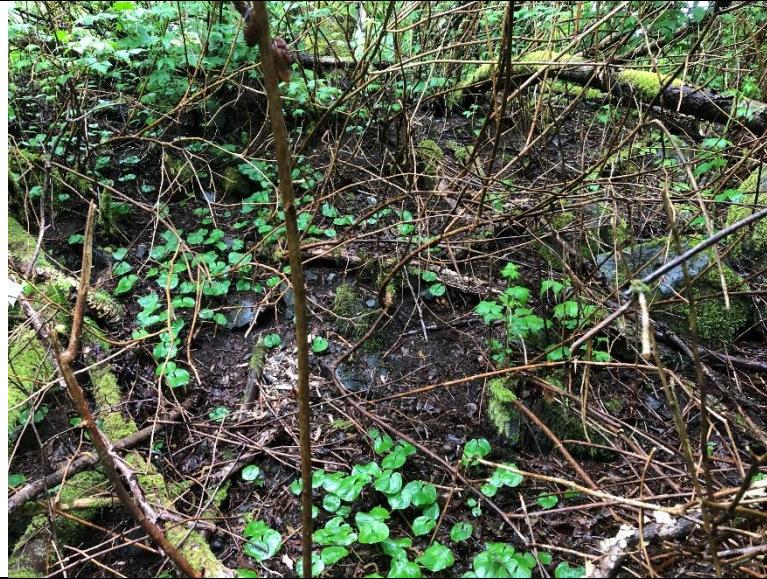
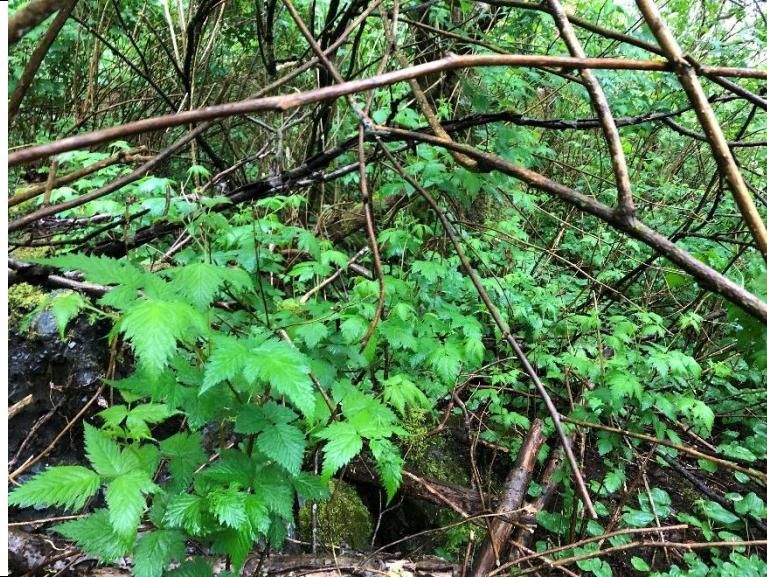
## Location Description: TH1 LANDSCAPE – FACING Southwest

A black histic was observed at TH1. This soil profile was characterized by 9 inches of organic material underlain by a sandy loam (B) horizon with a color of 7.5YR 3/2 from the Munsell Soil Color Chart (Munsell 2012). This site was moderately well drained, and no wetland hydrology was observed.

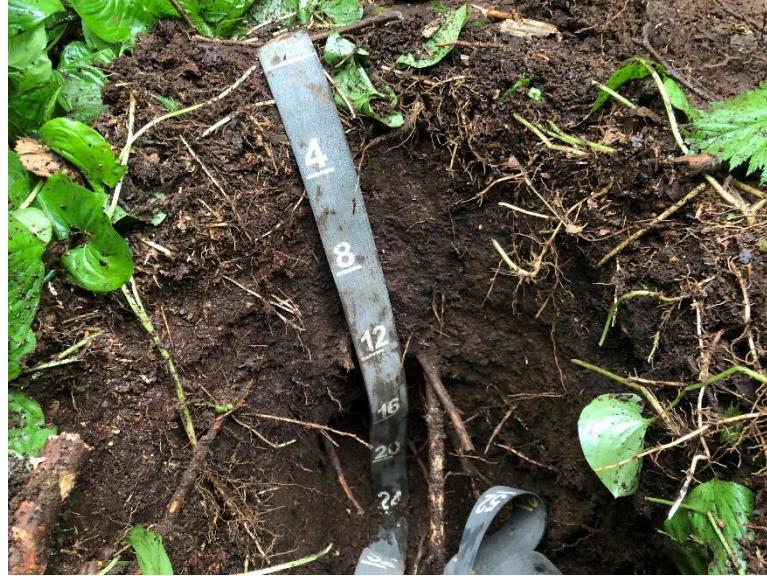
## SOILS: Soil pit

Black histic hydric soil indicator met.  
Dark mineral soil below organic  
No aquic soil conditions in 0-9" layers

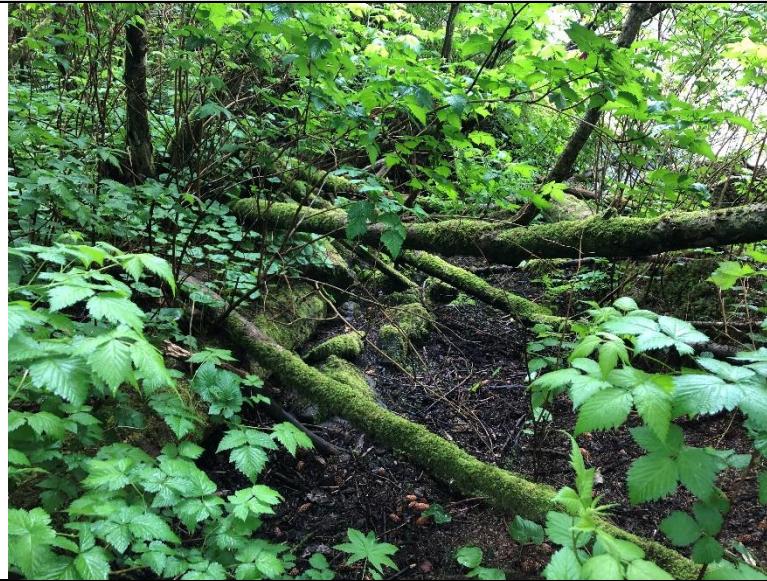
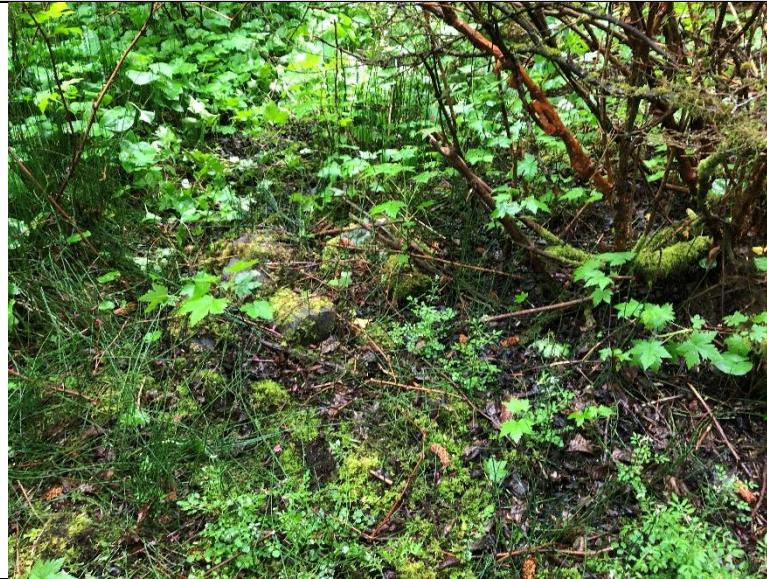
## Location Description: TH2 LANDSCAPE – FACING Northeast

A histosol (A1) was observed at TH2. This soil profile was characterized by 24 inches of organic material. This site was very poorly drained and was characterized by saturation and high water table (4 inches deep).

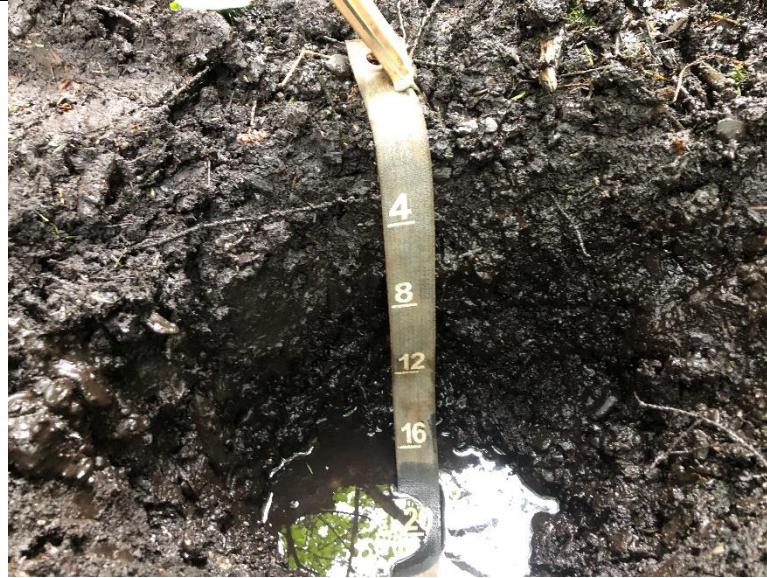
## SOILS: Soil pit

Broken down organics  
thick organics in swale

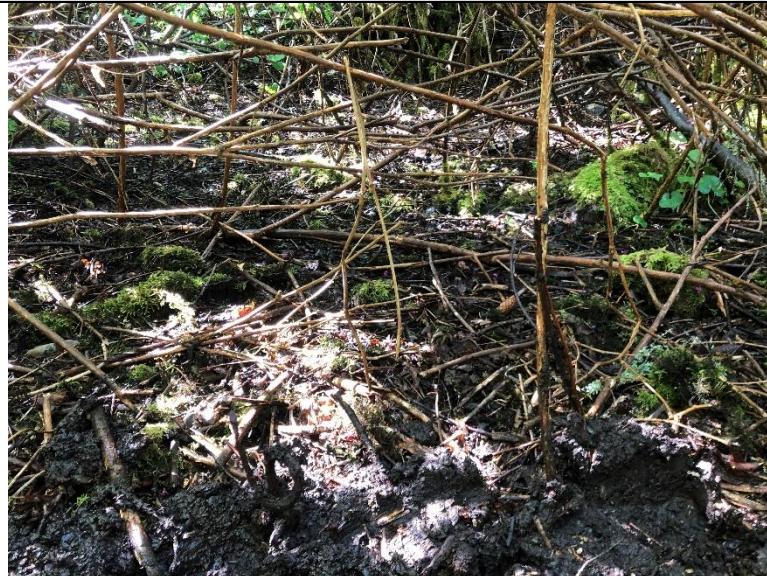
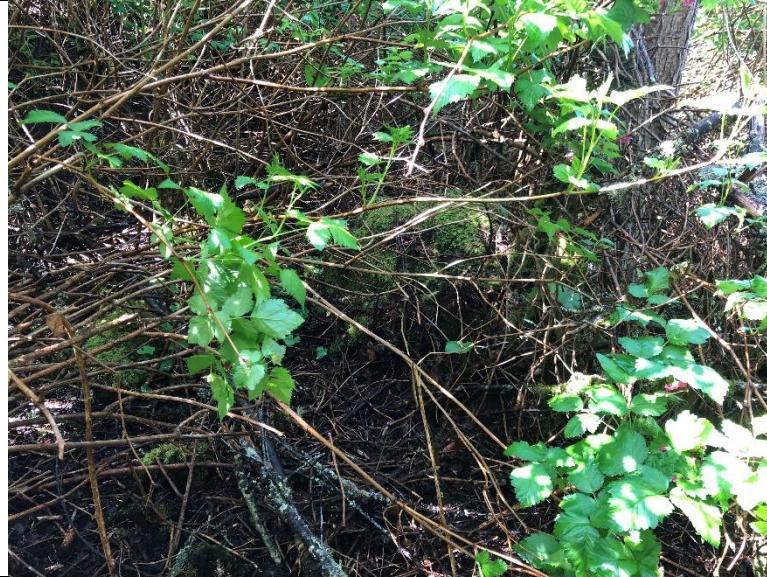
## Location Description: TH5 LANDSCAPE – FACING Northeast

A histic epipedon was observed at TH5. This soil profile was characterized by 12 inches of organic material underlain by a silt loam (B) horizon with a color of 10YR 2/1 from the Munsell Soil Color Chart (Munsell 2012). Soils at this site were poorly drained and primary wetland hydrology was present.

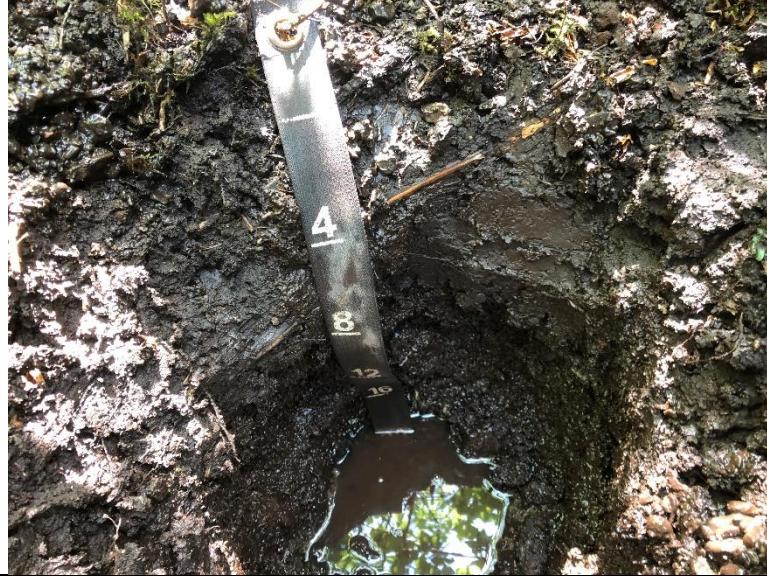
## SOILS: Soil pit

Seep starting at toeslope and flowing downhill  
AA(+) in 0-24'

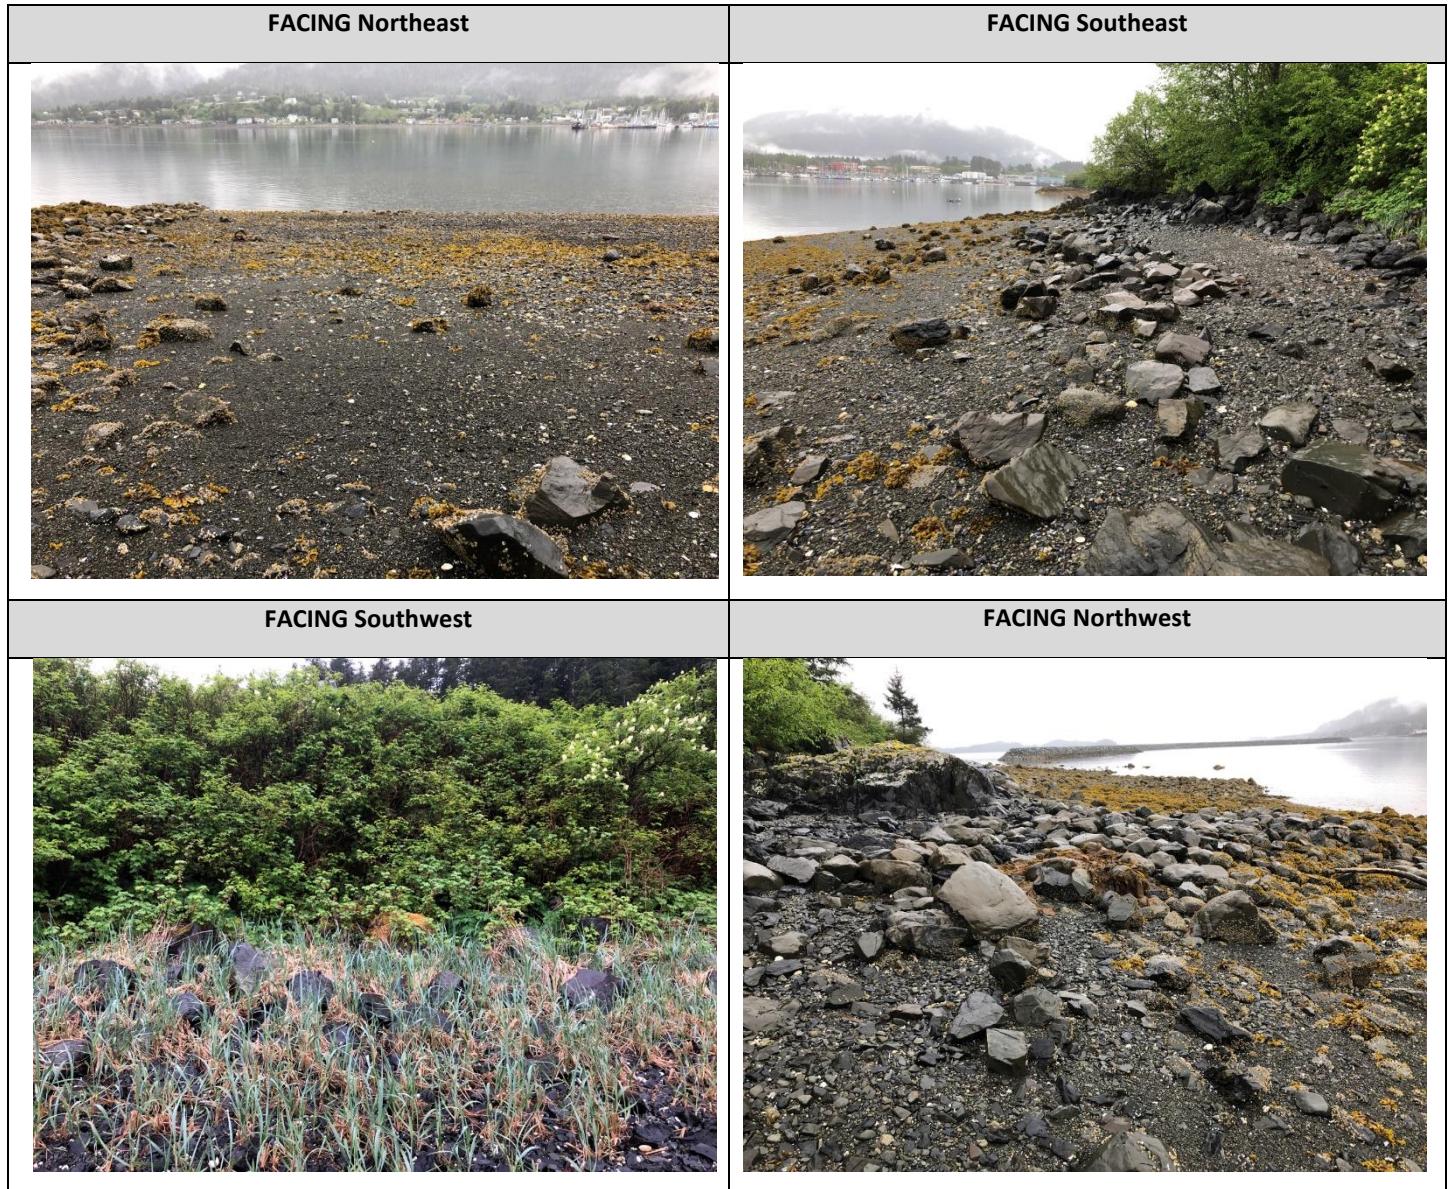
**Location Description: B1**

2" gravel swath down to low tide, boulders scattered along mean high water area.

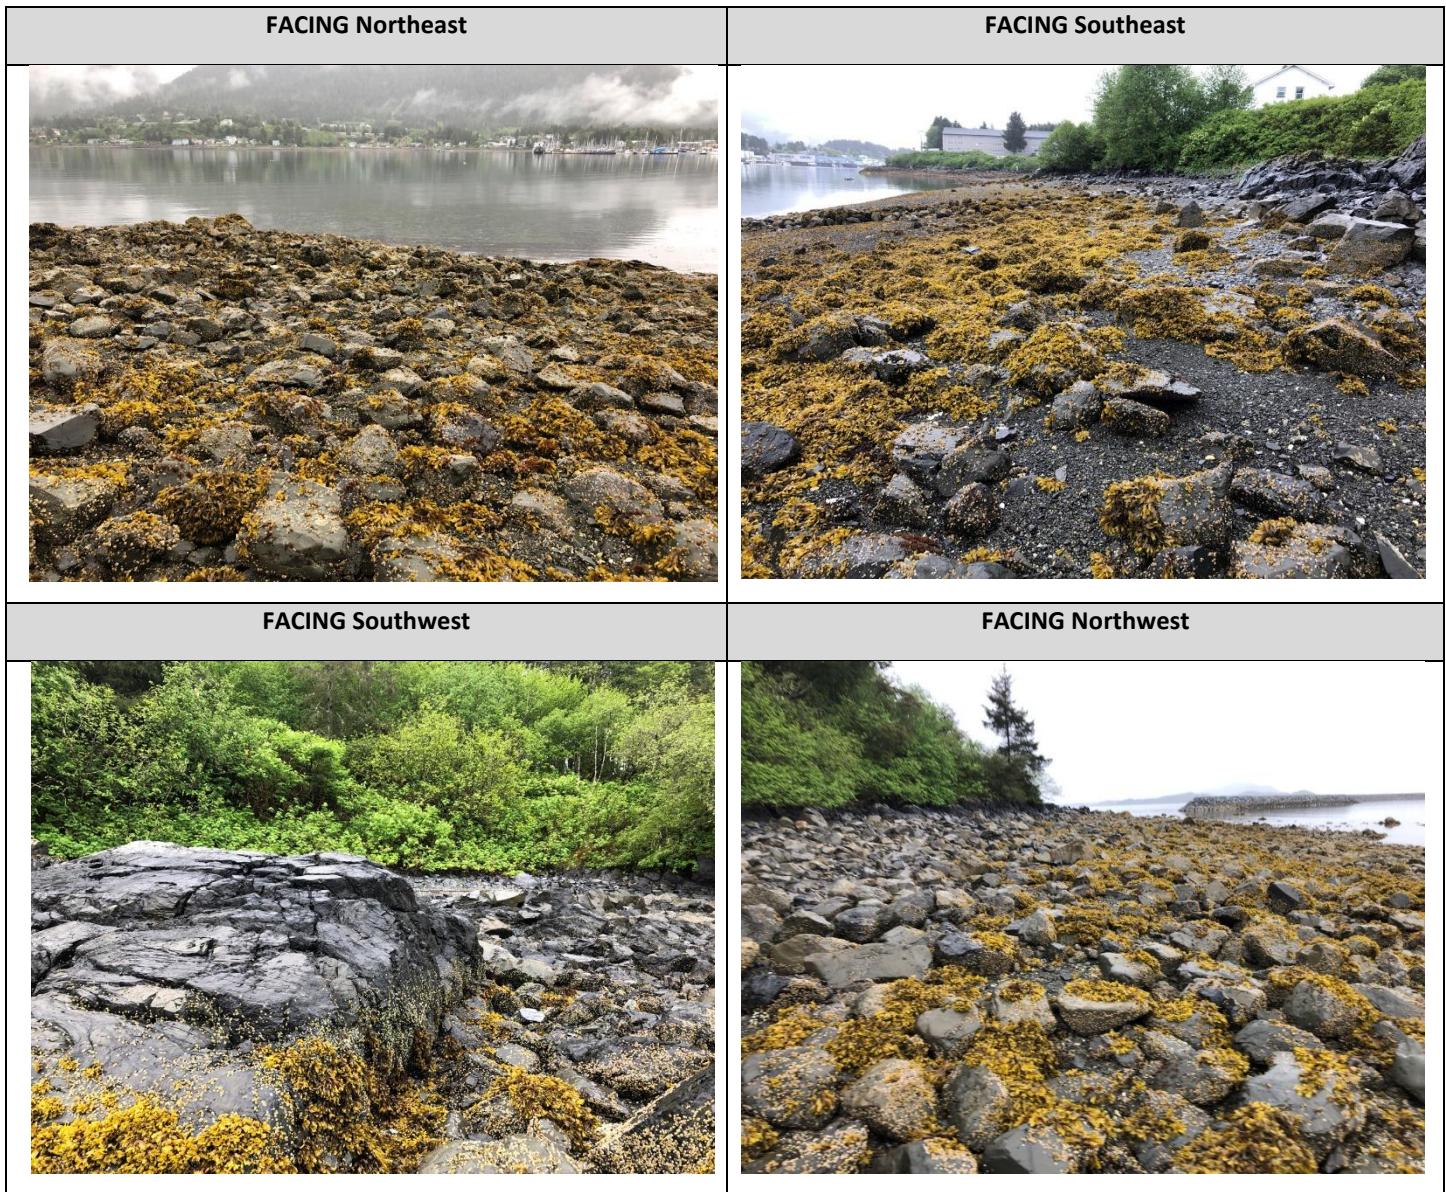
**Location Description: B2**

Boulders down to low tide, bedrock near mean high water area.

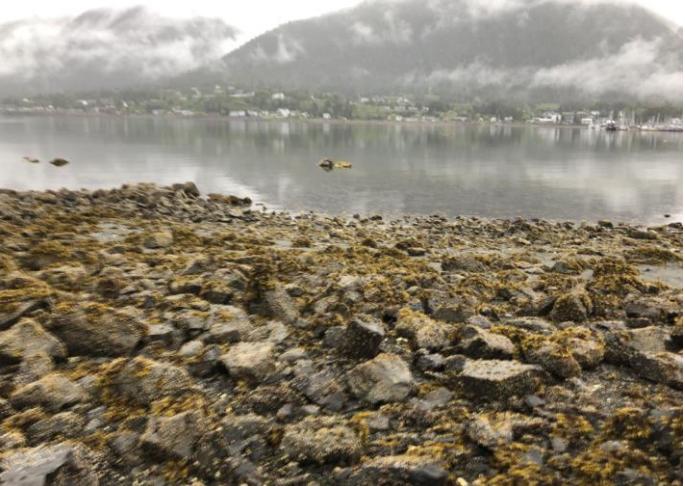
FACING Northeast	FACING Southeast

Boulders from mean high water to low tide.

A wide-angle photograph of a rocky beach facing Northeast. The foreground is covered in dark, irregular rocks and patches of bright yellow-green moss. In the middle ground, the calm water of a bay reflects the surrounding forested hills. A small, dark boat is visible on the water. The sky is overcast with grey clouds.

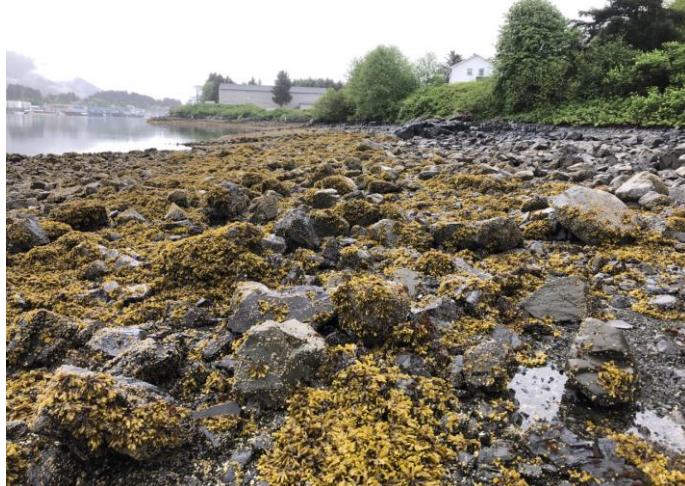
A photograph of a rocky beach facing Southeast. The foreground is covered in dark rocks and yellow-green moss. In the background, a shoreline with green trees and a white building is visible across the water. The sky is clear and blue.
FACING Southwest	FACING Northwest

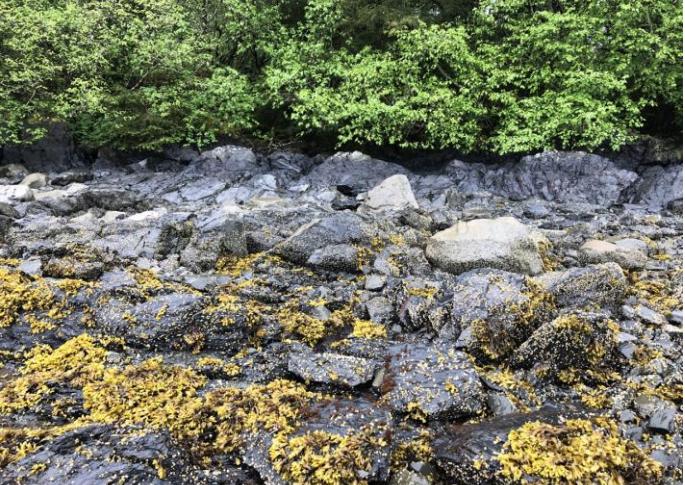
A photograph of a rocky beach facing Southwest. The foreground is covered in dark rocks and yellow-green moss. A dense line of green trees runs along the high-water mark in the background. The sky is clear and blue.

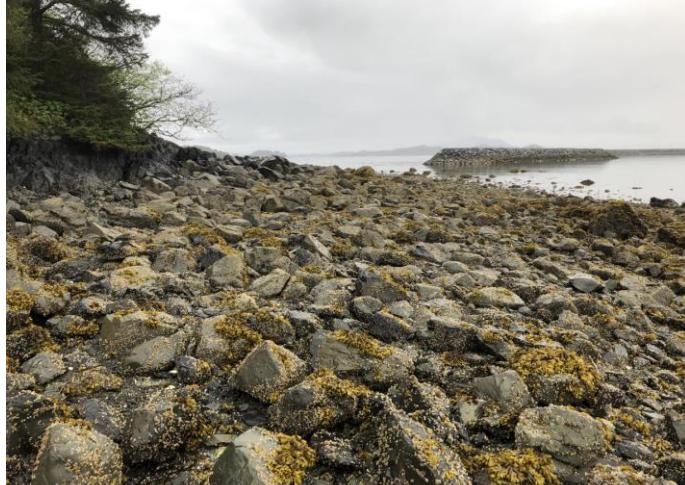
A photograph of a rocky beach facing Northwest. The foreground is covered in dark rocks and yellow-green moss. The background shows a wide expanse of water with distant hills under a cloudy sky.

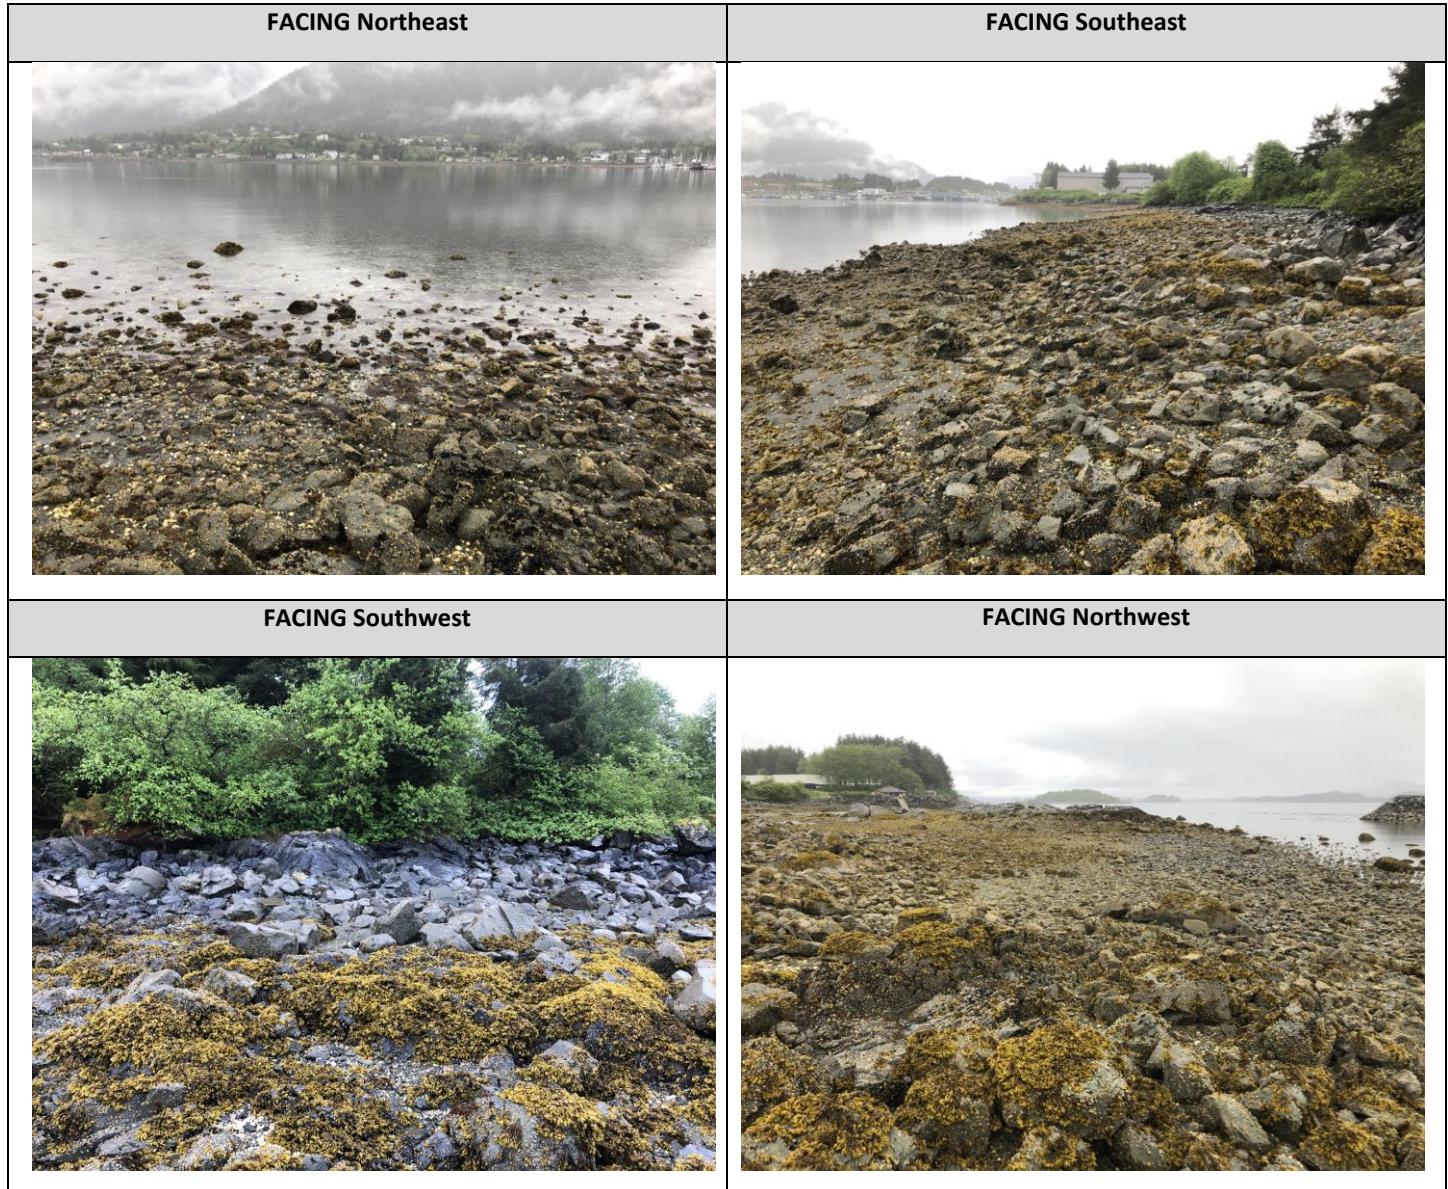
**Location Description: B4**

Cobbles and boulders down to low tide.

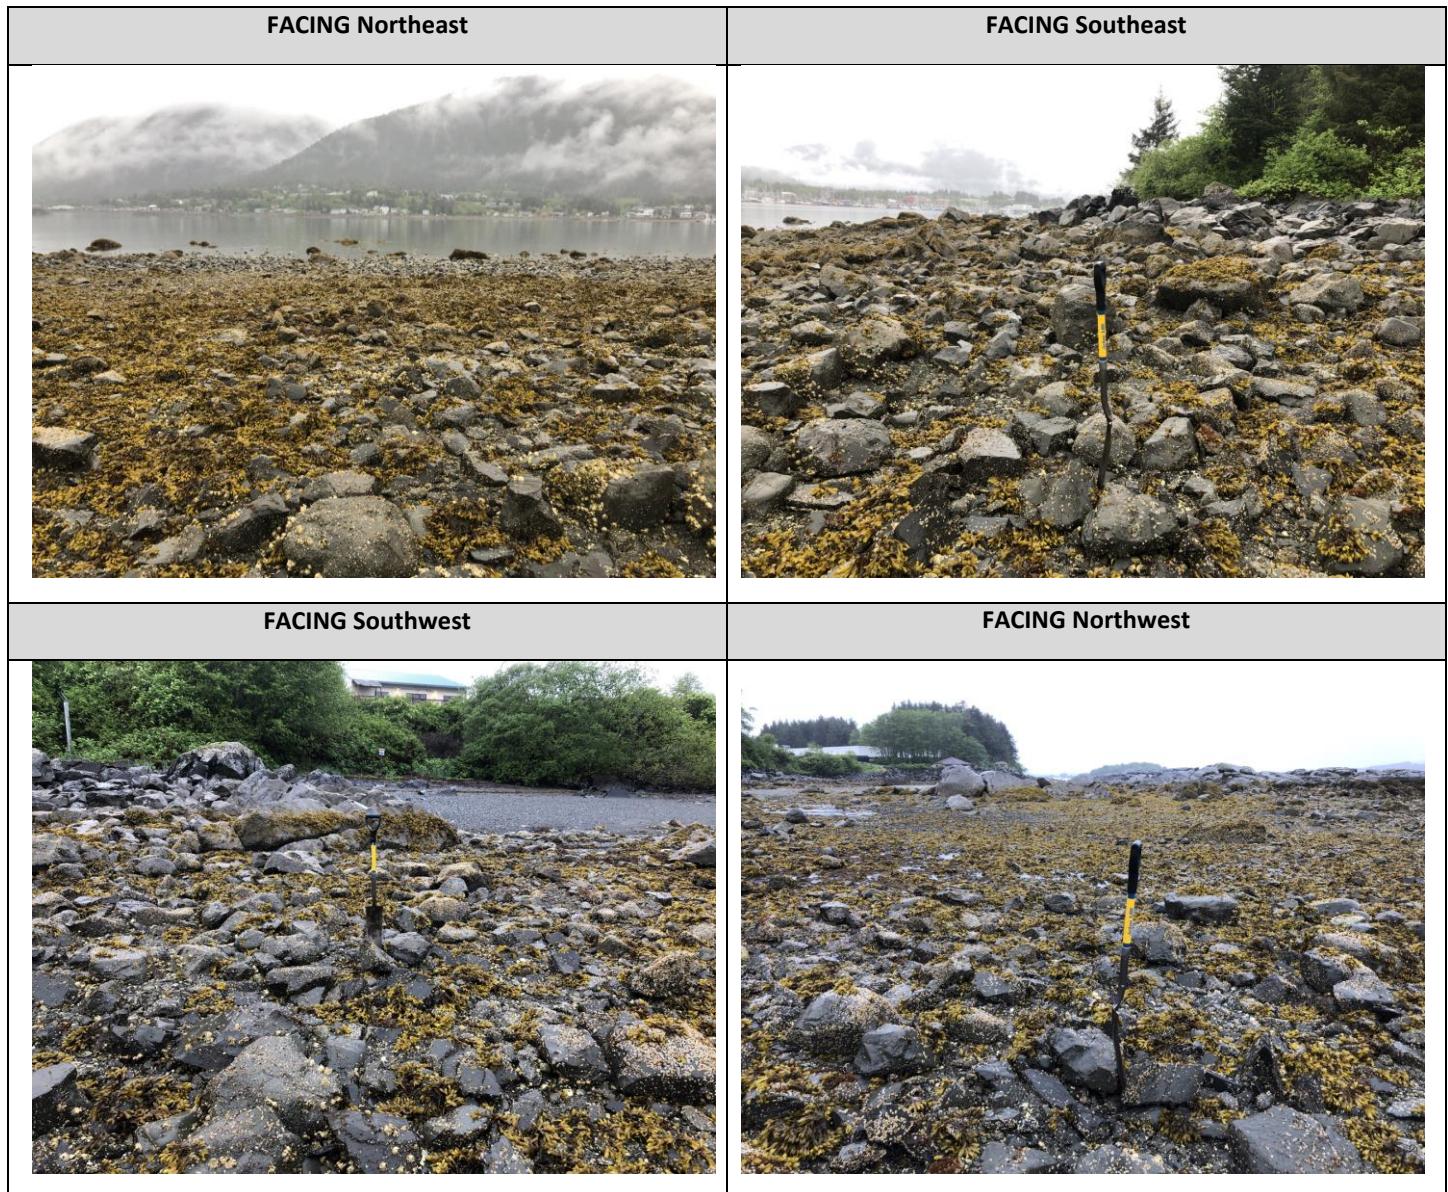
**Location Description: B5**

Boulders and cobbles down to low tide.

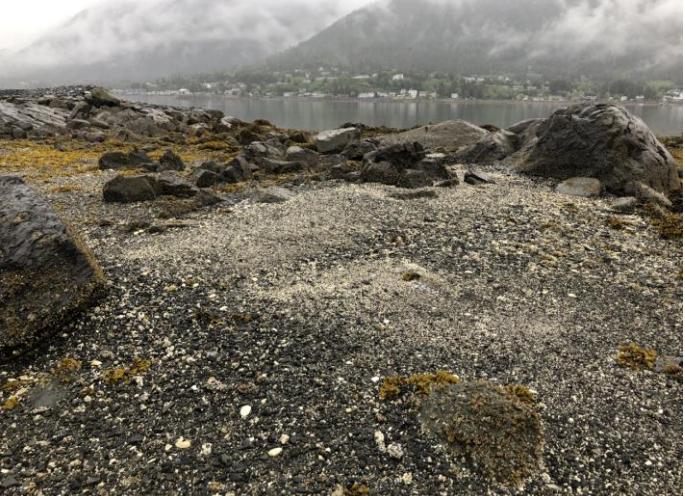
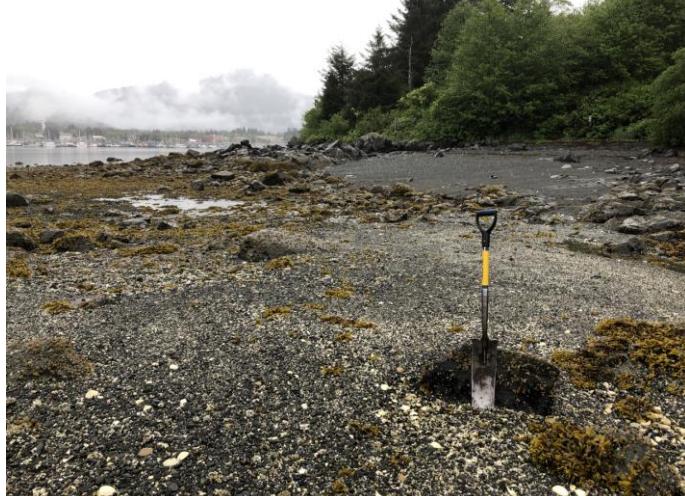
FACING Northeast	FACING Southeast

Gravel from mean high water to start of boulders, bedrock in areas.
