## Wetland Delineation & Functions & Values Report

CITY AND BOROUGH OF SITKA  
**New Sitka Seaplane Base**

# Wetland Delineation/ Functions & Values Report

# **SITKA SEAPLANE BASE**

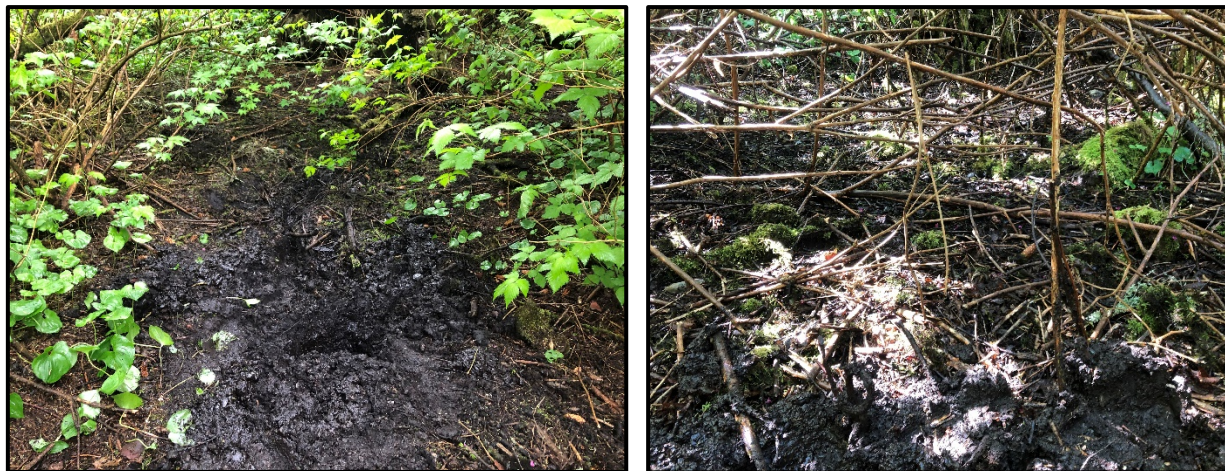
**Photo Set 1: Typical Scrub-Shrub Wetland**

Scrub-shrub wetlands (Cowardin classifications: PSS1B) are characterized by greater than 30% percent aerial cover in the shrub layer (Photo Set 1). These wetlands have a robust scrub shrub layer of stink currant (*Ribes bracteosum*) and salmonberry (*Rubus spectabilis*) with an herbaceous layer of false lily of the valley (*Maianthemum dilatatum*). All wetlands in the study area are classified as PSS1B. Characteristically, these wetlands are depressional, concave (two-to-three percent slopes) features that form as seeps.

These wetlands are located beneath the forest canopy but are small in size and have either scrub shrub vegetation or a sparsely vegetated concave surface. Both wetlands start as seeps flowing downhill. One wetland forms a swale while the other flows to a downhill point, forming a

The triangle-shaped seep wetland at TH 5 has problematic hydrophytic vegetation due to having a hydric soil, primary wetland hydrology, being a concave seep forming at a toeslope, and having a sparsely vegetated concave surface. The shrub stratum is growing over top of the wetland to maximize sunlight with few individuals rooted in the seep, and the herb stratum is growing at the downslope point of the triangle on a slight rise in elevation. The shrub stratum is dominantly salmonberry, which is most common on moist to wet, water-receiving sites in forested or wooded areas (Zouhar 2015). The Salmonberry aerial stems can be seen in Photo Set 1 on the right photo, growing laterally over top of the seep.

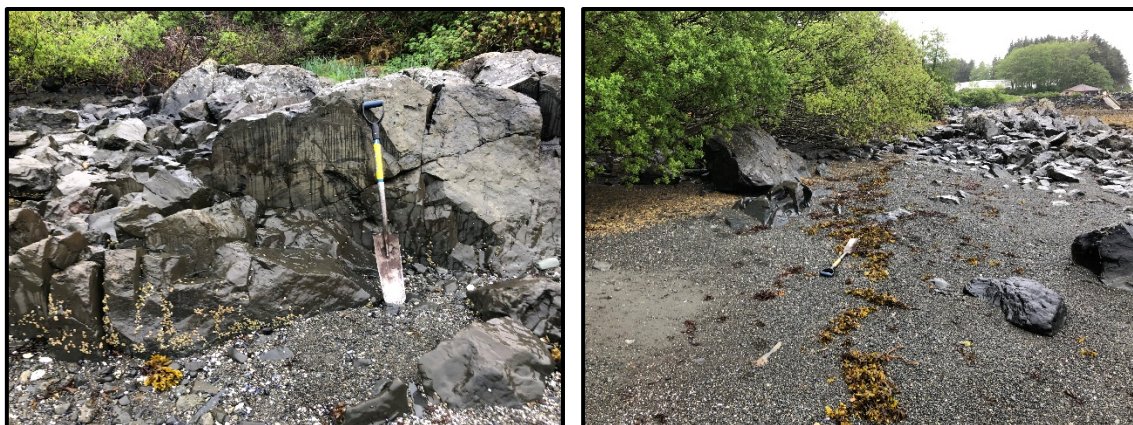
**Photo Set 2: Mean High Water**

Marine waters are found in tidal areas in Sitka Harbor below MHW. Waterbody consists of a tidally influenced coastline of Sitka Harbor. The MHW elevation of 9.16 feet was confirmed using a submeter accuracy GPS with visual observations of barnacles, saltwater vegetation growing on boulders, and debris deposits.

Marine waters below MHW are composed of gravel, cobble, boulder, and bedrock substrate with barnacles and marine vegetation growing along the rocks. A low tide survey was conducted with photos for various substrate types and is attached as Appendix C. Table 6 is a summary of marine waterbody data collected.

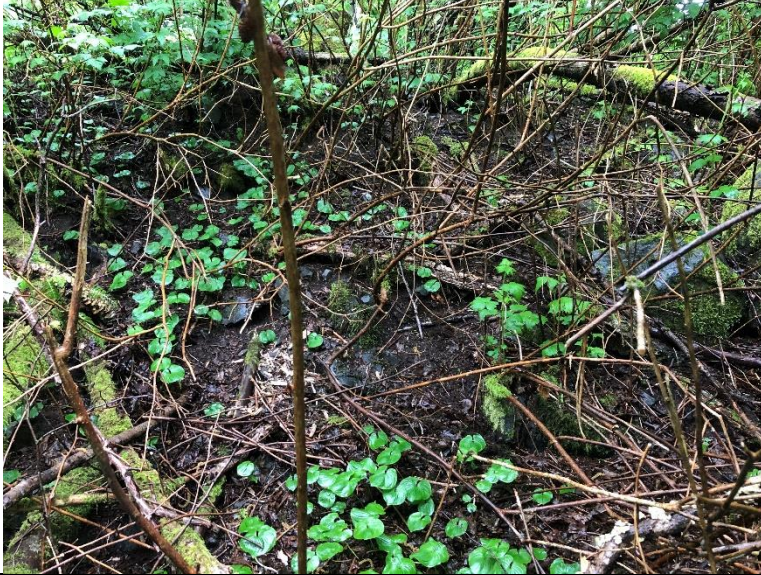
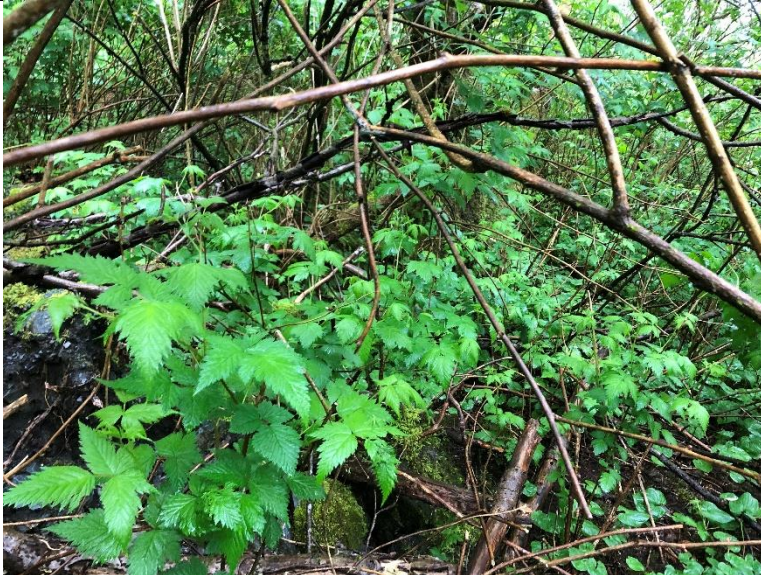
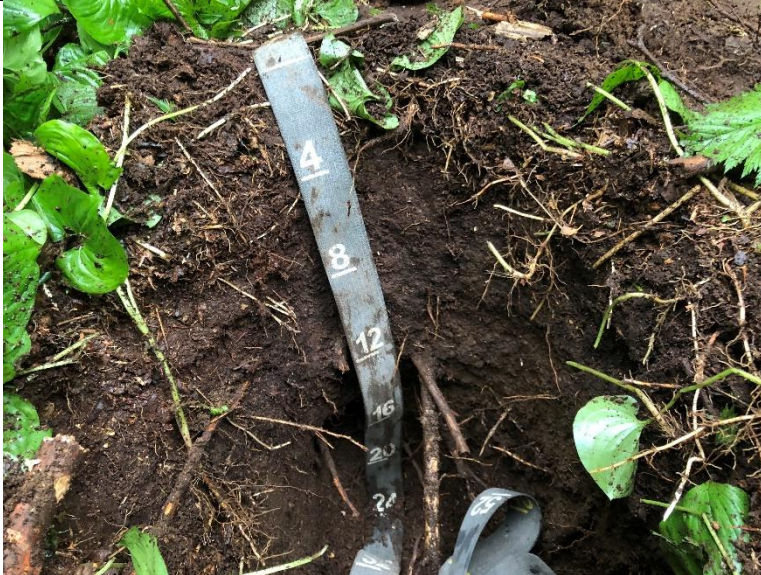
Location Description: TH1 LANDSCAPE – FACING Southwest

A black histic was observed at TH1. This soil profile was characterized by 9 inches of organic material underlain by a sandy loam (B) horizon with a color of 7.5YR 3/2 from the Munsell Soil Color Chart (Munsell 2012). This site was moderately well drained, and no wetland hydrology was observed.

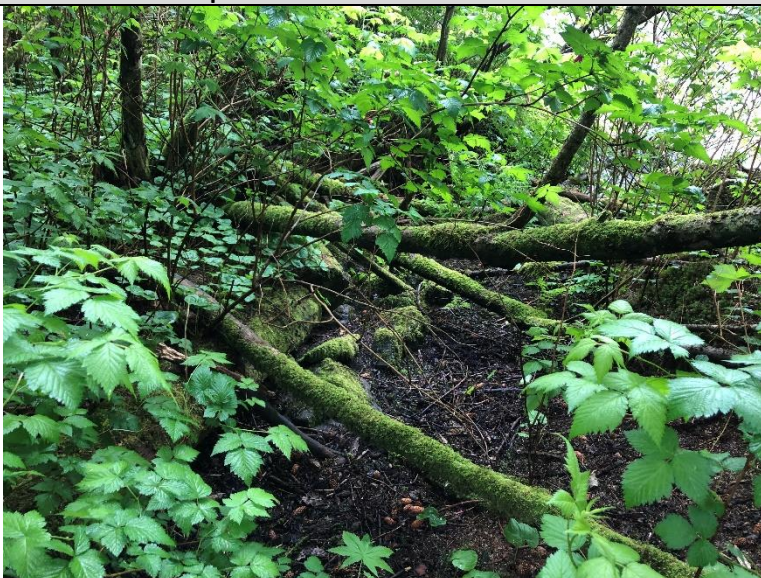
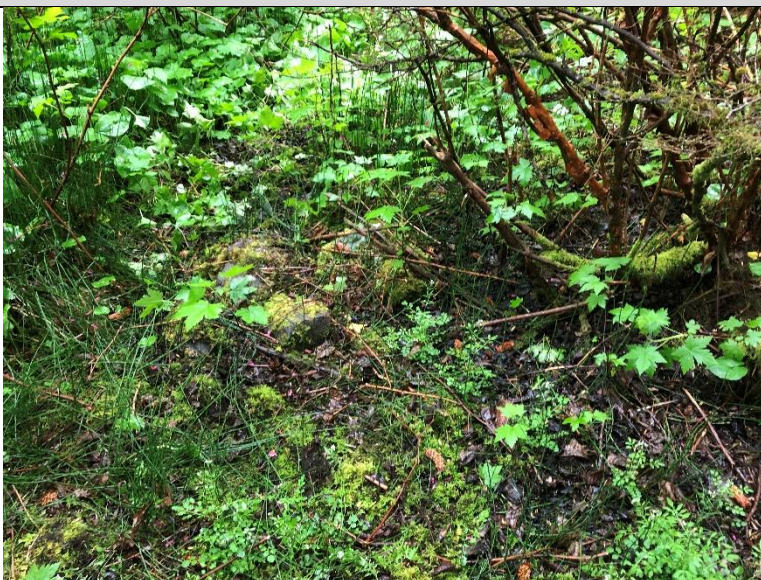
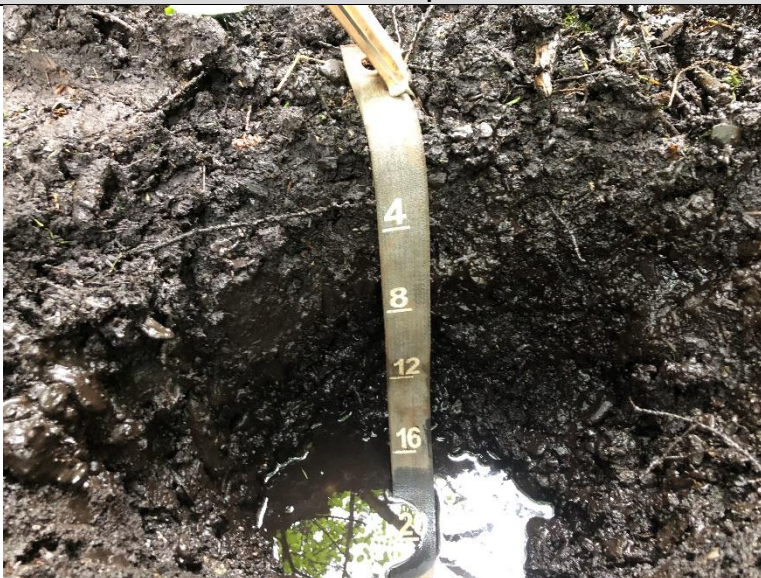
Location Description: TH2 LANDSCAPE – FACING Northeast

A histosol (A1) was observed at TH2. This soil profile was characterized by 24 inches of organic material. This site was very poorly drained and was characterized by saturation and high water table (4 inches deep).

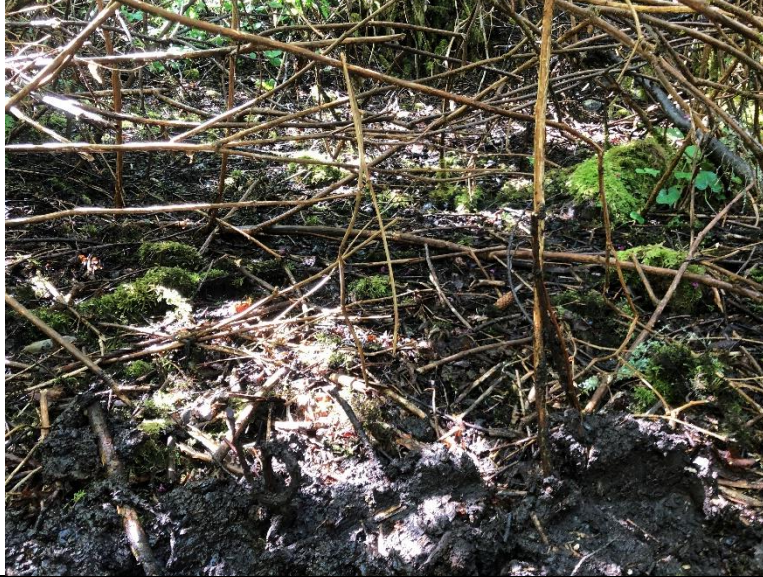
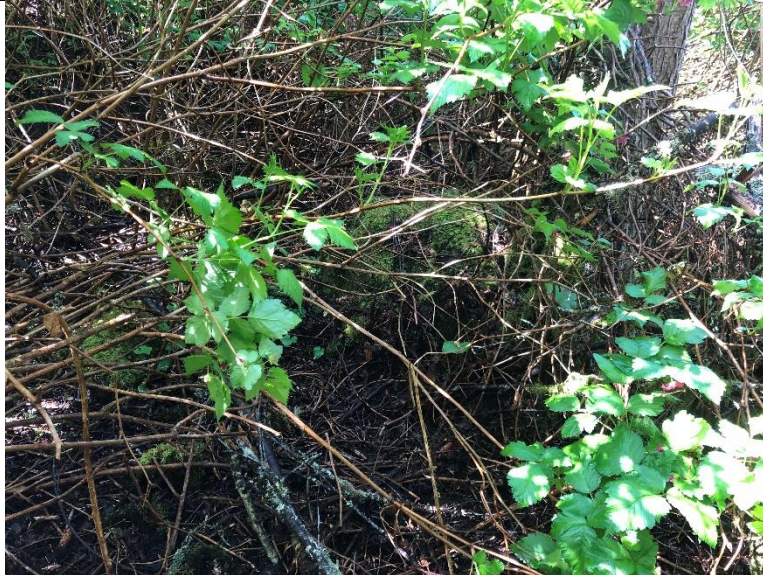
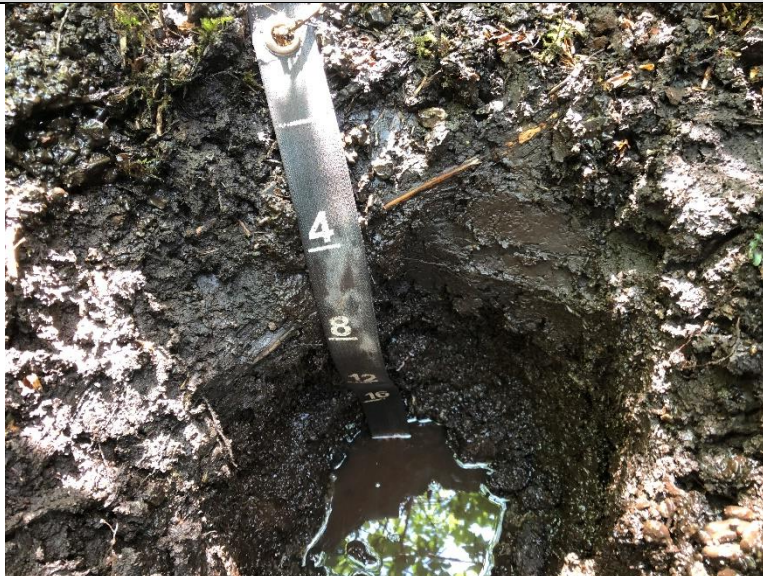
Location Description: TH5 LANDSCAPE – FACING Northeast

A histic epipedon was observed at TH5. This soil profile was characterized by 12 inches of organic material underlain by a silt loam (B) horizon with a color of 10YR 2/1 from the Munsell Soil Color Chart (Munsell 2012). Soils at this site were poorly drained and primary wetland hydrology was present.

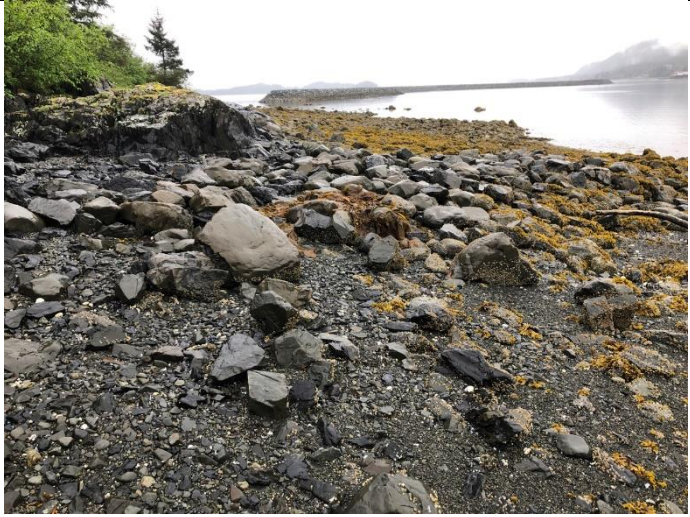
**Location Description: B1**

2" gravel swath down to low tide, boulders scattered along mean high water area.

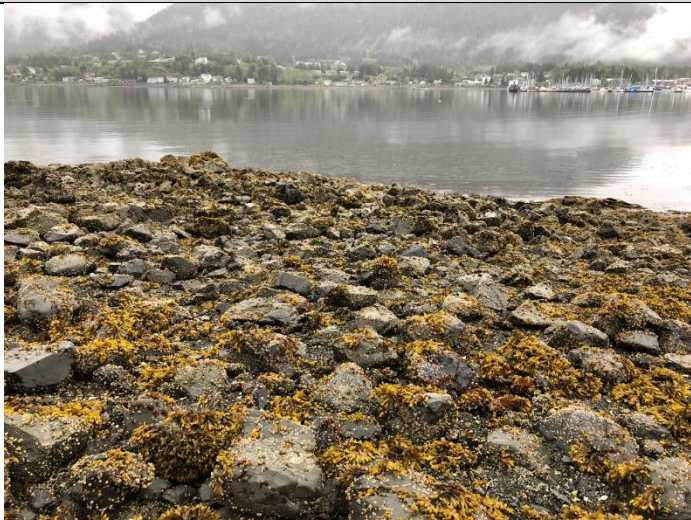
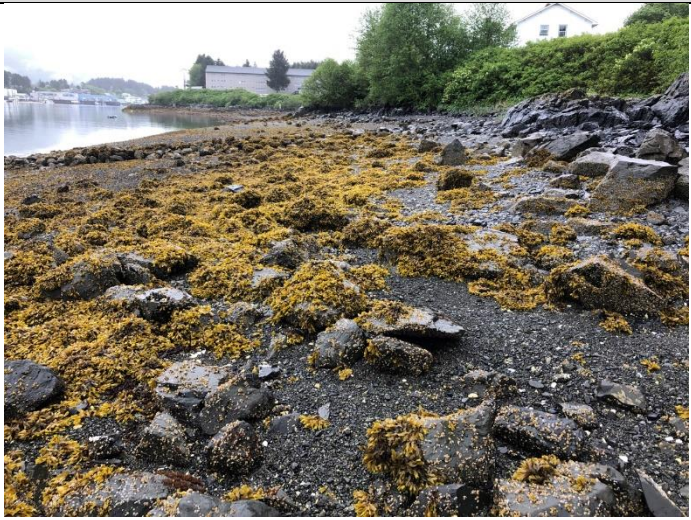
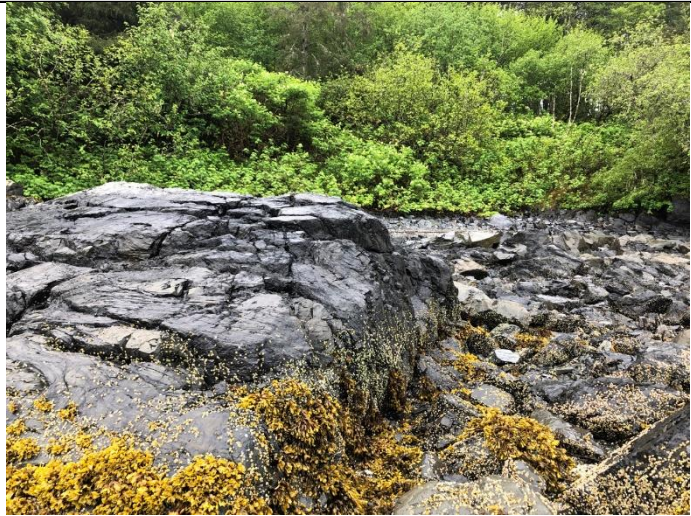
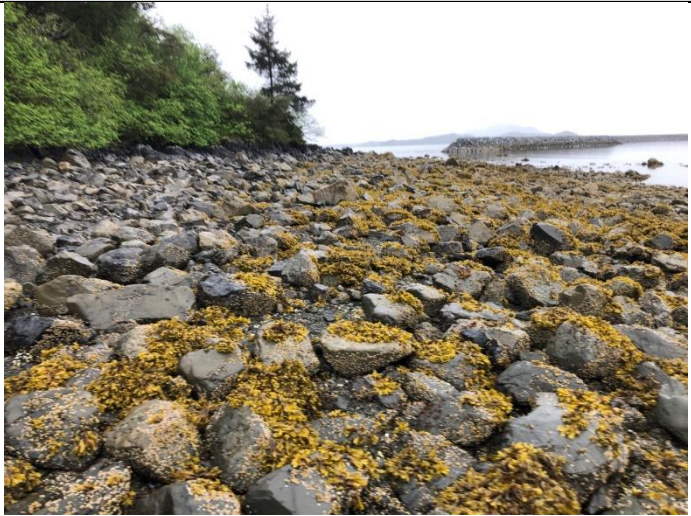
**Location Description: B2**

Boulders down to low tide, bedrock near mean high water area.
