SITKA HISTORIC PRESERVATION COMMISSION

Regular Monthly Meeting Harrigan Centennial Hall May 14, 2025 6:15 p.m.

HISTORIC STRUCTURES SURVEY REPORT (HSSR) AND NATIONAL REGISTER OF HISTORIC PLACES NOMINATION NARRATIVE FOR LINCOLN STREET, SITKA, ALASKA

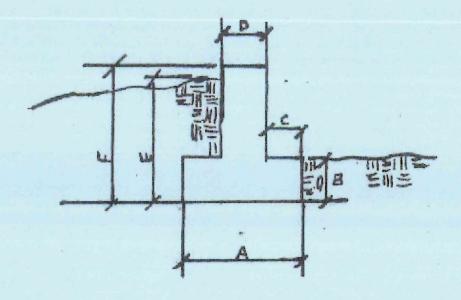
TYPICAL FOOTING/STEM WALL MINIMUM REQUIREMENTS

SINGLE STORY	2 STORY	3 STORY
A = 12"	A = 15"	A = 18"
B = 6''	$\mathbf{B} = 7$ "	B = 8''
C = 3''	C = 3 1/2"	C = 4''
$\mathbf{D} = 6''$	D = 8"	$\mathbf{D} = \mathbf{10''}$
E = 18"	$\mathbf{E} = \mathbf{18''}$	E=24"
F = VARIES	F = VARIES	F = VARIES

- 1. Additional design criteria include but are not necessarily limited to the following:
 - a. Frost Depth: 18" (Base of footing, or base of non-frost susceptible fill, must be 18" or more below grade)
 - b. Seismic: 0.2 second spectral response, $Ss = 0.97 \ g \ 1.0$ second spectral response, $S1 = 0.50 \ g$
 - c. Wind Speed, fastest 3-second gust 120 mph
 - d. Snowload 50 psf ground snow load
- 2. Reinforcing steel shall be designed for each structure following either the criteria outlined in the 2012 IRC (for residential) or 2012 IBC (for public/commercial), or other nationally recognized standards.

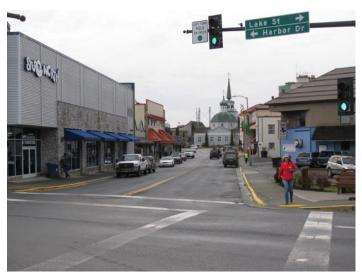
taller examples are present) with a parapet roof (Figure 1). Exterior facades are generally commercial in nature, with store-fronts containing large plate glass windows with kickplates below, glazed entrance doors, and awnings to protect pedestrians from inclement weather. Commercial signage is present either on the awnings or hanging from them. The buildings are primarily clad in wood lap or concrete siding, and ordered fenestration of upper level windows can be seen. Small stone retaining walls, interpretive signage, and alleyway sidewalks are characteristics of the streetscape. The viewshed within the district is primarily to the east and the west, where beautiful natural landscape scenes can be seen of Sitka Harbor to the west, and the Cathedral of Saint Michael the Archangel with the surrounding mountains to the east.

Figure 1. East Lincoln Street as seen from the intersection with Lake Street, view facing west (©TNSDS 2014).

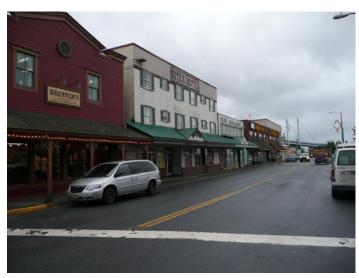
Figure 2. East Lincoln Street, western extent, as seen from the intersection with Barracks Street, view facing west (©TNSDS 2014).

The proposed district area is heavily used as a commercial center and a tourist destination, with numerous retailers closing their doors seasonally when tourism wanes. However, many of the mixed-use buildings containing upper levels have both civic and private office space and remain open throughout the year to serve the community of Sitka (Figure 2). The use of the buildings today are similar to some of the historic uses of the buildings. Buildings vary from single use (i.e. restaurant) to mixed use, such as a building with its first level functioning as commercial space and the upper level(s) consisting of residential apartments. Common building uses in the district are commerce, trade, domestic, social, government, recreation, healthcare, and defense. A commemorative historical site and small totem park are both present in the western extent of the district.

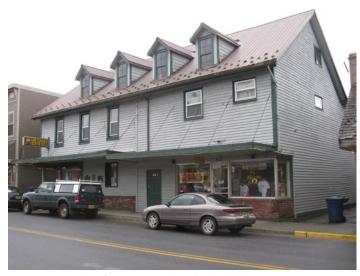
Figure 3. Example of a Russian Colonial style building, 206 East Lincoln Street (©TNSDS 2014). Also known as the Tilson Building (Building 29), this example of Russian Colonial architecture has compromised architectural significance due to alterations; the building was originally a log structure, with wood shingle roof, and has seen numerous changes through time. It is currently a National Historic Landmark, listed for its association with U.S. Political and Military Affairs.¹⁷

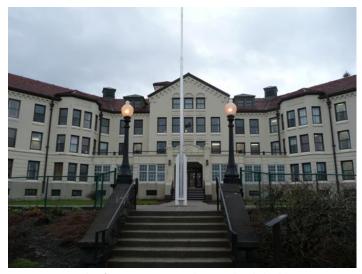
The Mission/Spanish Colonial style is extremely rare in Alaska. This style will likely be encountered with individual buildings and may exist within a historic district. To be eligible, a Mission/Spanish Colonial building should have a tile roof, low-pitched roof and stucco. Other primary and secondary features should be present, but are not necessary. Extreme flexibility should be exercised when applying integrity.¹⁸

Figure 4. Example of a Mission / Spanish Revival style building, 120 Katlian Avenue (©TNSDS 2014). The Sitka Pioneer's Home is currently listed on the NRHP for being exemplary of the Mission / Spanish Revival style and for its association with the first senior citizens social welfare plan in the United States.¹⁹

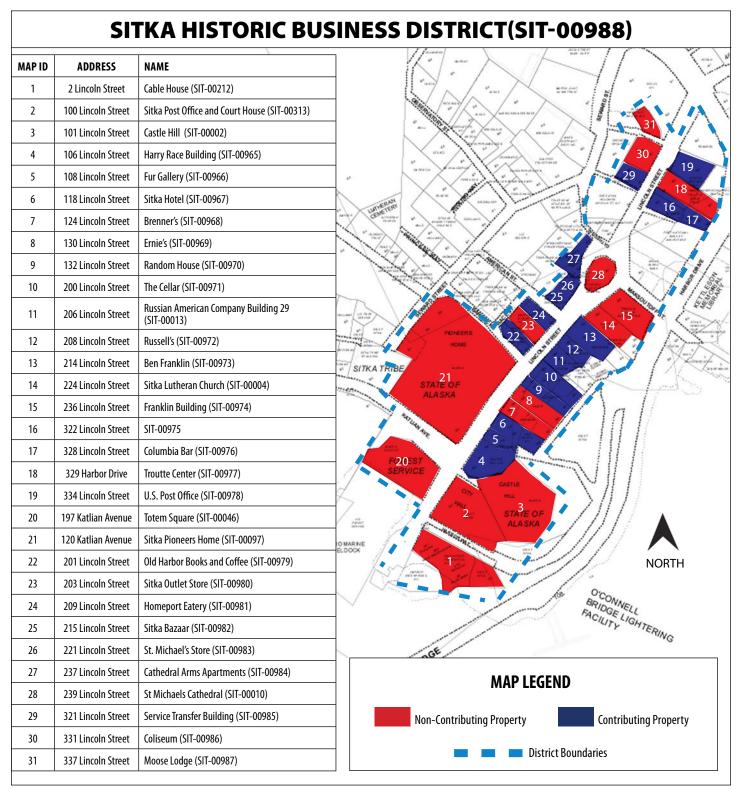
features that convey the sense of history associated with the period. The area of significance for the district is "commerce" with a period of significance from 1937 to the mid-1960s. The majority of the buildings located within the district date to the period of significance and are able to convey a stylistic sense of that period (Figure 15).

Figure 15. Map depicting the location, boundaries, and contributing status of the buildings within the downtown business area of Sitka.

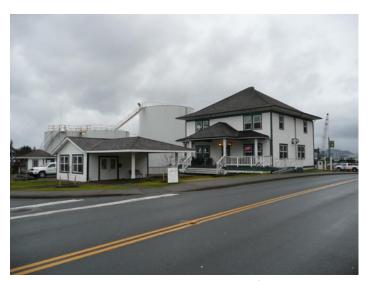
As the Cable House was constructed prior to 1910 and was not initially intended to operate as a commercial building, it is not considered to be contributing to the historic district. The building holds none of the qualifying characteristics of the commercial district such as storefront, parapet, and location against the streetscape.

Figure 16. The Cable House at 2 Lincoln Street, view facing northwest (©TNSDS 2014).

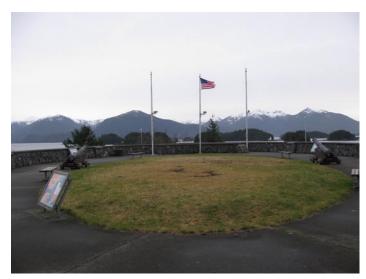
Figure 18. Castle Hill, at 101 Lincoln Street, view from on top of hill facing south (©TNSDS 2014).

Castle Hill is a hill located just to the south of the intersection of Lincoln and Katlian Streets. Originally the site of Tlingit homes prior to 1804, it became the permanent site of the Russian settlement of New Archangel (Figure 18). It was used as a militaristic fort and lookout for the protection of the settlement. Alexander Baranov lived atop the hill in a two-story home used for governance and referred to as "Baranov's Castle." In 1955, the site was cleared of construction and was named a park. In 1965, a circular stone parapet with space for six cannon, pilasters with interpretive plaques, and flagpoles were constructed as part of the Alaska Purchase Centennial celebrations. Foot access to the site from Lincoln Street consists of a paved path running through the alley between the U.S. Post Office and Court House building and the Harry Race Building, leading to steep stone steps. Handicap ramp access leads from the hill to the south, where a parking lot is located. As the site of the official raising of the American flag following purchase of Alaska, Castle Hill was listed as a National Historic Landmark in 1966.

Castle Hill is non-contributing to Sitka Historic Business District. While the property is historic in its own right, it is not a commercial property. It does not contain a building of any sort, and operates as an historical park celebrating the purchase of Alaska from Russia and chronicling the history of the area.

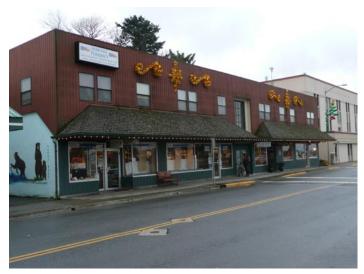
Harry Race Building is considered to be a contributing property to the Sitka Historic Business District. Constructed in 1942, it is an excellent example of the commercial style used in district during the period of significance. It contains all of the primary features (parapet, storefront, awning, and massing) and several of the secondary features (commercial entity signage, pronounced kickplate).

Figure 19. The Harry Race Building, 106 Lincoln Street, view facing southwest (©TNSDS 2014).

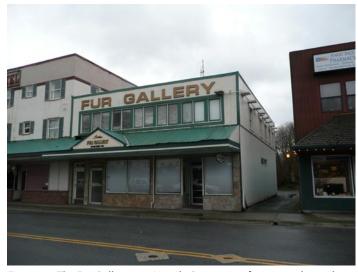
Figure 20. The Fur Gallery, 108 Lincoln Street, view facing south-southeast (©TNSDS 2014).

The Fur Gallery building, is located on the south side of Lincoln Street and faces north. It is a two-story rectangular commercial building constructed in 1940 to maximize lot size, with a large alley along the western façade and sharing a firewall with the adjacent Sitka Hotel (Figure 20). It has a flat roof with parapet and hidden foundation. The street façade contains two store-

fronts with separate access consisting of aluminum fixed storefront windows and aluminum framed glass commercial doors with transoms. Siding on the lower level is stone veneer and is separated from the upper story by a metal-roofed awning. The upper story is clad in vertical channel grooved wood siding painted off-white, and contains a ribbon of wood sash casement windows: five paired sets of paired single casement windows placed to either side. The windows, roofline, and corners are trimmed in green wood that is continued in the awning. The west façade of the building, facing the alley, continues the siding of the street façade in the upper story but contains wood framed one-over-one sash windows. The lower story is clad in stucco. A green corrugated metal awning across the façade of the building protects the entrance from inclement weather and connects to the adjacent Sitka Hotel, with a pediment in the awning oriented to provide a continuous visual front across the two buildings as opposed to delineating any individual aspect of the Fur Gallery building. A drainage system of scuppers runs along the west façade. The name of the building, denoting the commercial entity, is evident along the second story street façade in attached metal letters reading "Fur Gallery."

108 Lincoln Street is considered to be a contributing property to the Sitka Historic Business District. Constructed in 1940, it is an excellent example of the commercial style seen in the district during the period of significance. It contains all of the primary features (parapet, storefront, awning, and massing) and several of the secondary features (commercial entity signage, pronounced kickplate). Additionally, the building is situated adjacent to the Sitka Hotel, and the awning is constructed in such a way that it has visual continuity with the neighboring building.

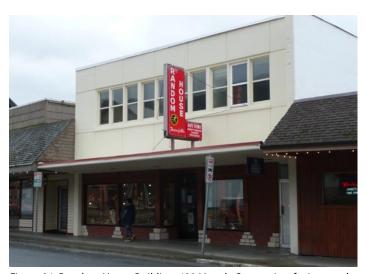
The Random House building is considered to be a contributing property to the Sitka Historic Business District. Constructed in 1950, it is an excellent example of the commercial style used in district during the period of significance. It contains all of the primary features (parapet, storefront, awning, and massing) and several of the secondary features (commercial entity signage, pronounced kickplate, ordered and pronounced fenestration patterns and groupings).

Figure 24. Random House Building, 132 Lincoln Street, view facing southeast (©TNSDS 2014).

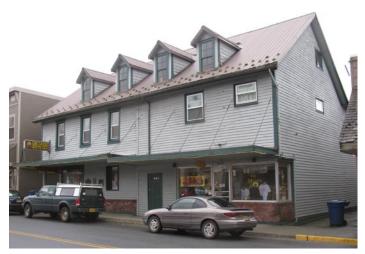
Figure 26. The Tilson Building/Russian American Building Number 29 at 206 Lincoln Street, view facing southeast (©TNSDS 2014).

The Tilson Building, also known as Russian American Company Building No. 29, is located at 206 Lincoln Street (Figure 26). It is a three-story log structure of the Russian Colonial style constructed on the south side of the street. It has a raised-seam metal, side-gabled roof with four gabled dormers and a partial basement. Construction dates vary from 1835 to the 1850s,

however, it was the last Russian building to be used in Sitka for commercial purposes. The building has undergone substantial renovation, including the addition of wood lap siding on the main and western façades, vinyl shiplap siding on the second story east facade, and wood shingle in the eastern gable end. Plate glass storefront windows are present in the northeast and northwest corners of the building, and a flat angled awning to protect the storefronts from inclement weather runs the entire length of the building. A brick-veneer kickplate has also been added along the northern façade of the building. Fenestration consists of one-over-one vinyl sash windows set in the second story and four-over-four wood sash windows in each of the four north-facing third story dormers. The storefront to the northwest contains a metal-framed glass door centrally placed within the display, while the entrance to the northeast is a wood-framed glass door to the extreme east of the display. A panel door with a single light is located in the center of the north façade. An addition to the south side of the building, not visible from Lincoln Street, has extended the roofline into a saltbox form. Plexiglas has been placed over the northeast corner of the first story to reveal and protect the original logs of the building. It is significant as one of the few remaining Russian structures in Alaska, and it was included in the NRHP as a National Historic Landmark in 1987.

The Tilson Building is considered to be a contributing property to the Sitka Historic Business District. Originally constructed during the Russian Period prior to 1850, it is has undergone numerous renovations during the interceding 160 years. In its present form, it is an excellent example of the commercial style used in district during the period of significance. It contains all of the primary features (parapet, storefront, awning, and massing) and several of the secondary features (commercial entity signage, pronounced kickplate, ordered and pronounced fenestration patterns and groupings).

The Tilson Building is considered to be a contributing property to the Sitka Historic Business District. Originally constructed during the Russian Period prior to 1850, it is has undergone numerous renovations during the interceding 160 years. In its present form, it is an excellent example of the commercial style used in district during the period of significance. It contains all of the primary features (parapet, storefront, awning, and massing) and several of the secondary features (commercial entity signage, pronounced kickplate, ordered and pronounced fenestration patterns and groupings).

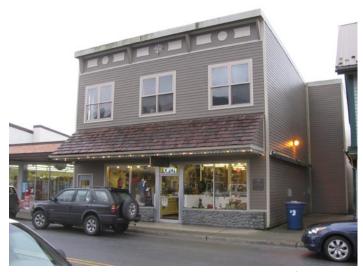
208 Lincoln Street is considered to be a contributor to the Sitka Historic Business District. It was constructed in 1940, inside the period of significance for the historic district, but has undergone extensive remodeling in recent years. The result is that it embodies all of the primary features (parapet, storefront, awning, and massing) and several of the secondary features (commercial entity signage, pronounced kickplate, ordered and pronounced fenestration patterns and groupings) required for inclusion in the district. While the building is not individually eligible for listing, it is considered to be contributing due to the visual continuity it conveys to the historic district.

Figure 27. Russell's Sporting Goods, 208 Lincoln Street, view facing southeast (©TNSDS 2014).

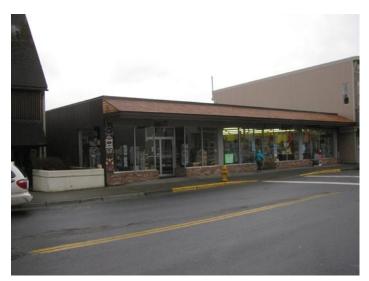
The Ben Franklin Building is considered to be a contributing property to the Sitka Historic Business District. Constructed in 1964, it is an excellent example of the commercial style used in district during the period of significance. It contains all of the primary features (parapet, storefront, awning, and massing) and several of the secondary features (commercial entity signage, pronounced kickplate, ordered and pronounced fenestration patterns and groupings).

Figure 28. The Ben Franklin Store, 214 Lincoln Street, view facing southwest (©TNSDS 2014).

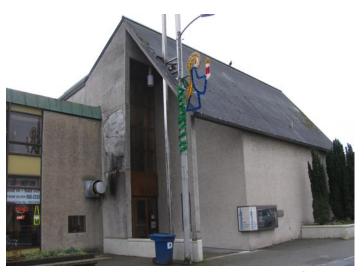
The Sitka Lutheran Church is not considered to be a contributing building to the Sitka Historic Business District. Constructed in 1966 to replace the original church destroyed by the fire in January 1966, it is not a commercial building and contains none of the primary features necessary for inclusion in the district.

Figure 29. The Sitka Lutheran Church, 224 Lincoln Street, view facing southwest (©TNSDS 2014).

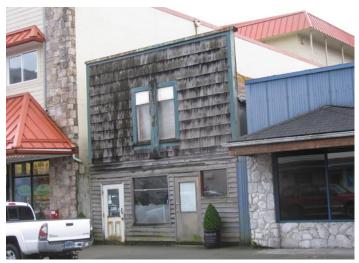
The Columbia Bar is considered to be a contributing property to the Sitka Historic Business District. Constructed in ca.1910 outside of the period of significance, it nonetheless is an excellent example of the commercial style used in district during the period of significance. It contains most of the primary features (parapet, storefront, and massing) and several of the secondary features (wood lap siding, ordered and pronounced fenestration patterns and groupings).

Figure 32. The Columbia Bar, 328 Lincoln Street, view facing southeast (©TNSDS 2014).

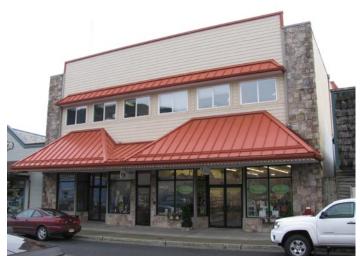
Figure 33. Troutte Center, 329 Linocln Street, view facing southeast (©TNSDS 2014).

The Troutte Center, is a two-story rectangular vernacular commercial building constructed in 1967 on the south side of Lincoln Street (Figure 33). It was built to maximize the property lot, with the main façade facing north directly onto Lincoln Street. It has a flat roof with parapet and a concrete foundation. The main north façade has vinyl lap siding with stone veneer along the first story storefront and corners of the building; the east and west facades are painted concrete block. Fenestration consists of a series of plate glass storefront display windows across the first story and an evenly spaced row of six sliding glass windows in the upper story. The lower story contains two storefronts separated by a single metal-framed glass door with transom that provides access to a central staircase to the upper story. Storefront entrances are recessed, with paired metal-framed glass doors with transoms. The kickplate below the display windows is stone veneer. Paired red raised-seam metal hipped awnings protect the storefronts from inclement weather; a metal clad pent protects the upper story windows. Signage for the resident commercial entities hangs from the underside of the awning.

The Troutte Center Building is not considered to be a contributing building to the Sitka Historic Business District. It was constructed outside the period of significance (1967) and has un-

dergone extensive renovation in recent years. While it contains several of the necessary features, the massing of the building and necessary features is such that it does not convey visual continuity with the rest of the historic district.

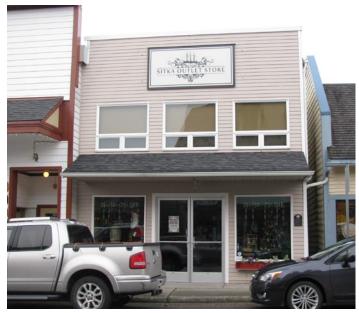
203 Lincoln Street is considered to be a contributing property to the Sitka Historic Business District. Constructed in 1940, it is an excellent example of the commercial style used in district during the period of significance. It contains all of the primary features (parapet, storefront, awning, and massing) and several of the secondary features (commercial entity signage, pronounced kickplate, ordered and pronounced fenestration patterns and groupings).

Figure 38. The Sitka Outlet Store, 203 Lincoln Street, view facing west (©TNSDS 2014).

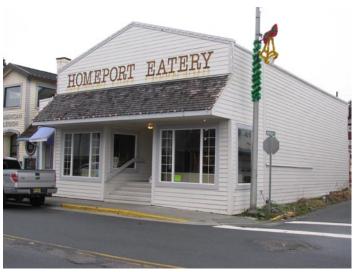
209 Lincoln Street is considered to be a contributing property to the Sitka Historical Commercial District. Although constructed outside the period of significance in 1923, it is an excellent example of the commercial style used in district during the period of significance. It contains all of the primary features (parapet, storefront, awning, and massing) and several of the secondary features (commercial entity signage, pronounced kickplate, ordered and pronounced fenestration patterns and groupings).

Figure 39. Homeport Eatery, 209 Lincoln Street, view facing west (©TNSDS 2014).

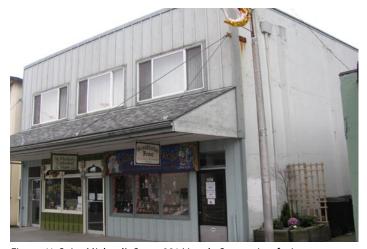
221 Lincoln Street is considered to be a contributing property to the Sitka Historic Business District. Constructed following the fire of 1966, it is an excellent example of the commercial style used in district during the period of significance. It contains all of the primary features (parapet, storefront, awning, and massing) and several of the secondary features (commercial entity signage, pronounced kickplate, ordered and pronounced fenestration patterns and groupings).

Figure 41. Saint Michael's Store, 221 Lincoln Street, view facing west (©TNSDS 2014).

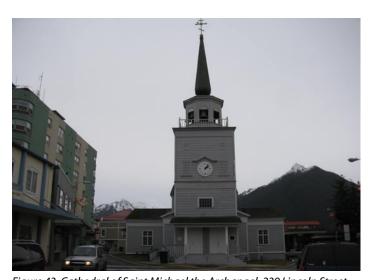
The Cathedral of Saint Michael the Archangel is not considered to be a contributing property to the Sitka Historic Business District. Originally constructed during the Russian period and replaced in 1967 following construction by fire in 1966, the building is not a commercial building and contains none of the primary or secondary features necessary for visual continuity for the historic commercial district.

Figure 43. Cathedral of Saint Michael the Archangel, 239 Lincoln Street, view facing northeast (©TNSDS 2014).

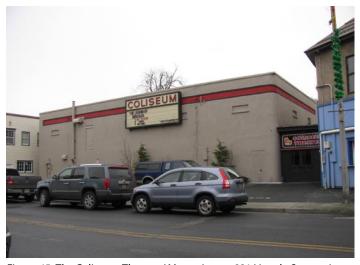
The Coliseum Theater is not considered to be a contributing building to the Sitka Historic Business District. Constructed in 1920, outside the period of significance, it contains none of the primary features necessary for inclusion in the historic district. Additionally, the setback and stylistic modifications mean that this building does not represent any visual continuity for the district.

Figure 45. The Coliseum Theater / Moose Lanes, 331 Lincoln Street, view facing west (©TNSDS 2014).

g. Review and recommendation of entryway at 331 Lincoln Street.Will presented the commission with a request for review of an entryway and window at 331 Lincoln Street. The applicant was looking to reinstall an entryway at the Coliseum Theater, and place a window next to the existing doorway.

No public comment was received. Commissioner Poulson noted that the building was likely eligible for listing on the National Register of Historic Places, and that it had once been a part of the Moose Lodge.

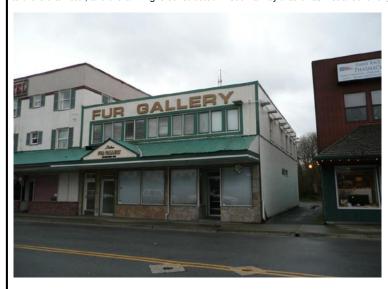
108 Lincoln Street is considered to be a contributing property to the Sitka Historic Business District. Constructed in 1940, it is an excellent example of the commercial style seen in the district during the period of significance. It contains all of the primary features (parapet, storefront, awning, and massing) and several of the secondary features (commercial entity signage, pronounced kickplate). Additionally, the building is situated adjacent to the Sitka Hotel, and the awning is constructed in such a way that it has visual continuity with the neighboring building.

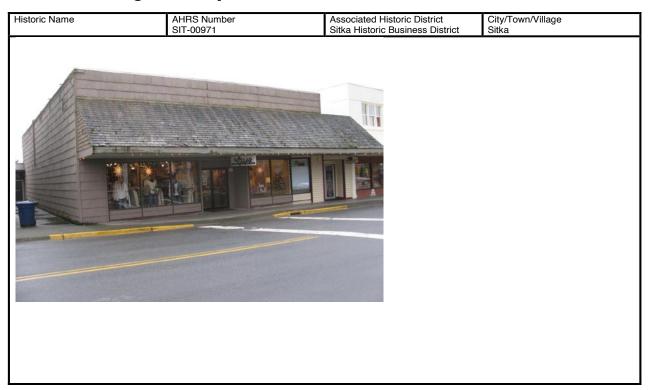
Alaska Building Inventory Form AHRS #: SIT-00979 Associated District: ANC-00988

201 Lincoln Street is considered to be a contributing property to the Sitka Historic Business District. Although constructed prior to the period of significance in 1890, it is an excellent example of the commercial style used in district during the period of significance. It contains all of the primary features (parapet, storefront, awning, and massing) and several of the secondary features (commercial entity signage, pronounced kickplate, ordered and pronounced fenestration patterns and groupings). Historic photographs from the period of significance show the building is nearly unchanged in character since the period of significance.
