RE: Green Lake Hydroelectric Project (P-2818) Initial Study Report Filing

**Green Lake
Hydroelectric Project
FERC No. P-2818**

Initial Study Report

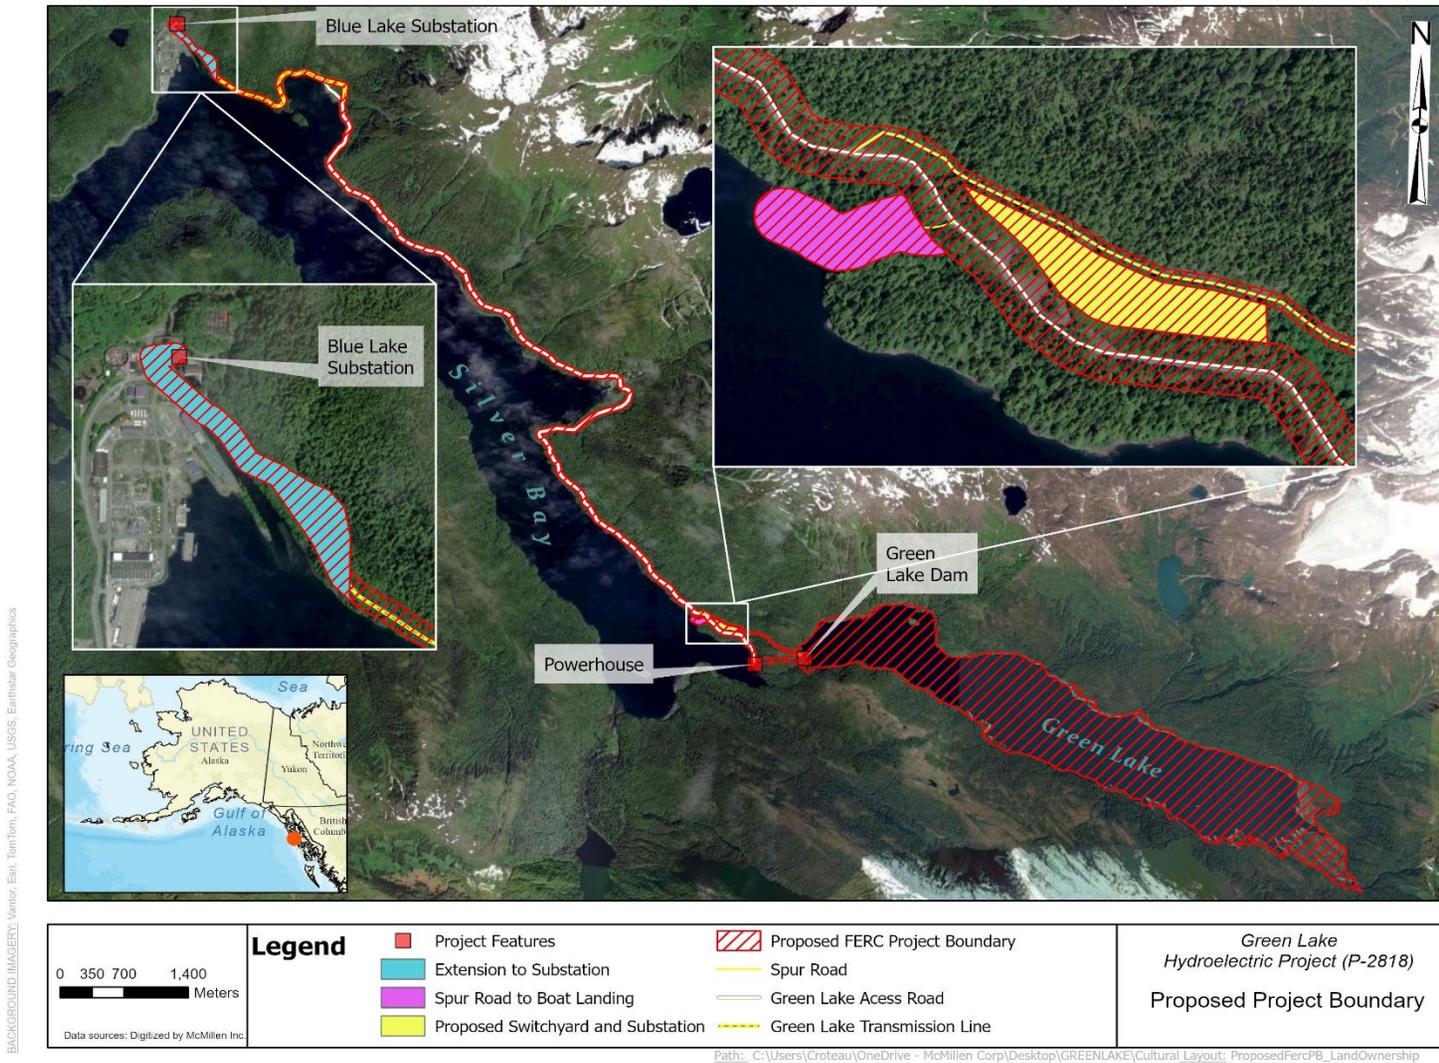
Figure 1-2. Proposed Changes to FERC Project Boundary

3. The current FERC Project Boundary does not extend to the point of interconnection at the Blue Lake Hydroelectric Project substation and instead ends just over one mile to the southeast. This corresponds to the previous extent of the Blue Lake Hydroelectric Project Boundary, which has since been modified. CBS proposes extending the current FERC Project Boundary along the existing transmission line and access road to the Blue Lake substation for accuracy and completeness (Figure 1-2). The proposed extension encompasses 16.4 acres, is 1.24 miles in length, and is located wholly on CBS-owned land.

These proposed changes to the FERC Project Boundary affect the study areas for the three Project studies as follows:

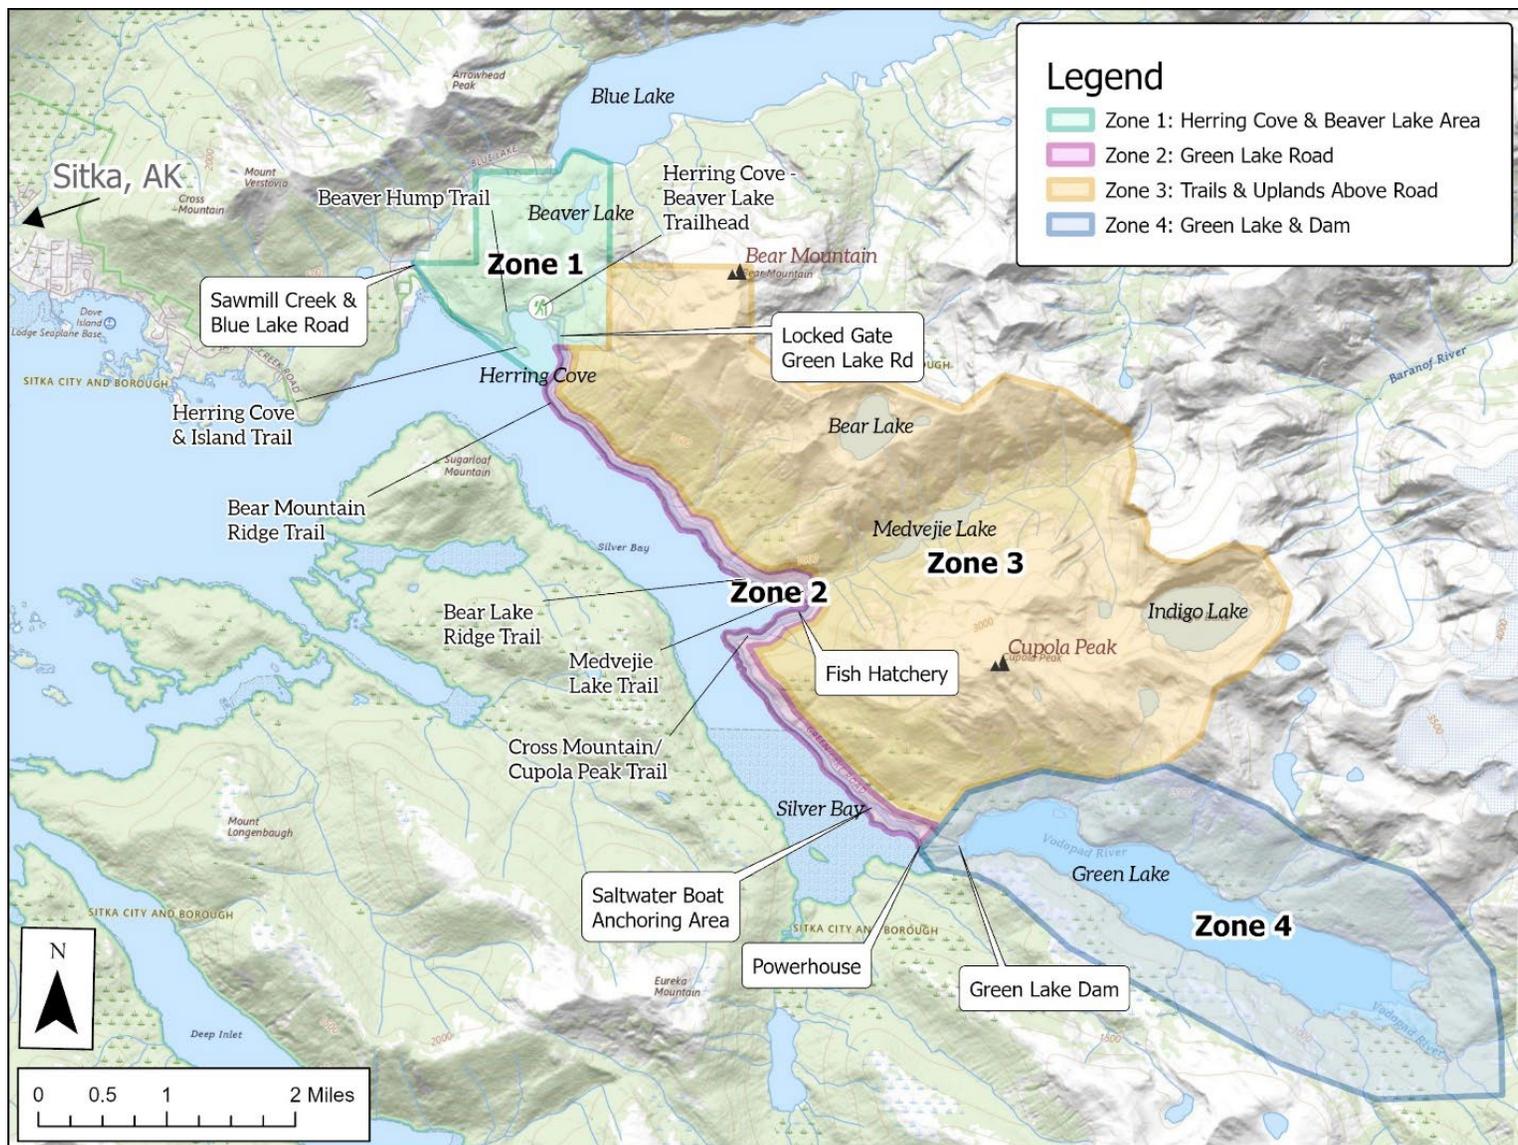
Figure 2-2 Green Lake Recreation Study Area Zone Map

Zone 1 Herring Cove and Beaver Lake Area	Zone 2 Green Lake Road Corridor	Zone 3 Trails and Uplands above Green Lake Road	Zone 4 Green Lake and Dam
<ul style="list-style-type: none"> • Sawmill Creek Road • Herring Cove Point and Island • Beaver Hump Trail • Herring Cove – Beaver Lake Trail 	<ul style="list-style-type: none"> • Green Lake Road • Medvejie Hatchery at Bear Cove • Saltwater boat landing • Powerhouse 	<ul style="list-style-type: none"> • Medvejie Lake Trail • Bear Mountain West Ridge Route • Bear Mountain Lake Route • Cross Mountain 	<ul style="list-style-type: none"> • Green Lake and Dam

The Green Lake Study Area is remote and, with one exception (Zone 1 Herring Cove-Beaver Lake Trail and trailhead area), lacks facilities developed specifically for recreational use such as developed parking areas, toilets, trailheads and signs, developed trails, etc. Recreation use of the area appears regular but relatively low in volume. In the absence of facilities developed specifically for recreation, visitors use Project facilities, including the roads, boat landing area, and Green Lake, to access the area and natural features. These facilities and natural features are described below, organized by zone (Sections 2.4.1.1 through 2.4.14). Facilities and features are described in terms of their setting characteristics that may contribute to different types of recreational opportunities. Characteristics of the physical, managerial, and social setting are considered; these characteristics are listed in Table 2-3. All facilities used for recreation are open to the public year-round, 24/7.

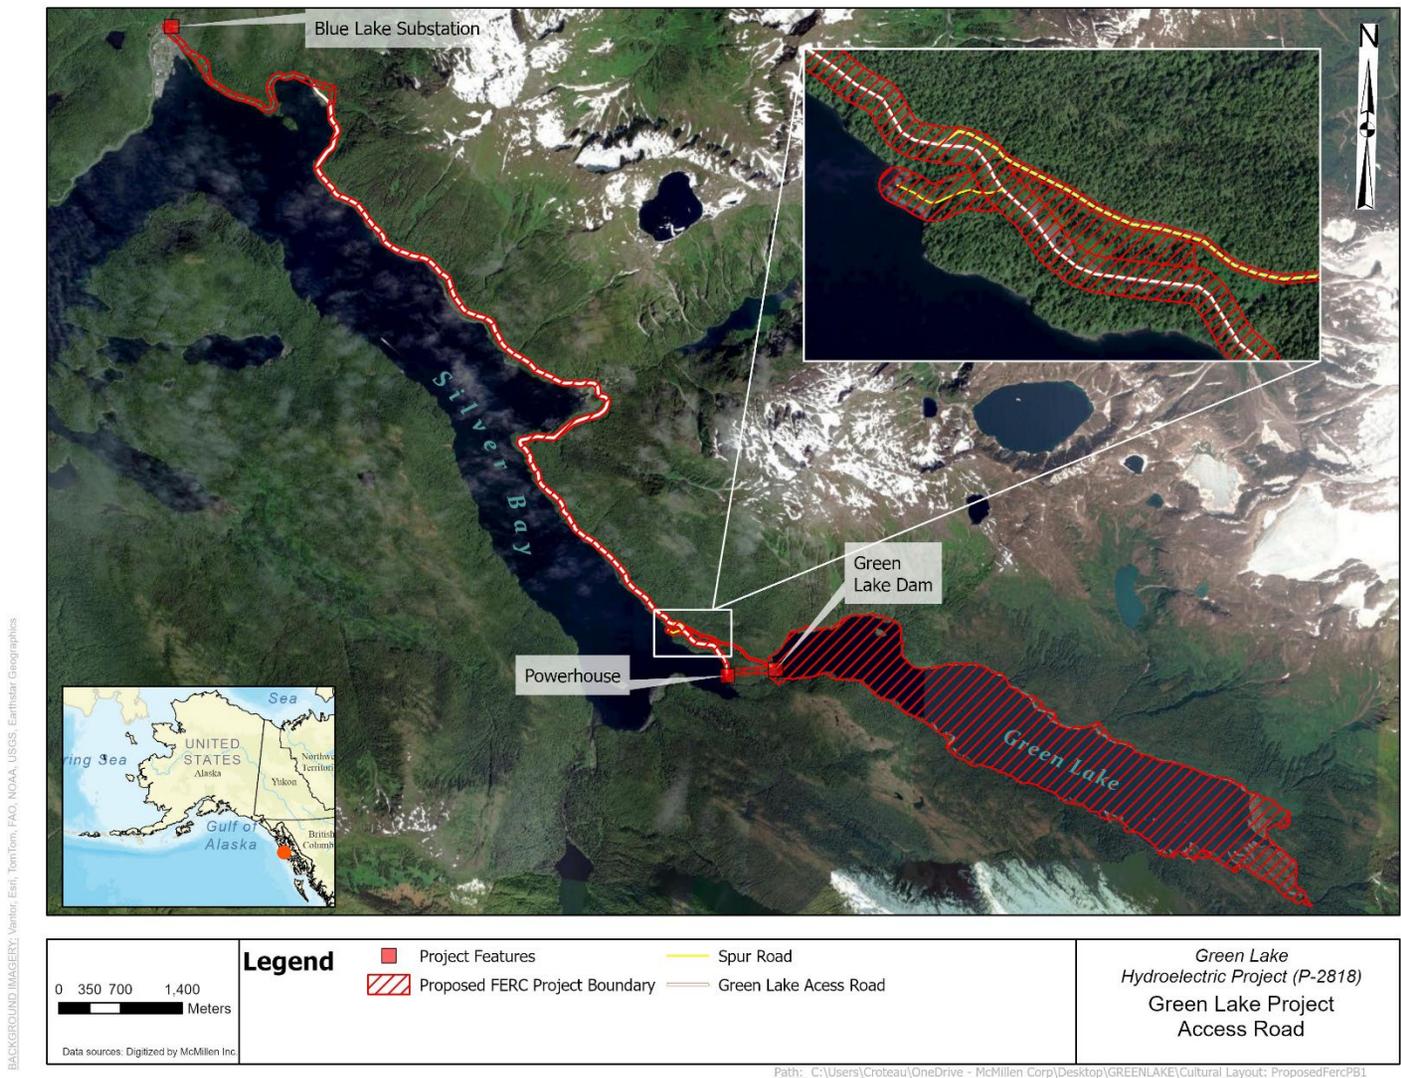
Figure 2-1. Study Area for Access Road Water Crossing Structures Study

CBS conducted this study along the approximately seven-mile stretch of the Green Lake access road from the end of the Alaska Department of Transportation & Public Facilities (ADOT&PF) maintained section of road just before the locked gate near Herring Cove to the powerhouse, as well as on the spur road to Green Lake (Figure 2-1). CBS controls and maintains this stretch of access road and the spur road to Green Lake. The portion of the road that is owned and maintained by ADOT&PF is not included in this study even though approximately 1.5 miles is within the Proposed FERC Project Boundary; CBS has no control over this section of the road (Figure 2-1).

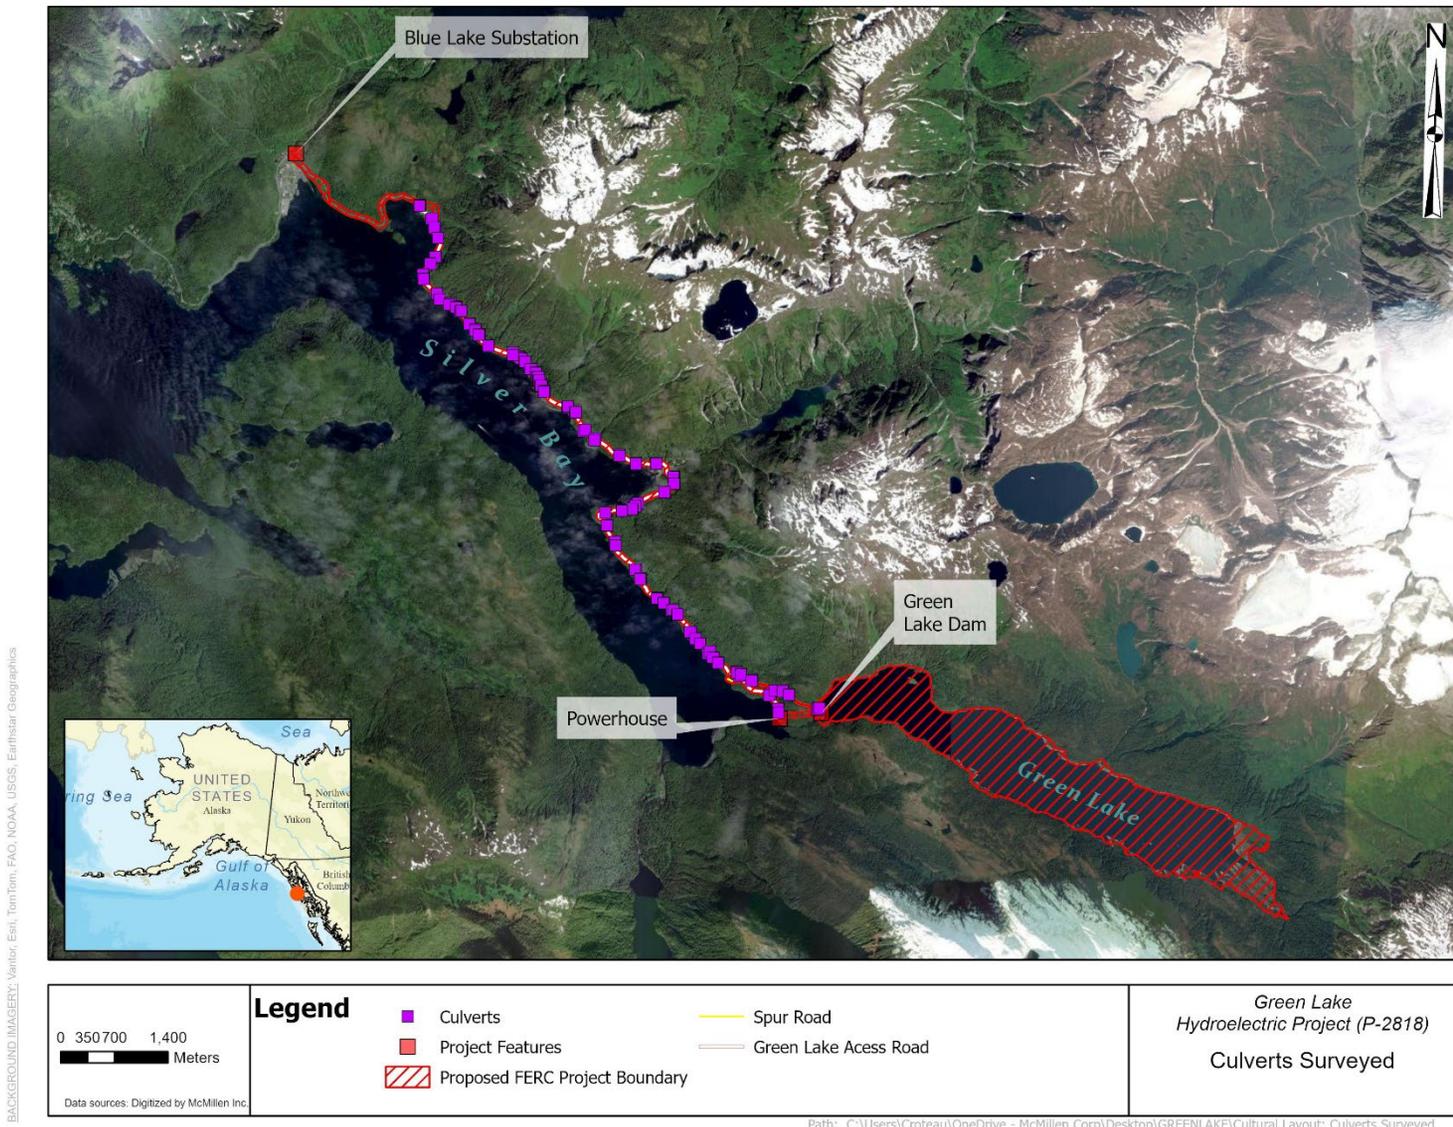
Figure 2-2. Culverts Surveyed

Of the 69 culverts identified along the Green Lake access road, 12 culverts were associated with active stream channels, while 57 culverts were associated with non-stream features such as roadside drainage ditches, ephemeral flow paths, or shallow swales. The eight culverts along the spur road to Green Lake were not associated with streams except for GD02, which consisted of extremely steep cascades both above and below the culvert. This made surveying the culvert in the field unsafe and, therefore, this culvert is not further evaluated. However, the steep bedrock cascades both upstream and downstream of this culvert preclude fish passage (see photos in Appendix C).

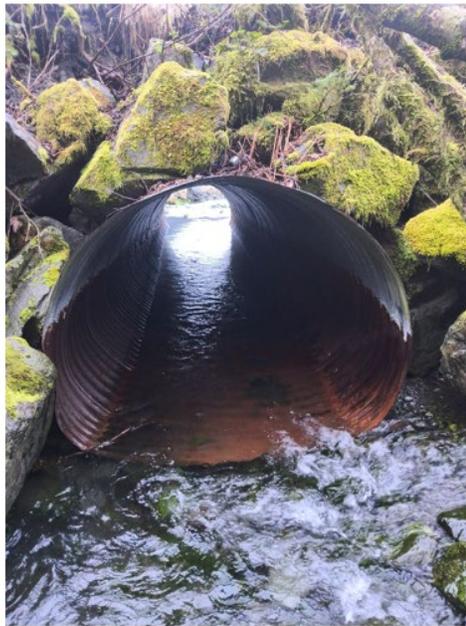
G31-A Inlet

The stream associated with G31-A was classified as a Class I stream based on FSH 2090.21 criteria, which are streams that have anadromous or adfluvial fish or fish habitat. ADFG maintains anadromous waters data for the state in their online Anadromous Waters Catalog (AWC; ADFG 2025). The AWC confirms the stream associated with culvert G31-A (Stream 113-41-10240) is anadromous and was most recently surveyed by ADFG in 2012 (ADFG 2016). This stream has a defined stream channel, and the G31-A culvert is functioning as intended and is not showing signs of significant erosion or overtopping, indicating it is appropriately sized for this stream. The inlet and outlet are not perched and are submerged in the stream, allowing for aquatic organism passage (see photos below).

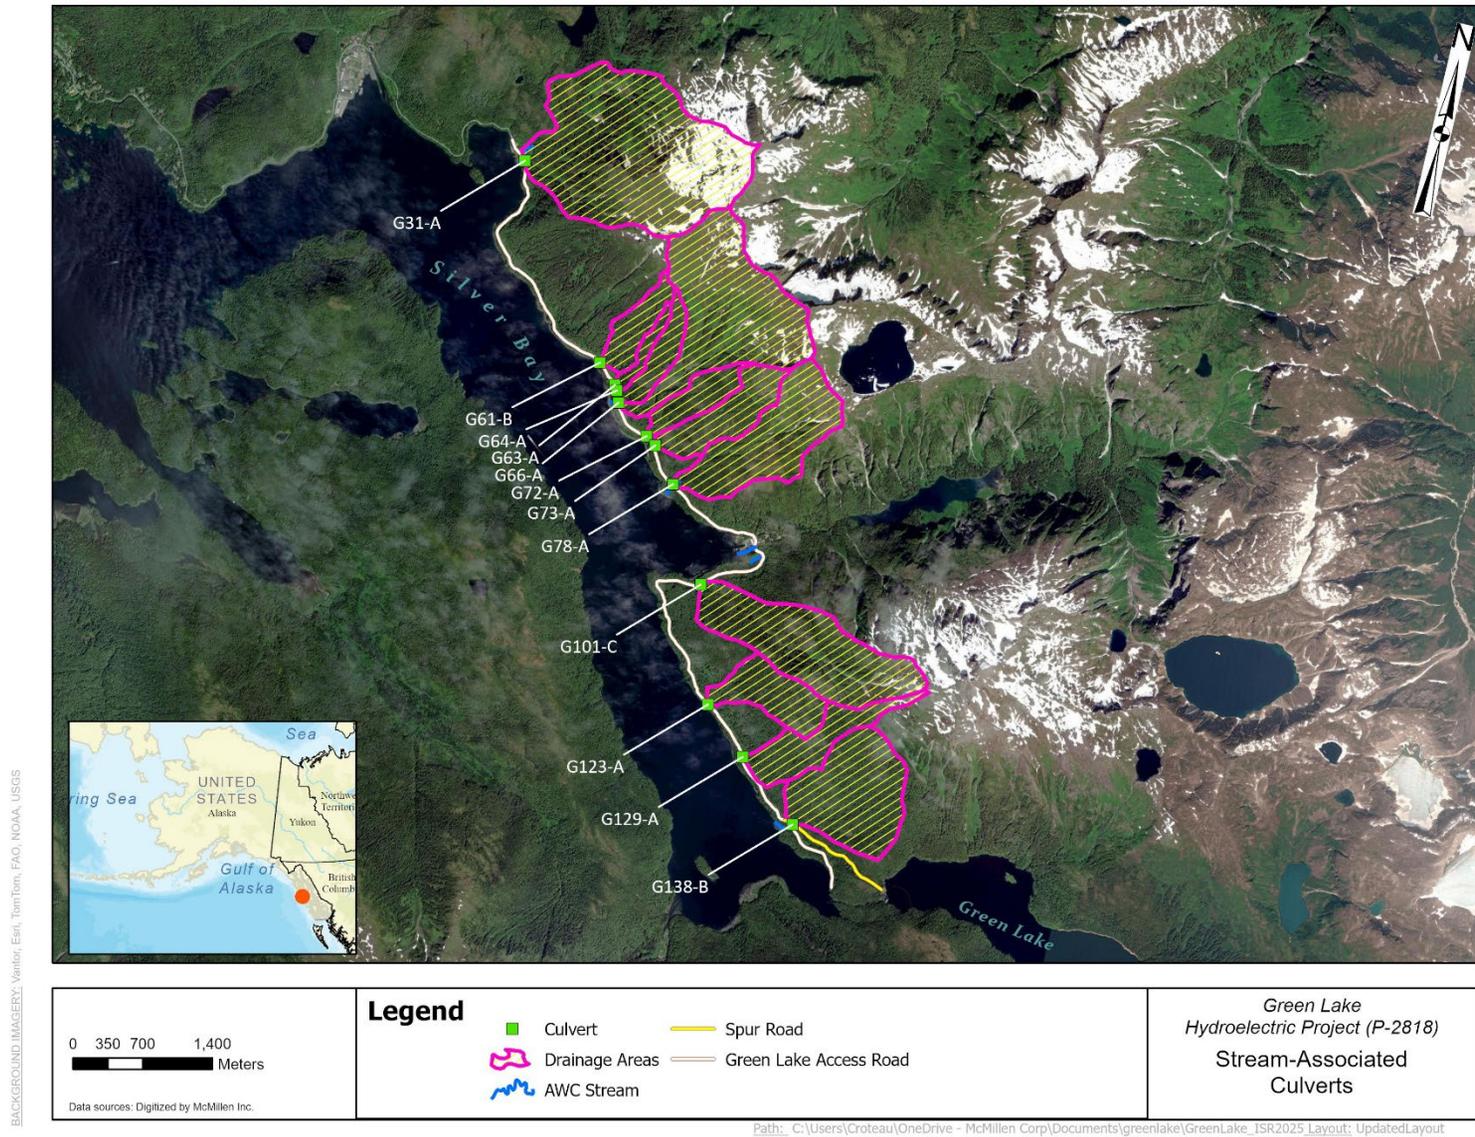
Figure 2-3. Stream-Associated Culverts

6.20	G138-B	0.42	Class III	Moderate Gradient Contained/High Gradient Contained	High gradient, upstream of anadromy limit, AWC Stream 113-41-10305

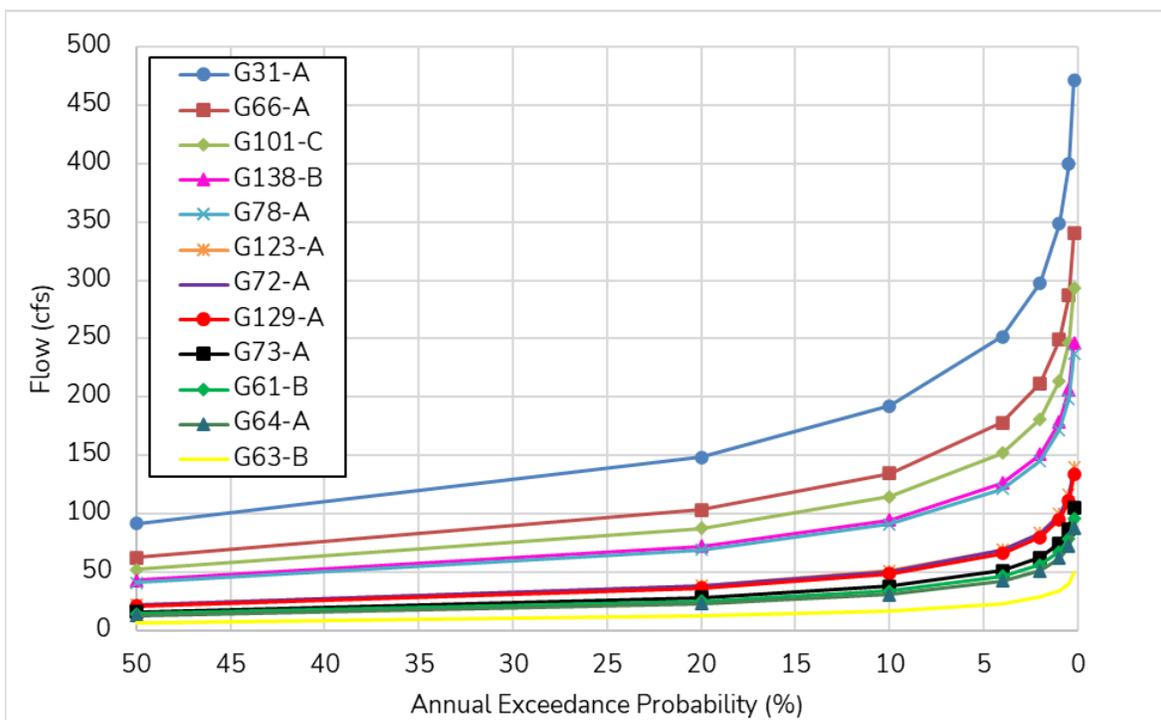
Figure 2-4. Flood Frequency Flows (1991-2020 Normal)

The 50% annual exceedance probability ranged from 6 cubic feet per second (cfs) at G63-B to 91 cfs at G31-A and the 0.2% annual exceedance probability ranged from 49 cfs at G63-B to 400 cfs at G31-A. Flood frequency flows are directly related to the drainage area of each respective culvert, as the same precipitation value was used for all, with the larger drainage area culverts exhibiting higher flood frequency flows and the smaller drainage area culverts exhibiting lower flood frequency flows. As expected, flood frequency flows increased under the CCSM and GFDL climate projection models, as annual precipitation is expected to increase under these models.
