Sitka Seawalk Phase II Project (DOT&PF Project No. SFHWY00312)

Tier 1 Eelgrass Delineation Report

Sitka, Alaska

September 2022

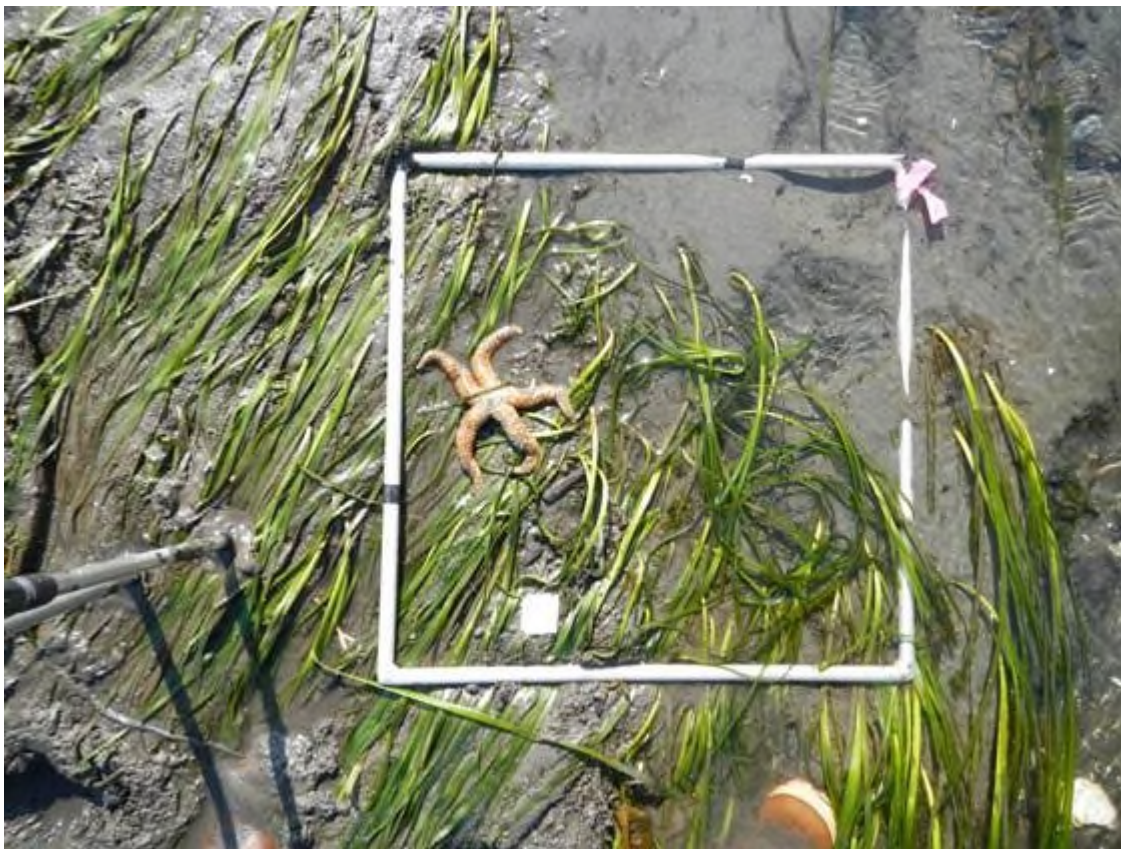
Photo 1. A sample station with a 0.5 m × 0.5 m quadrat.

Intertidal beds were sampled at stations along transects placed perpendicular to the waterline (Figure 3). At each sampling station, a 0.5 m × 0.5 m quadrat was placed on the ground (Photo 1). Within the quadrat, eelgrass percent cover was determined as the percentage of the quadrat covered by eelgrass shoots to the nearest 5%; the field crew conferred to determine an estimate. Each station was photographed in a straight-down perspective, showing the substratum, vegetation, and fauna within the quadrat.

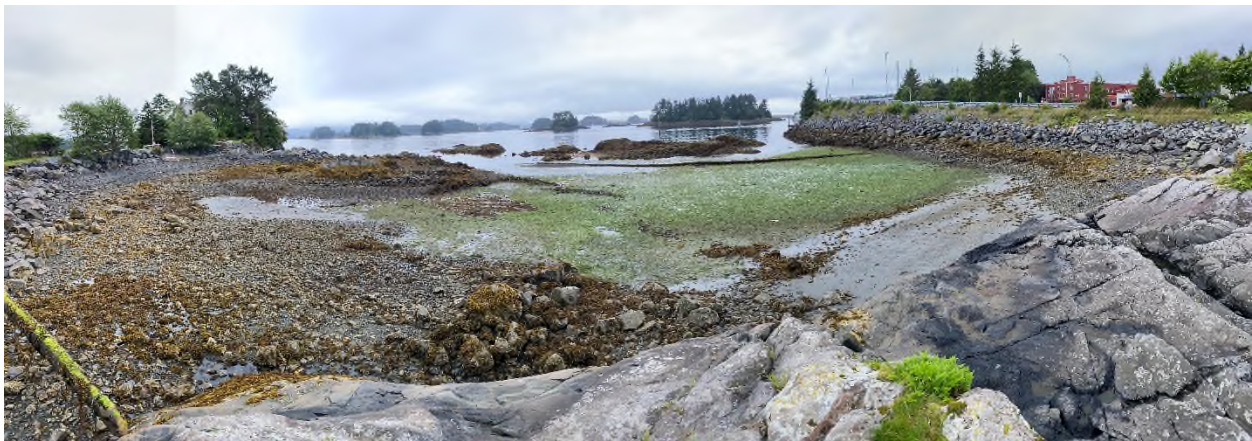
Photo 2. Study area for the Sitka Seawalk Phase II Eelgrass Survey in Sitka Channel. Bed 1 (described below) is visible in this photo.

The intertidal eelgrass bed (Bed 1) filled the majority of the cove at the northern end of the study area (Photo 2), extending from +0.97 m to -1.0 m (-3.2 ft to -3.3 ft) relative to MLLW. The western edge of the bed was between 0 m and 3 m (0 ft to 9.8ft) from the riprap for about 85 m of shoreline (Figure 3). Total area of Bed 1 was 3,750 m² (0.93 acres), or roughly 40% of the study area.

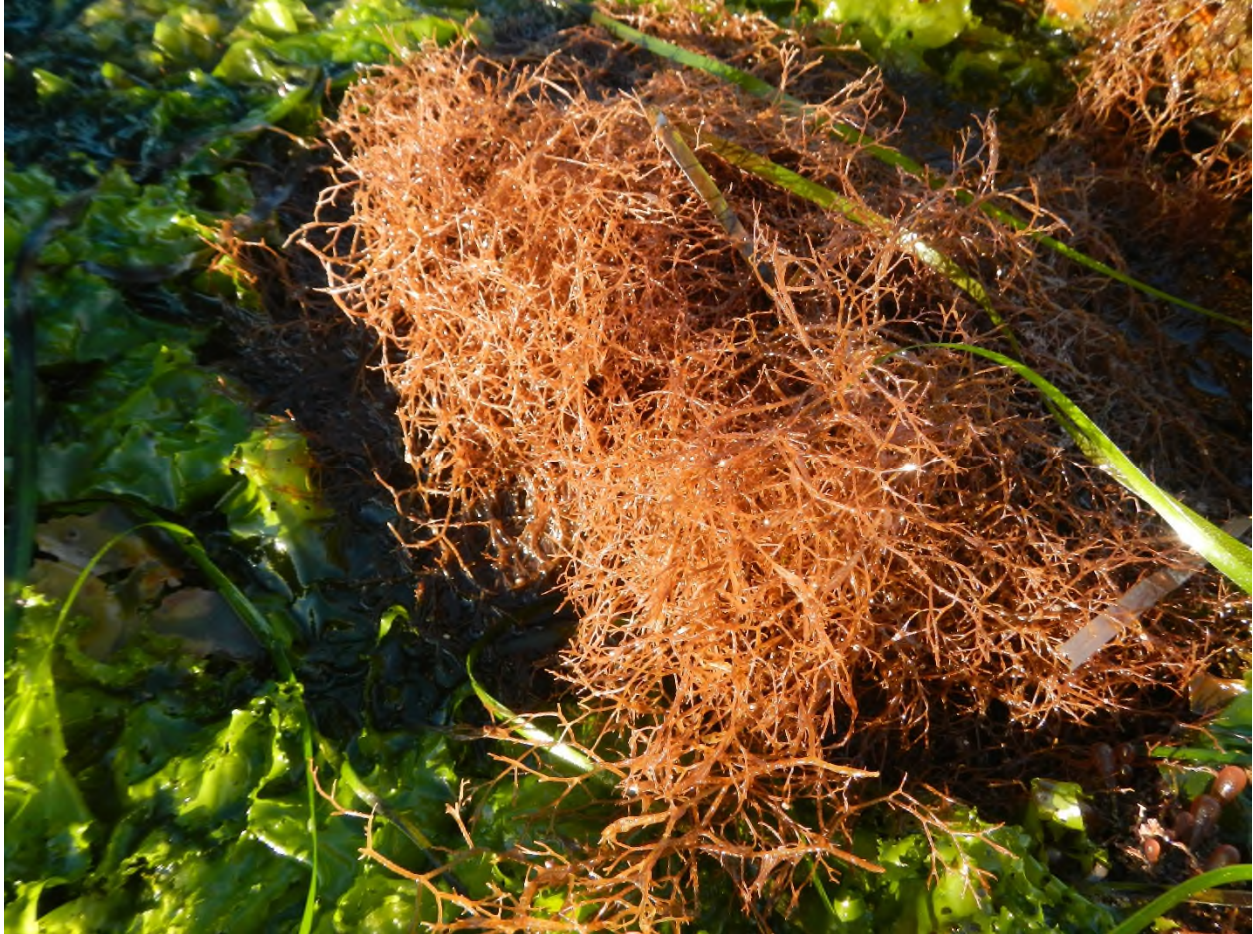
Photo 3. Red alga, tentatively identified by photo as an invasive species of the genus *Ahnfeltia*, between Stations C3 and C4 in Bed 1 of the study area for the Sitka Seawalk Phase II Eelgrass Survey area in Sitka Channel.

Five species of marine algae were identified in Bed 1. In Transect C, sugar kelp (*Saccharina latissima*), sea lettuce (*Ulva lactuca*), and a red alga were present. The red alga, tentatively identified by photo as an invasive species of the genus *Ahnfeltia* based on personal communication with Mandy Lindeberg¹, was located between station C3 and C4 (Photo 3; Figure 3). The epiphytic sea cauliflower (*Leathesia marina*) was found on a species of *Neorhodomela* algae in Sampling Station G5, and rockweed (*Fucus distichus*) dominated portions of Transect F (Photo 9).

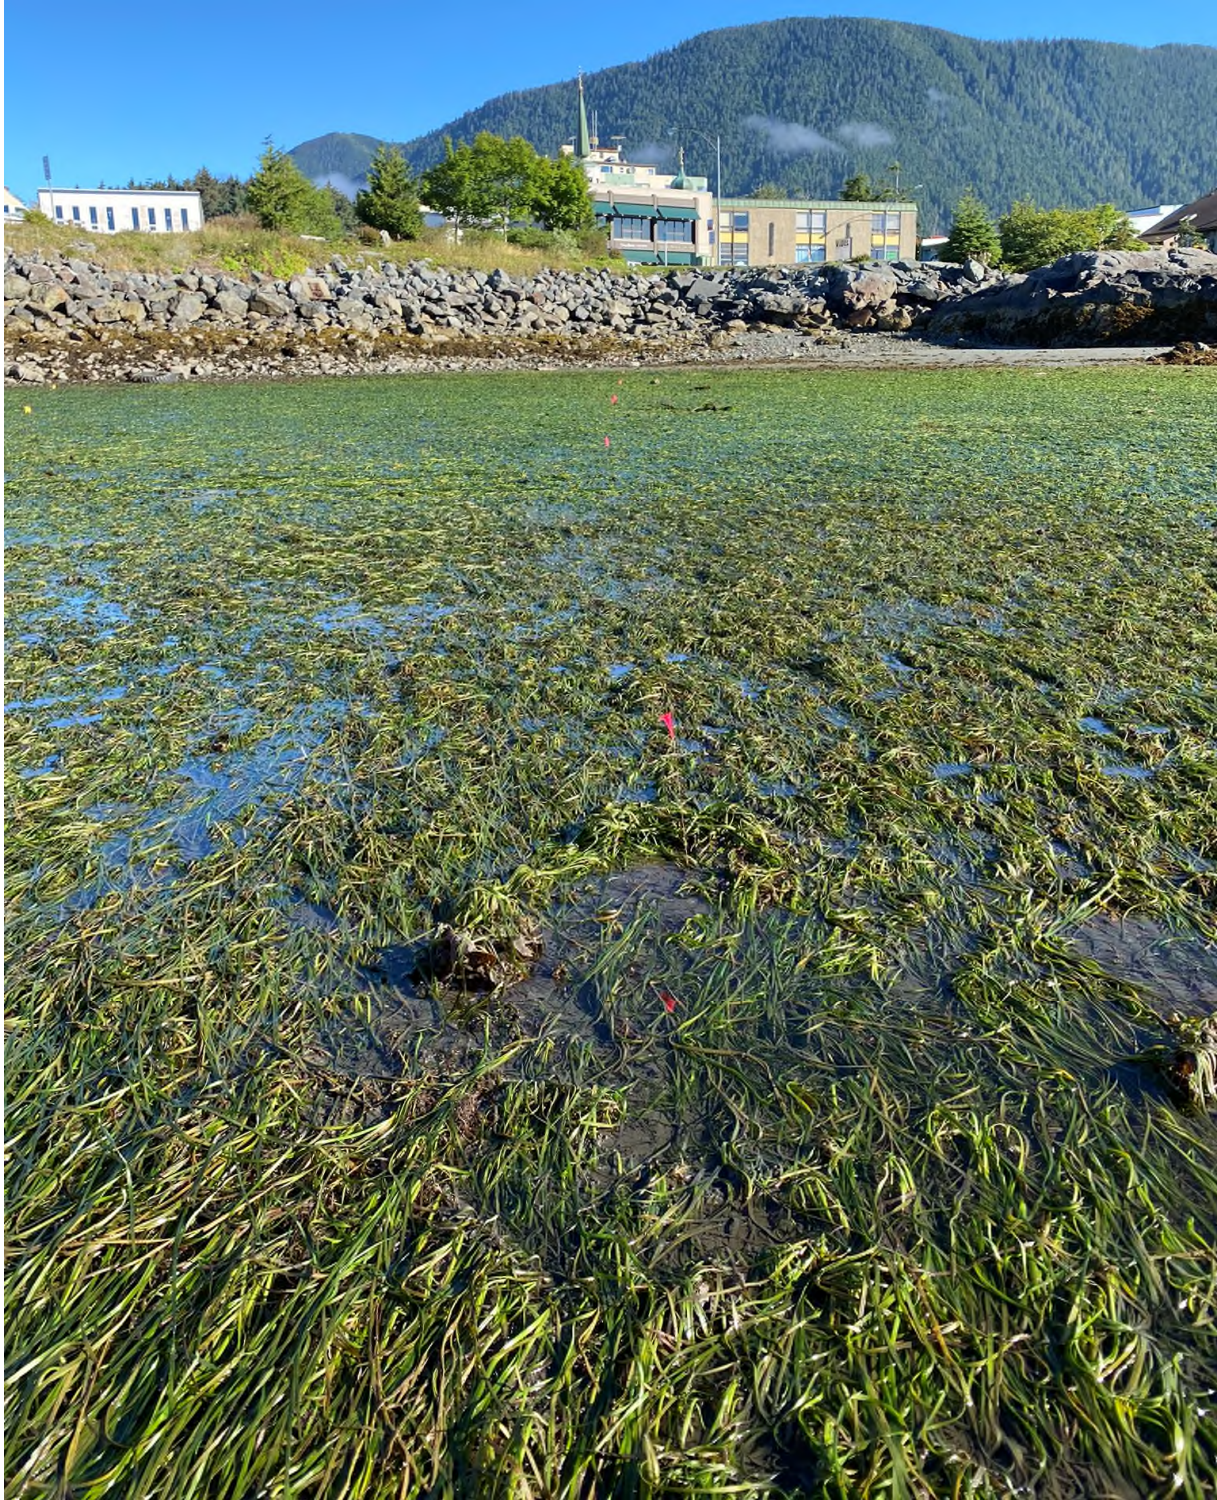
Photo 4. Pink flags mark Transect A in Bed 1 of the study area for the Sitka Seawalk Phase II Eelgrass Survey in Sitka Channel.

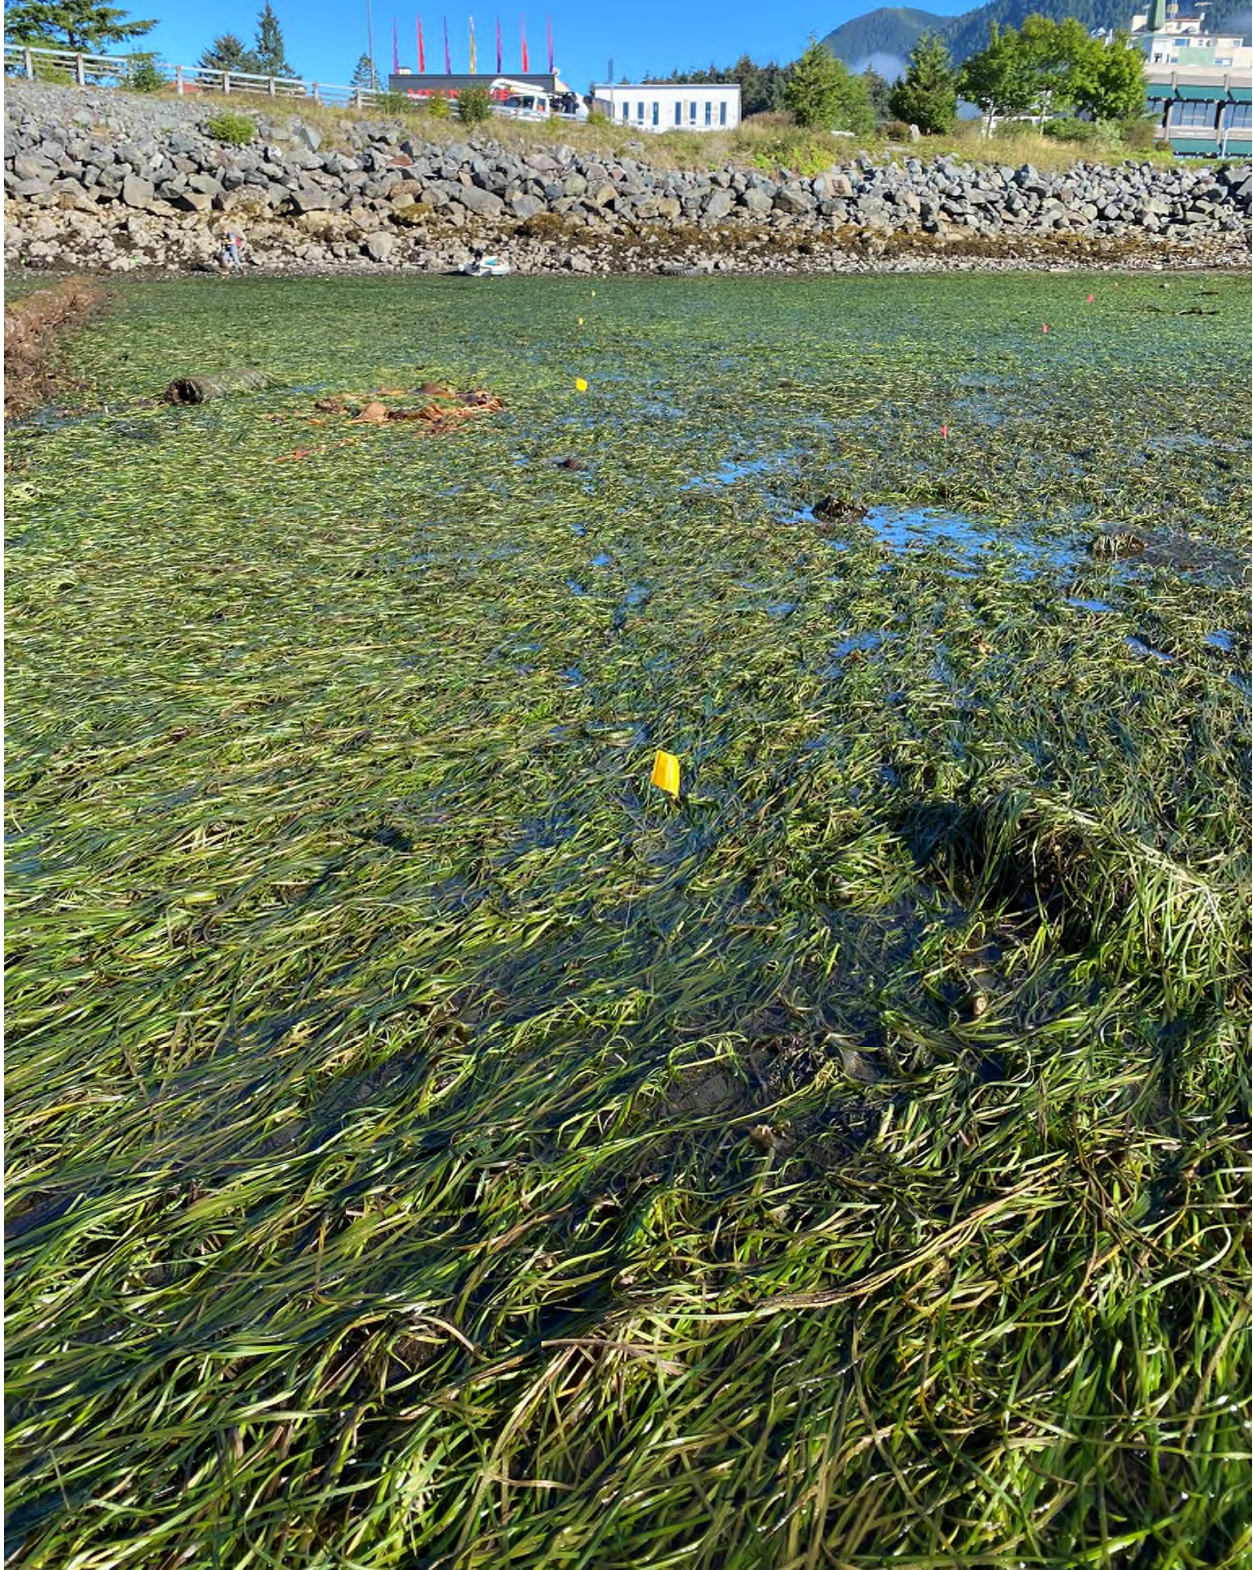
Photo 5. Yellow flags mark Transect B in Bed 1 of the study area for the Sitka Seawalk Phase II Eelgrass Survey in Sitka Channel.

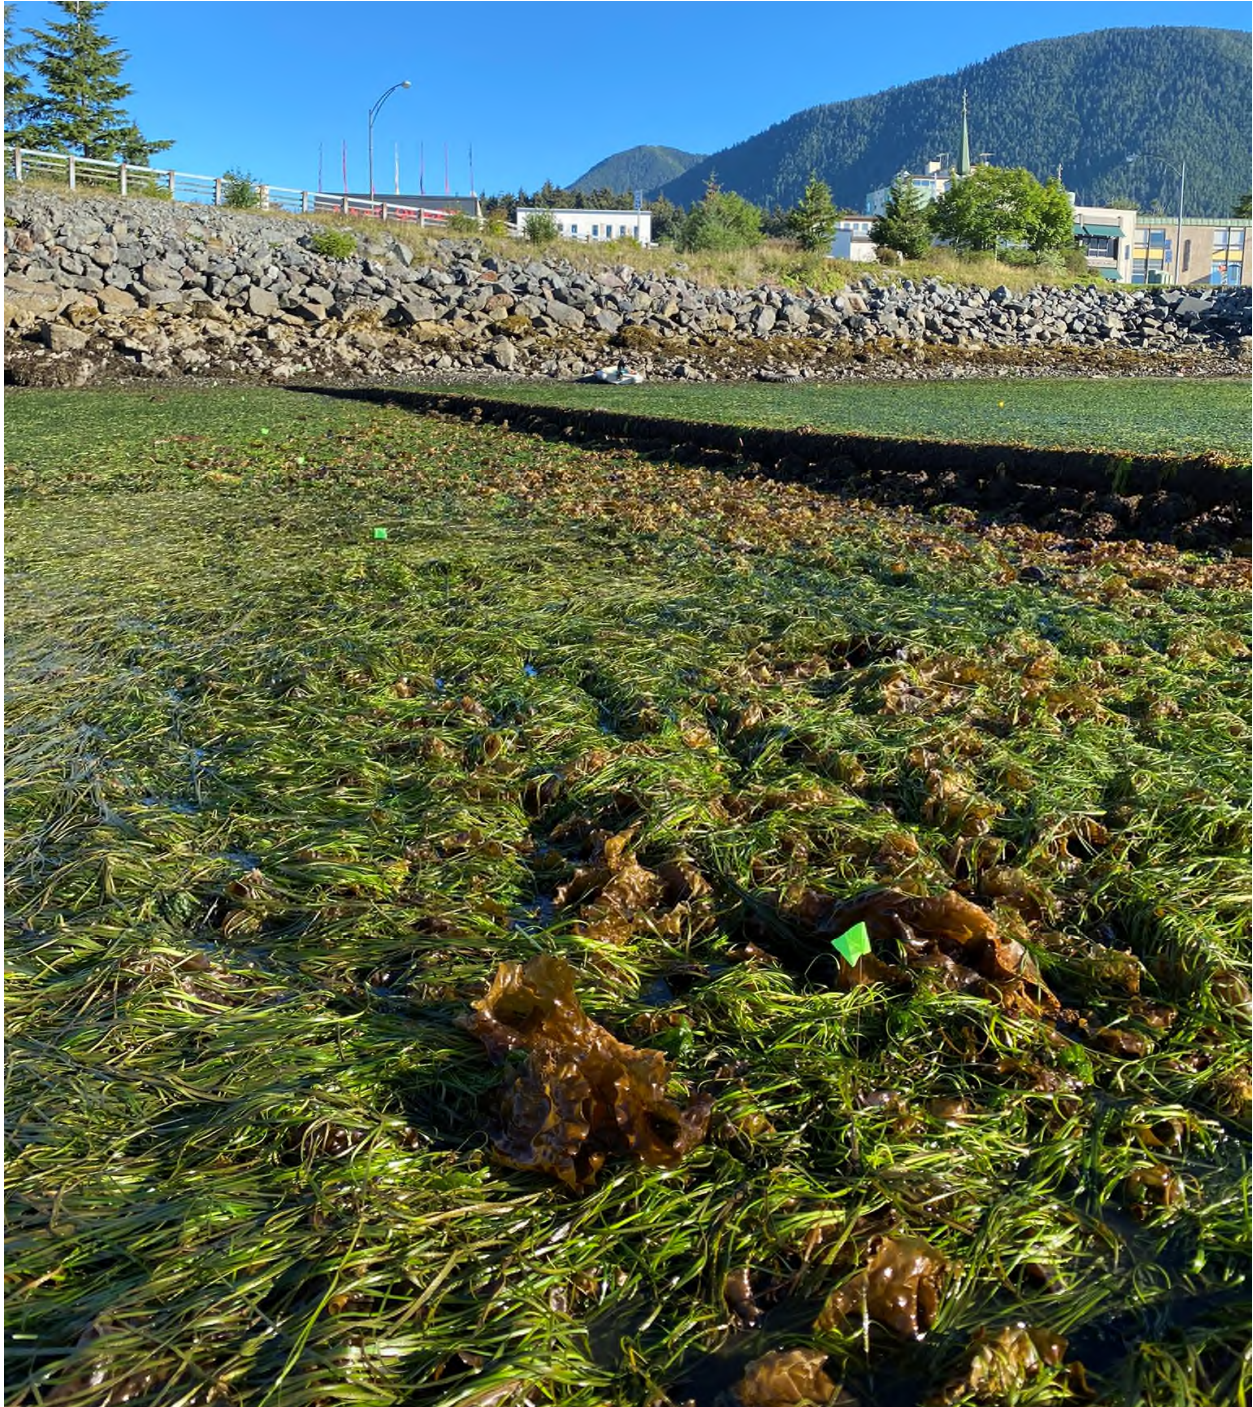
Photo 6. Green flags mark Transect C in Bed 1 of the study area for the Sitka Seawalk Phase II Eelgrass Survey in Sitka Channel. This transect runs almost parallel to a derelict metal pipe.

Two humanmade structures were present in Bed 1. A presumably derelict metal pipe outfall was immediately north of Transect C. The end of Transect E also intersected the metal pipe with Sampling Station E11 on the pipe's south side (Photos 6 and 8). A manmade rock wall of unknown purpose or age was identified on the eastern side of Bed 1 and intersected Transects F and G (Photos 9 and 10).

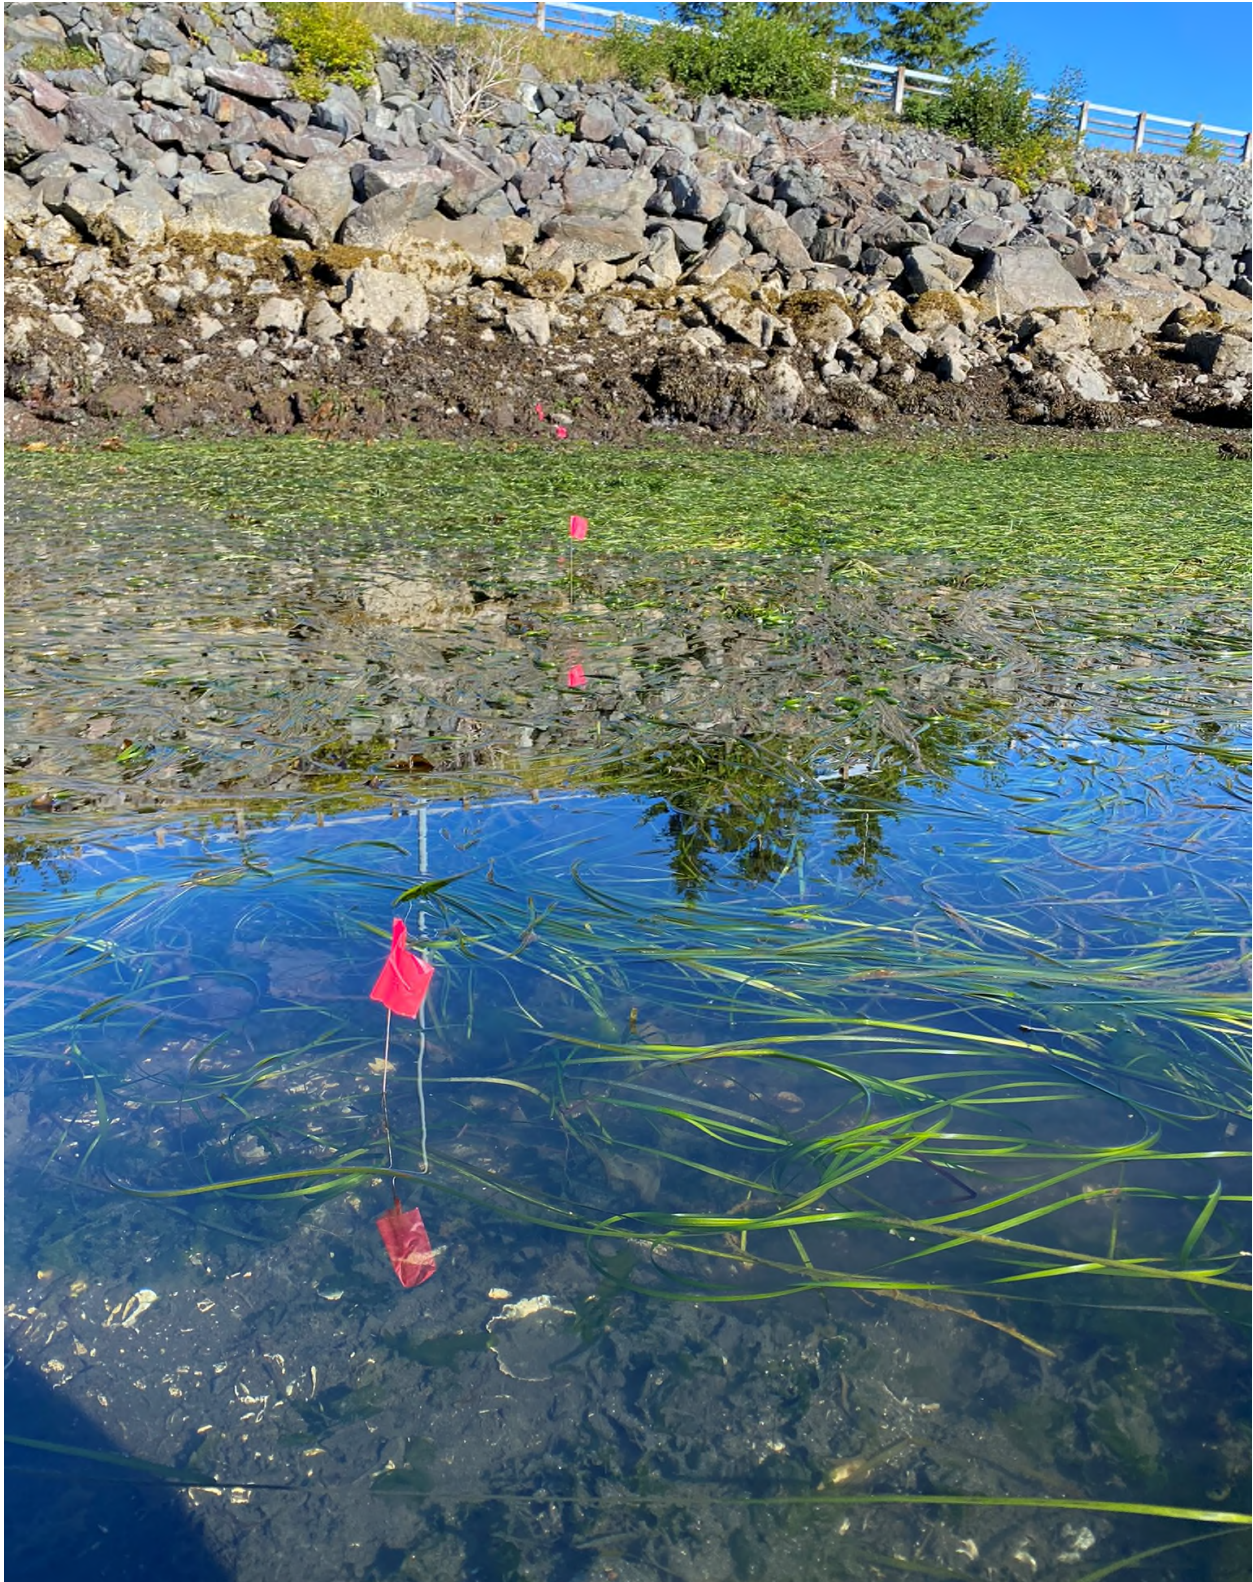
Photo 7. Pink flags mark Transect D in Bed 1 of the study area for the Sitka Seawalk Phase II Eelgrass Survey in Sitka Channel.

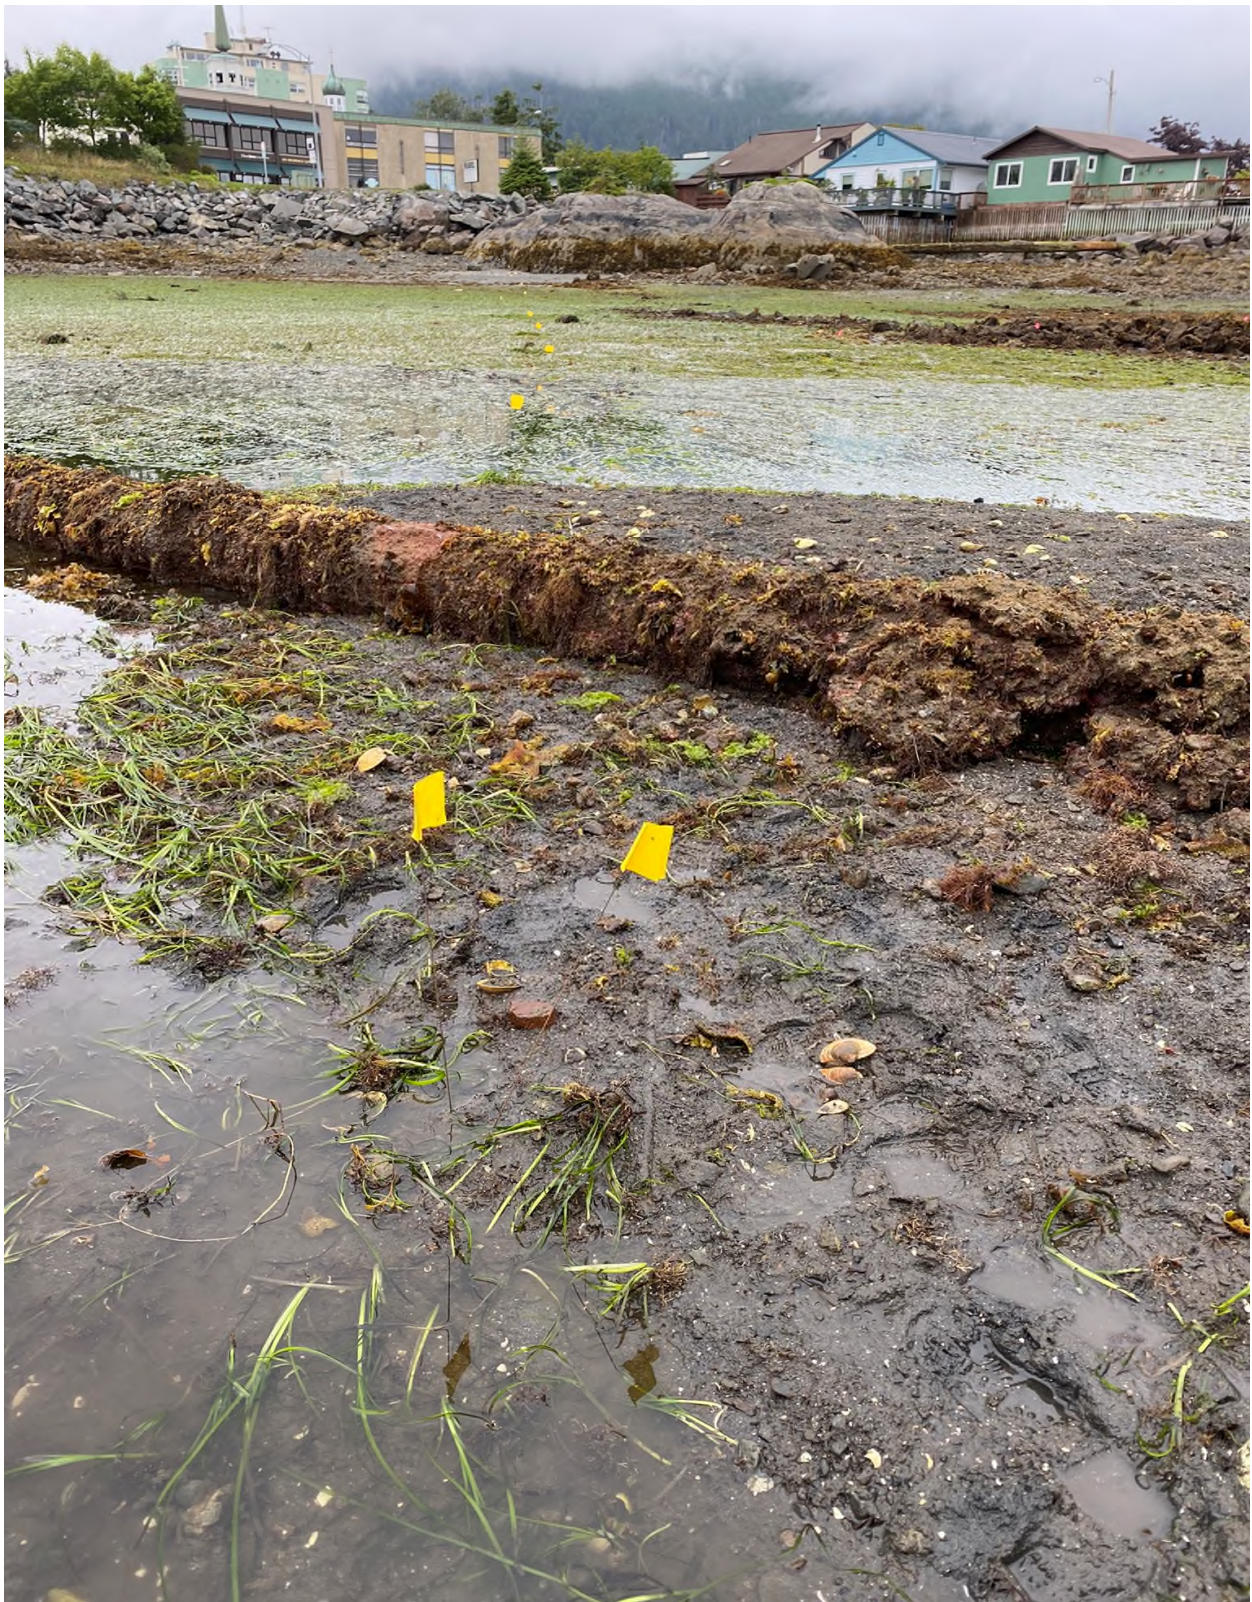
Photo 8. Yellow flags mark Transect E in Bed 1 of the study area for the Sitka Seawalk Phase II Eelgrass Survey in Sitka Channel. This transect intersects a derelict metal pipe outfall.

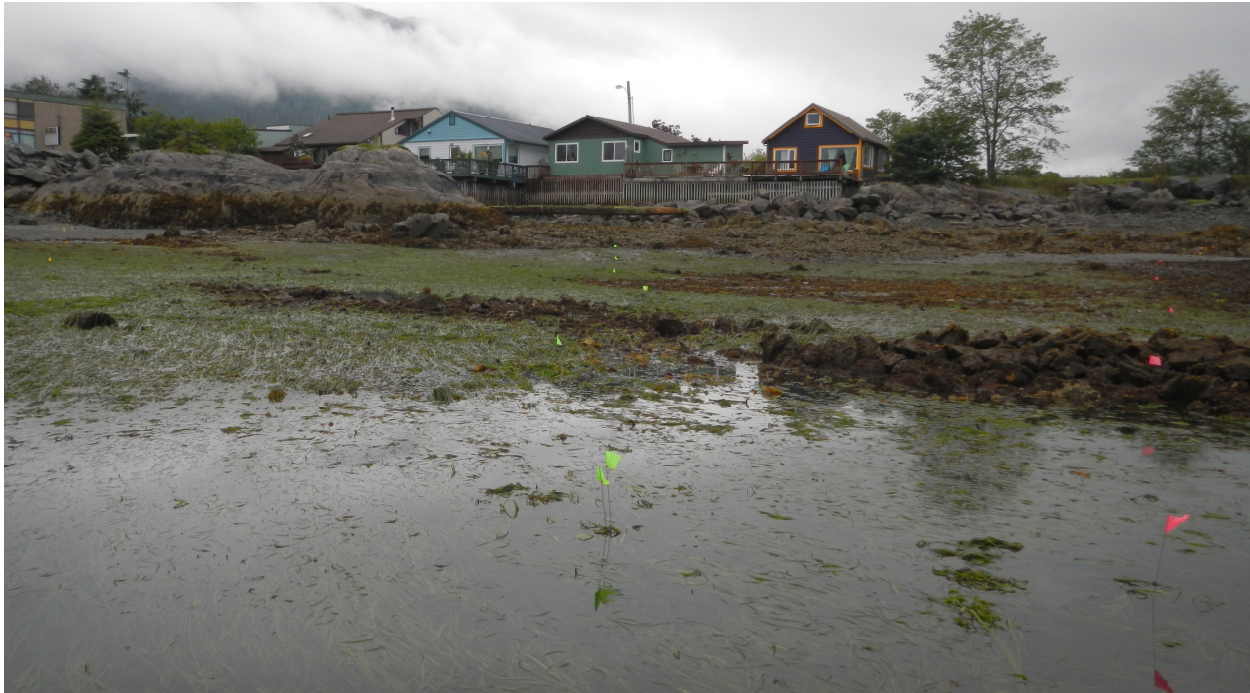
Photo 9. Green and pink flags mark Transects F and G in Bed 1 of the study area for the Sitka Seawalk Phase II Eelgrass Survey in Sitka Channel. Both transects intersect remnants of a manmade rock wall.

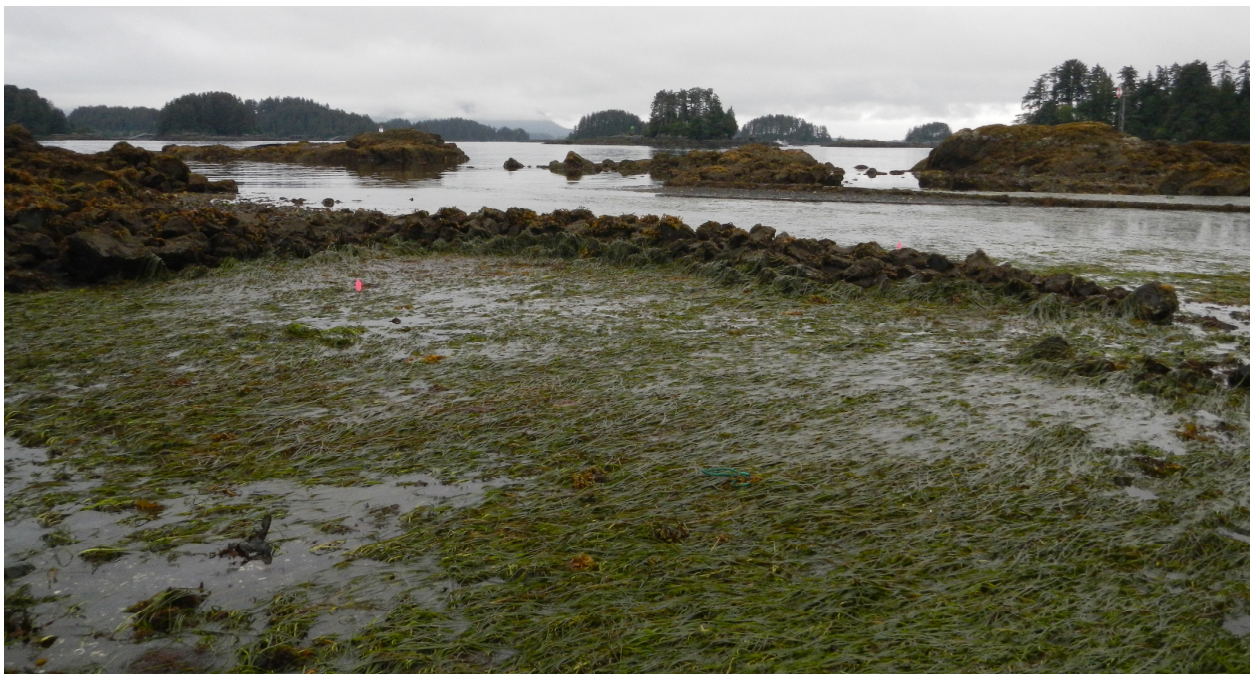
Photo 10. A prominent section of a manmade rock wall on Transect G in Bed 1 of the study area for the Sitka Seawalk Phase II Eelgrass Survey area in Sitka Channel.

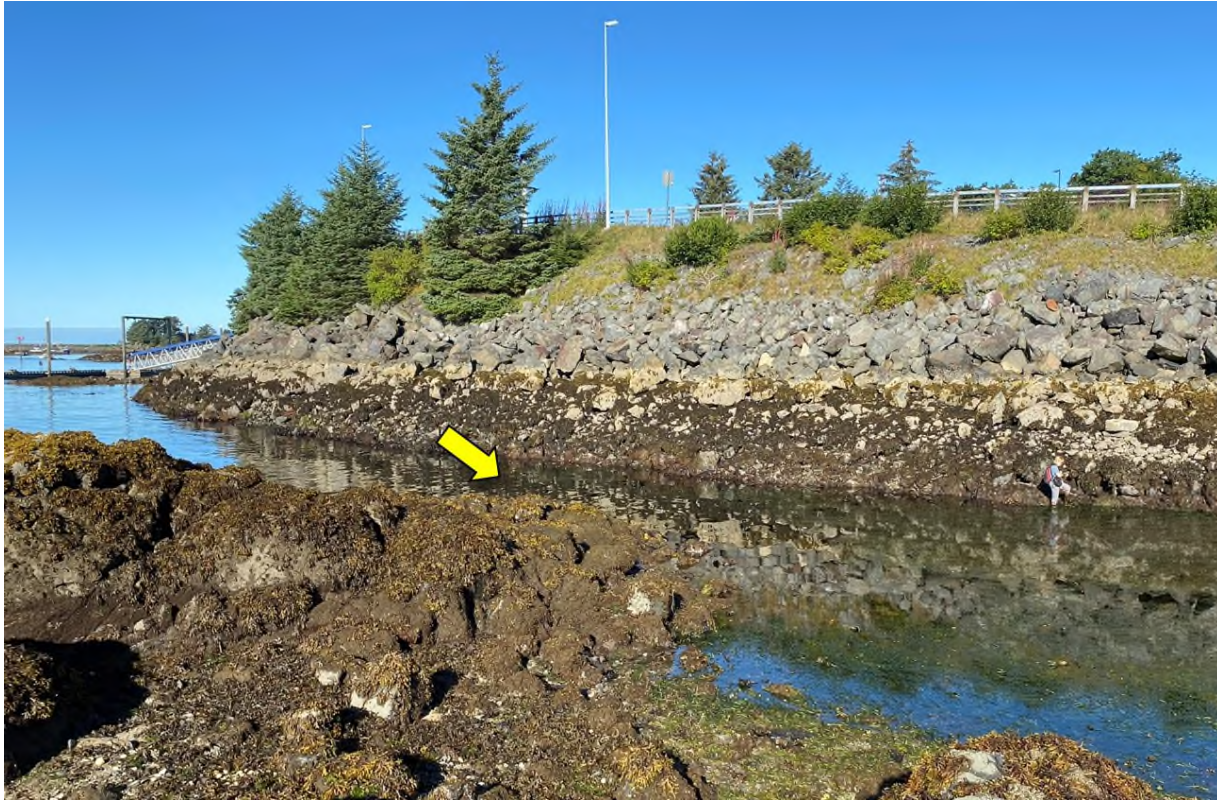
A subtidal bed (Bed 2) was observed just south of the most southeastern point of Bed 1 at -1.1 m (-3.6 ft) MLLW (Photo 11). Total area of Bed 2 had an estimated area of 4.3 m² (46.3 ft²).

Photo 11. Yellow arrow marks the approximate location of Bed 2 in the study area for the Sitka Seawalk Phase II Eelgrass Survey in Sitka Channel marked with an arrow. The O'Connell Bridge Lightering Float is visible at the middle left area of the picture.

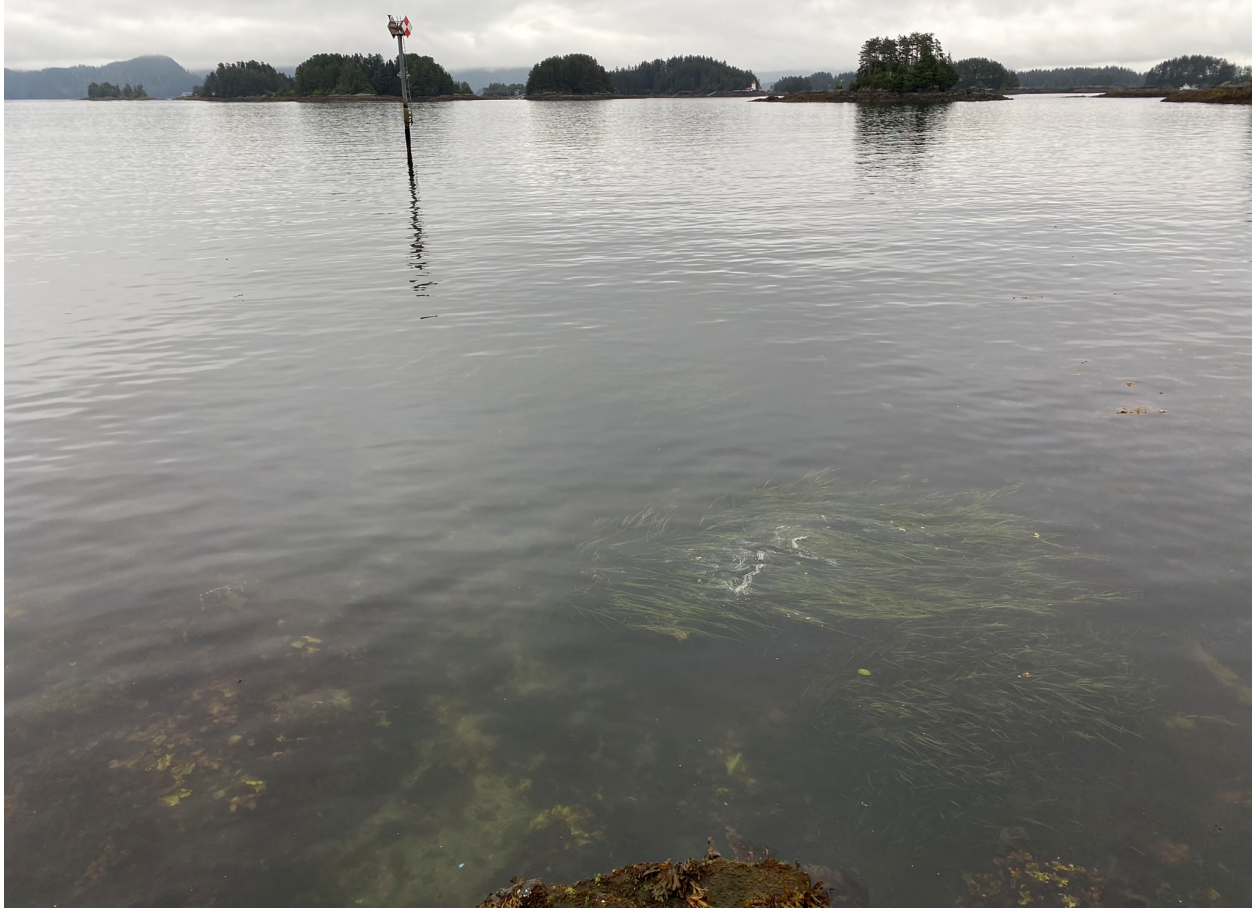
Roughly equidistant of Bed 2 and the gangway of the O'Connell lightering facility (Figure 1) were two subtidal beds (Bed 3 and 4) separated by about 10 m. Bed 3 was located at a depth of about -2.6 m (8.5 ft) MLLW and had an estimated area of 3.4 m² (36.6 ft²; Photo 12). Bed 4 was at a depth of about -1.9 m MLLW and was estimated at 0.7 m² (7.5 ft²; Photo 13). The blades of Beds 3 and 4 were fully submerged, and it was unable to verify whether these were eelgrass or surfgrass (*Phyllospadix scouleri*) beds. Surfgrass occurs in Sitka and is found in upper subtidal bedrock habitats with moderate to high wave exposure (Lindeberg and Lindstrom 2010)².

Photo 12. Bed 3 of the study area for the Sitka Seawalk Phase II Eelgrass Survey in Sitka Channel. Bed 3 is visible at the surface of the water near the bottom of the picture.

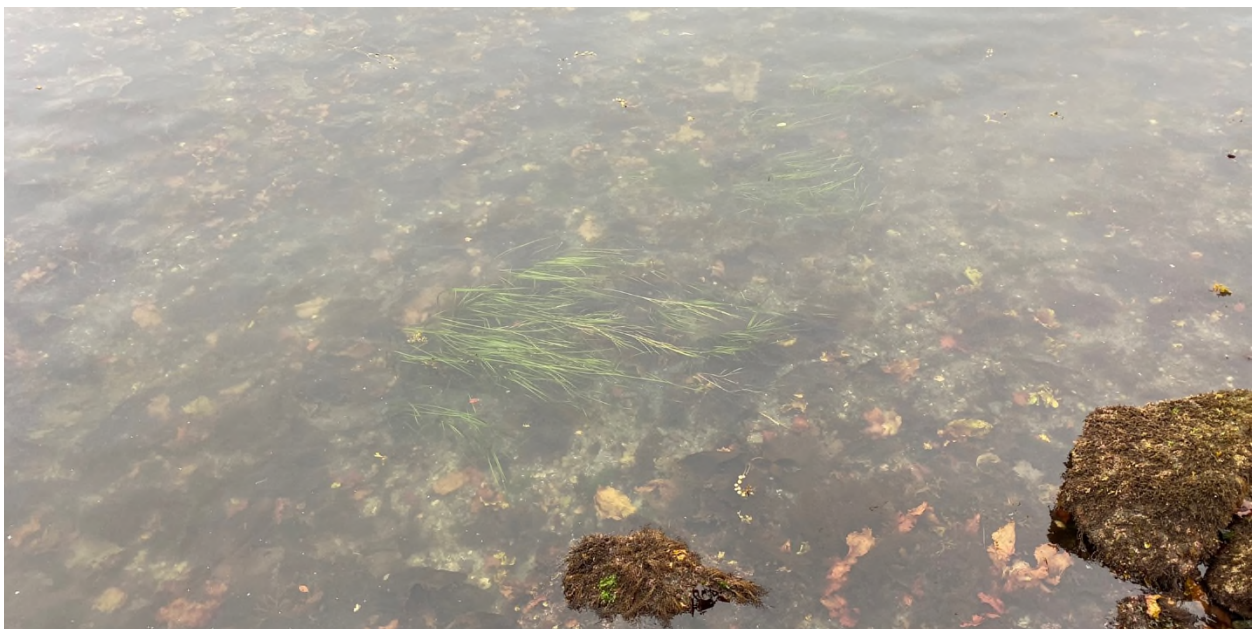
Photo 13. Bed 4 of the study area for the Sitka Seawalk Phase II Eelgrass Survey in Sitka Channel.

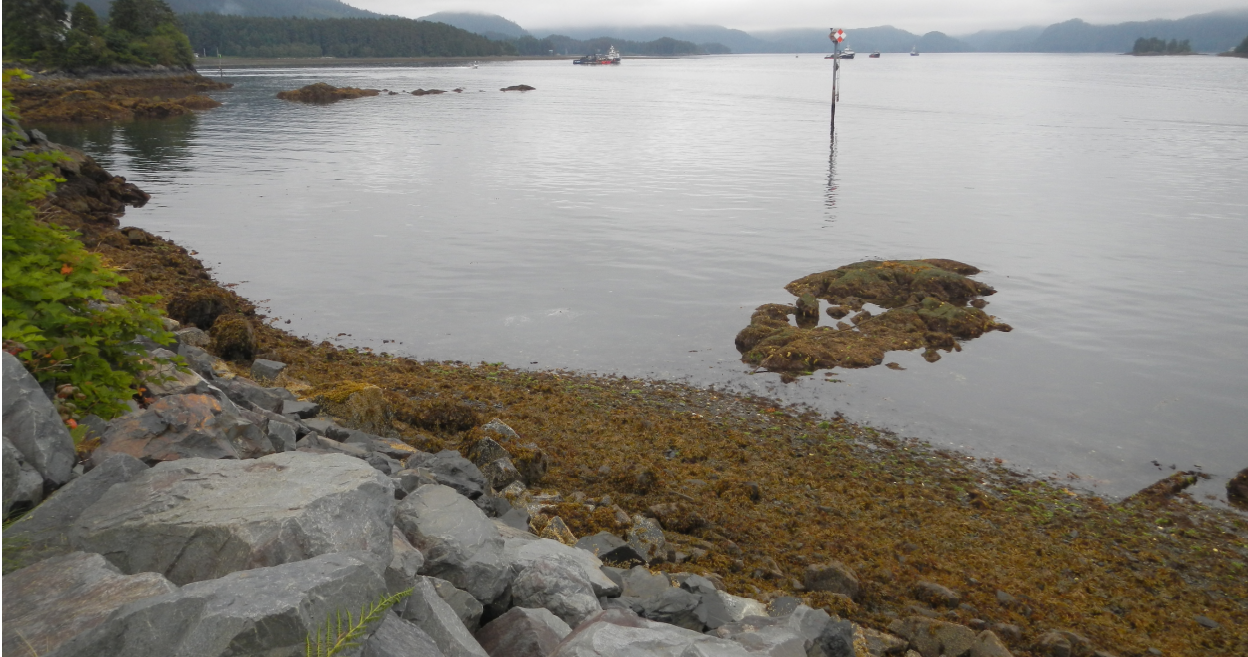
The shoreline between Bed 4 and the gangway of the O'Connell Bridge Lightering Dock was exposed at low tide (Photo 14). The area was scanned from the edge of the parking lot and characterized by a hard substrate of boulders and cobble covered with dense rockweed and some sea lettuce. No eelgrass or evidence of habitat conducive to eelgrass was visible.

Photo 14. Shoreline immediately north of the O’Connell lightering facility in the study area for the Sitka Seawalk Phase II Eelgrass Survey in Sitka Channel.
