November 18, 2016

Mr. Dan Tadic, PE
City and Borough of Sitka
100 Lincoln Street
Sitka, AK 99835

**RE: GARY PAXTON INDUSTRIAL PARK DEBRIS FLOW ANALYSIS,
SITKA, ALASKA**

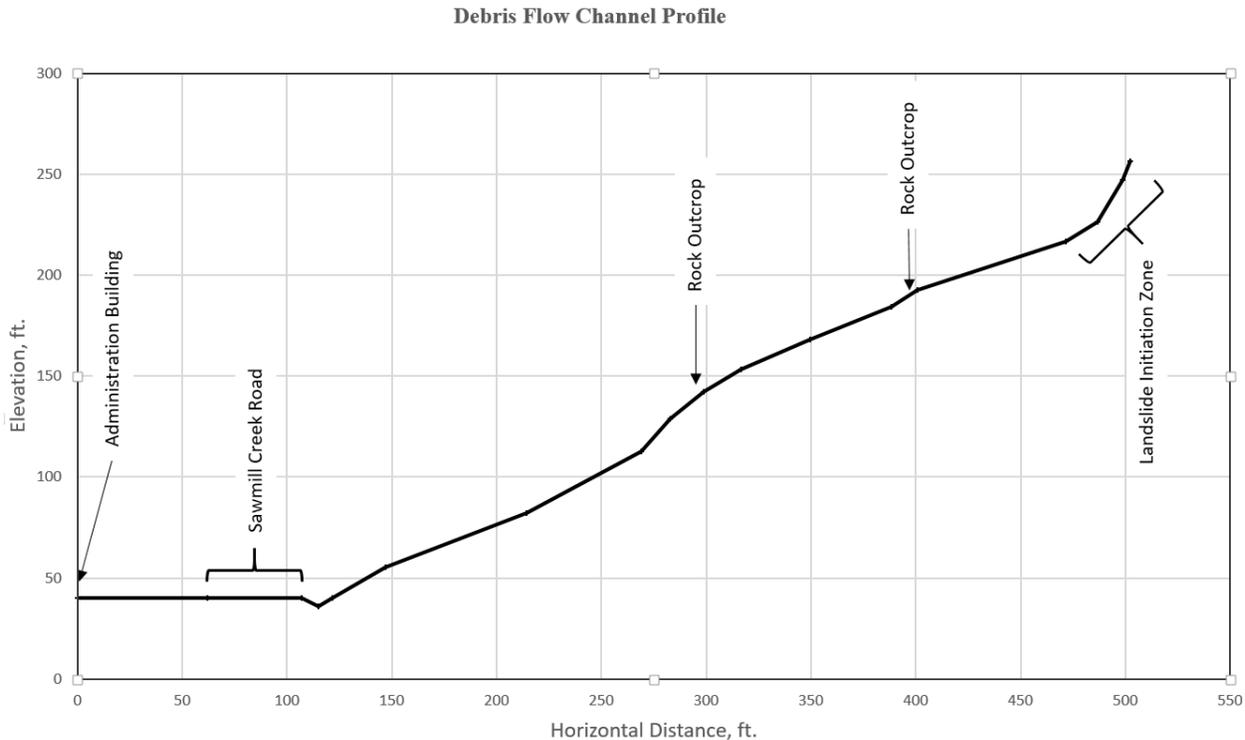
The debris flow likely began with a landslide near the base of the rocky escarpment, which is between about Elevation 260 to 300 feet. The triggering landslide occurred mostly in volcanic ash and colluvial soil that formed below the rocky escarpment. Glacial till underlies the volcanic ash and colluvial soil. The landslide was mostly about 5 feet thick, with a maximum headscarp height of about 15 feet. We believe the triggering landslide or landslides occurred between about Elevations 220 and 260 feet. The maximum width of the landslide initiation area at its base is about 45 feet. Photograph 5 shows the triggering landslide area, which is partially obscured by downed trees in the foreground. The accompanying profile shows the slopes along the bottom of the debris flow channel. Above the landslide area shown on the profile, the slope continues up to the rocky escarpment for about 10 to 30 feet. As shown in Table 1 above, we estimate the triggering landslide volume was about 500 to 600 cubic yards.

Below the triggering landslide area, the debris remolded into a soil slurry with boulders, trees, roots, and other vegetation debris. Typically, debris flows scour a channel and accumulate additional debris. Depending on the channel length and the type of soil and rock present, the total debris flow volume can be orders of magnitude larger than the triggering landslide or landslide.

Most of the channel scoured downslope from the triggering landslides contained colluvium and glacial till. In two areas, the debris flow scoured down to bedrock, as shown in the profile above. The higher bedrock area shown in the profile above is visible in the foreground of Photograph 5. The scoured channel shown in Photograph 6 is underlain by glacial till. The glacial till and bedrock are resistant to erosion, and the debris flow had a relatively short runout before reaching flat ground. Therefore, the total debris flow volume was about 2,000 cubic yards, which was on the order of four times the triggering landslide volume.

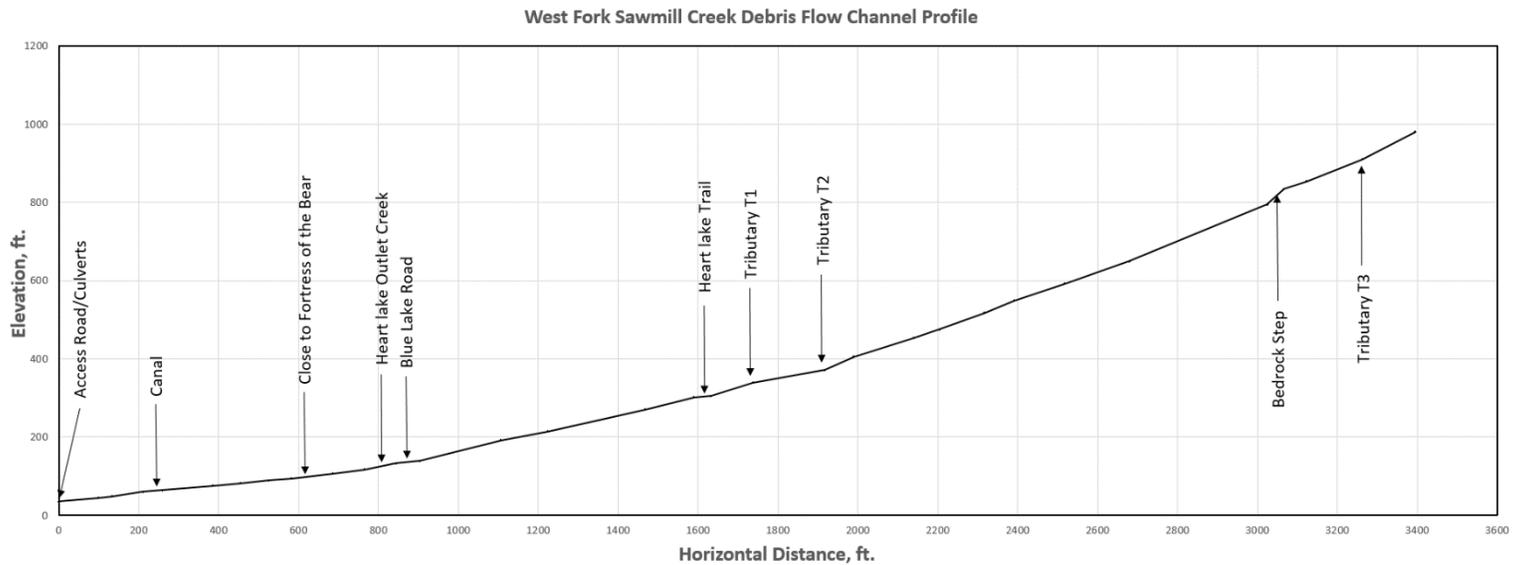
measurements in the tributary channels. The following profile shows the slopes along the bottom of the main channel.

Debris flows in the West Fork Sawmill Creek likely begin along the main or tributary channel banks. We observed evidence for small landslides as low as the right bank below the Heart Lake Trail crossing. Landslides could initiate in numerous locations above that in the main channel or in a tributary. Further, we anticipate that late season wet snow avalanches that impact bare ground could mobilize soil and water and trigger a debris flow. The August 18, 2015, storm likely triggered a debris flow by bank erosion.

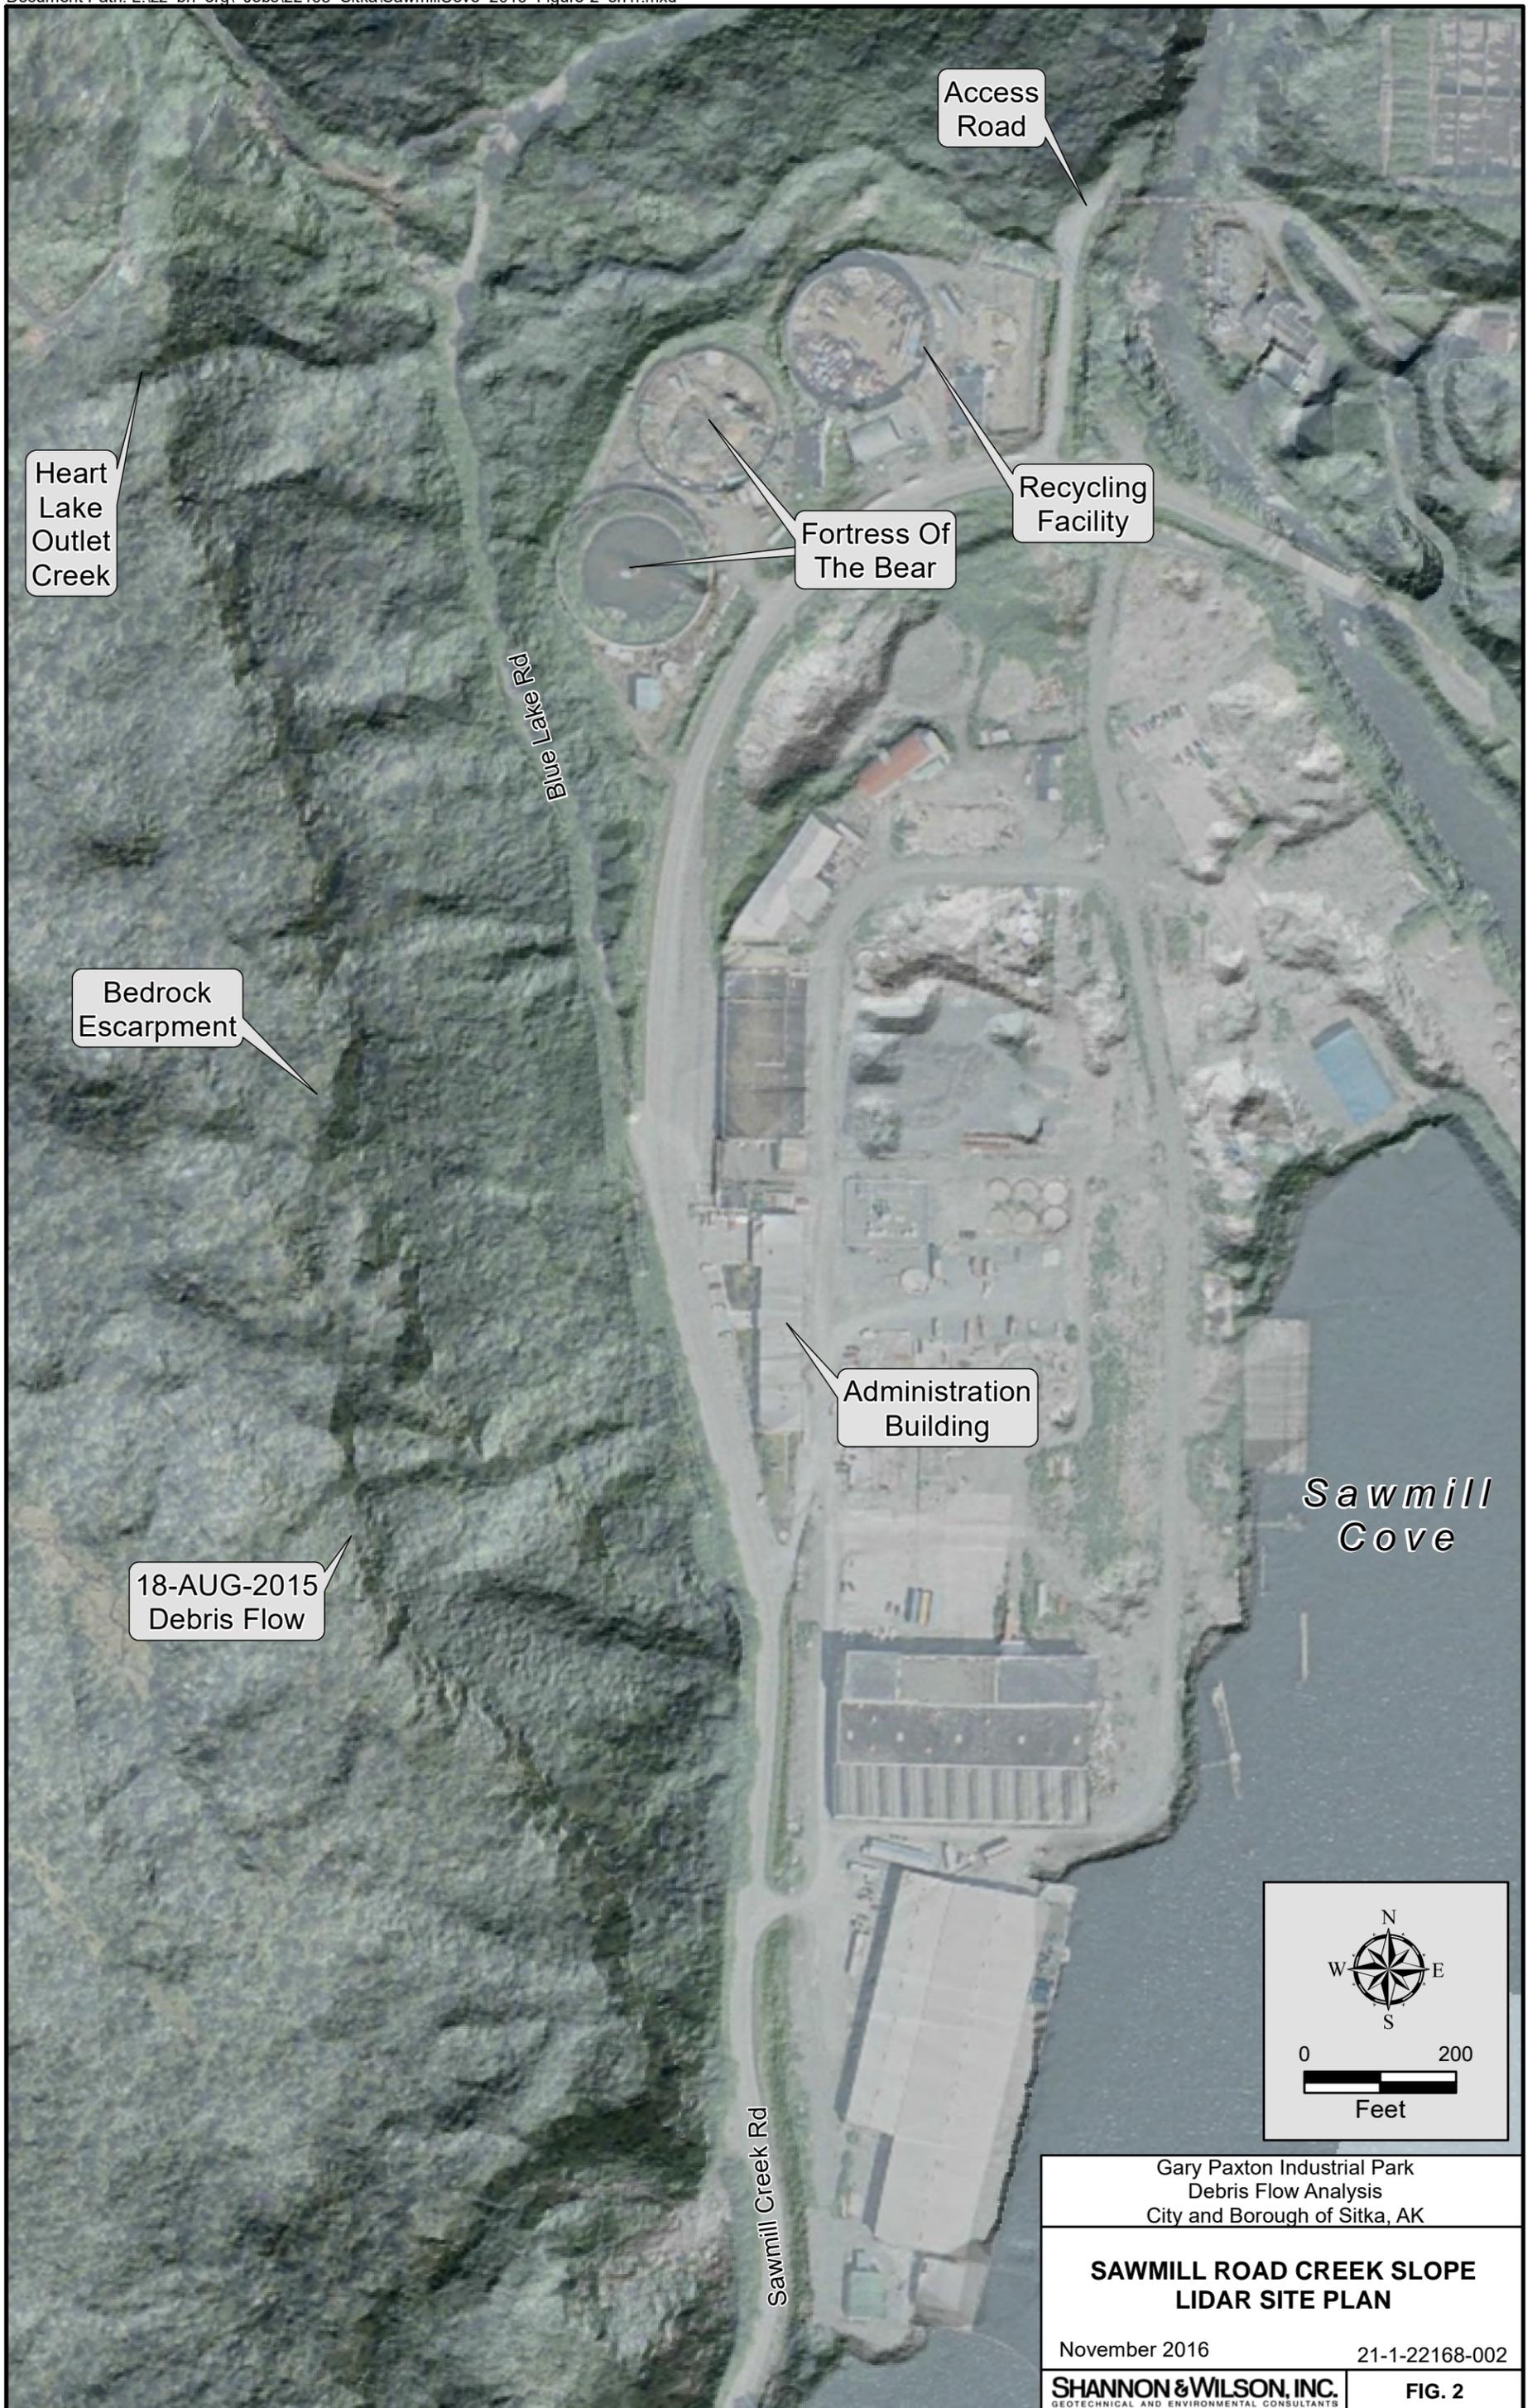
SHANNON & WILSON, INC.
GEOTECHNICAL AND ENVIRONMENTAL CONSULTANTS **FIG. 2**

The slope west of the Administration Building, referred to as the Sawmill Creek Road Slope (Figure 2) hereafter, is about a 1/2-mile-long ridge that is roughly parallel to Sawmill Creek Road. Photograph 4 shows an overview of the slope, looking west from near the CBS hydroelectric facility. The slope is the east flank of a hill above Sawmill Cove and Heart Lake. Heart Lake is in a bench northeast of the hill, and south of Mt. Verstovia and West Fork Sawmill Creek. A ridge southeast and east of the Heart Lake extends from the outlet creek south to nearly above the Administration Building. There, it intersects the higher hill that rises above Heart Lake. This ridge forms the top of the Sawmill Creek Road Slope. At the toe of the Sawmill Creek Road Slope, Sawmill Creek Road is at about Elevation 30 feet. Northeast of the Administration Building, the top of the ridge is about Elevation 400 feet, and decreases to about Elevation 340 feet at the north end near the outlet of Heart Lake and to about Elevation 360 at its south end where it merges with the hill above Heart Lake.

The Sawmill Creek Road Slope has a rocky escarpment with near-vertical sections below the ridge crest at about Elevations 260 to 280 feet, as shown in the LiDAR hillshade image in the LiDAR Site Plan, Figure 2, and the Topographic Site Plan, Figure 4. The channels or chutes on the slope typically originate at or below this bedrock escarpment. Below the rocky escarpment, the slopes are mostly between 25 and 70 percent, with short segments steeper than 100 percent.

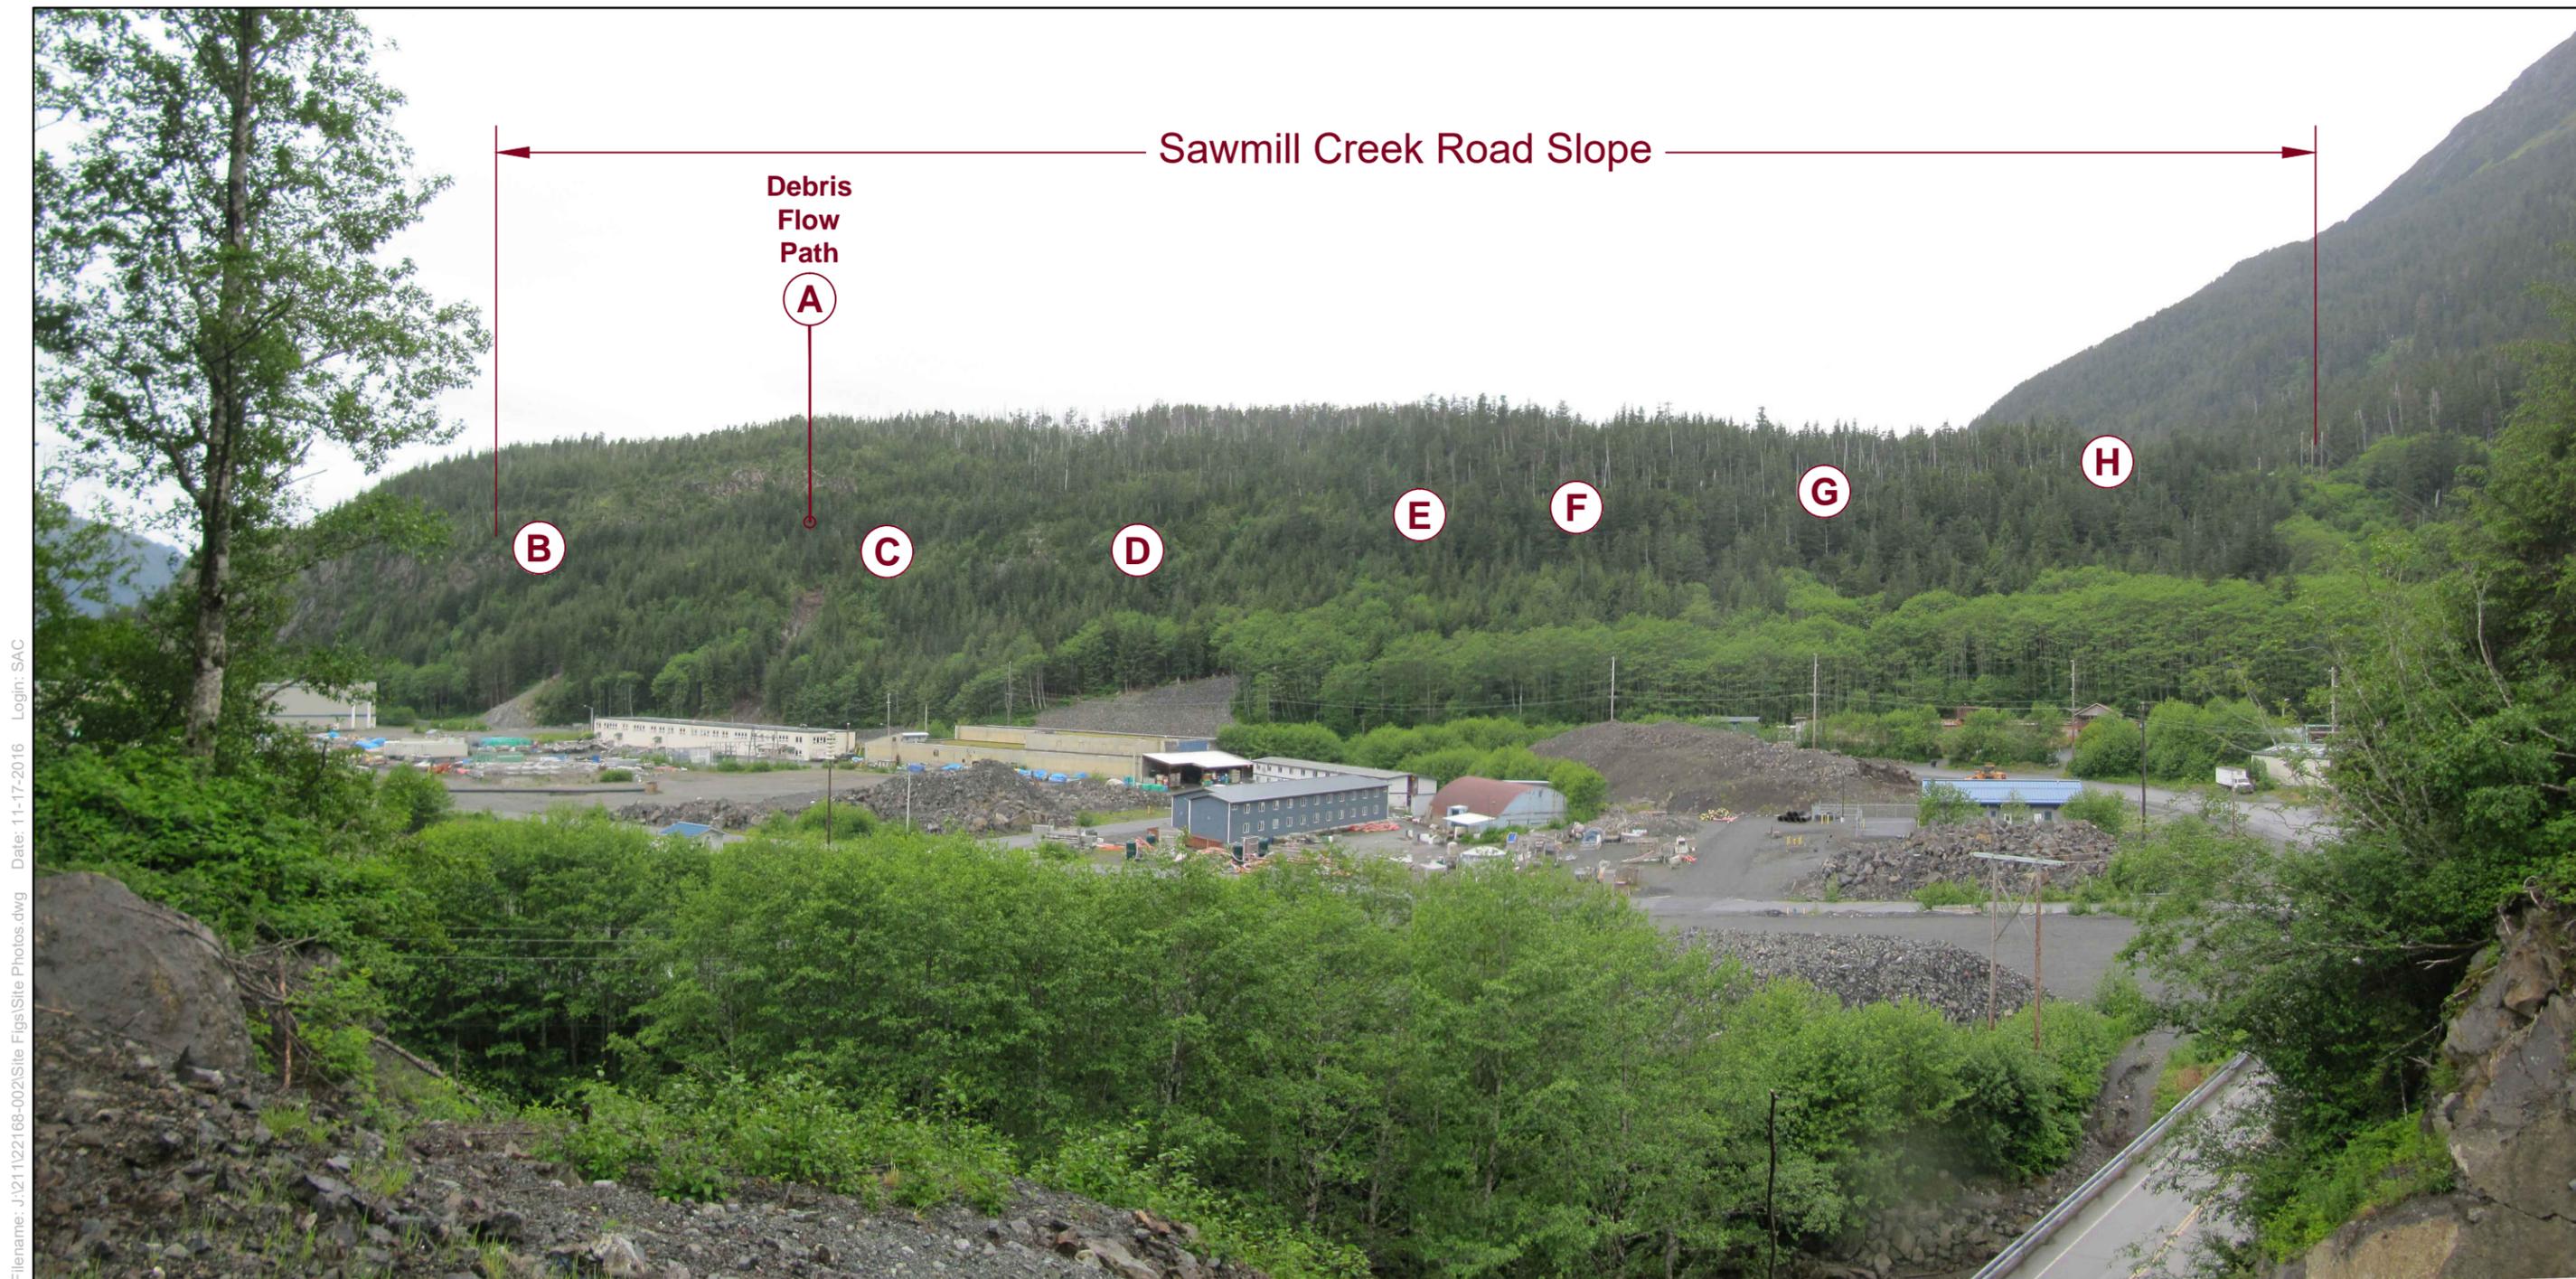
As described previously, six small ephemeral creeks are located on Sawmill Creek Road Slope, including the August 18, 2015, debris flow site. These creeks are unnamed; therefore, we used the alphabetical designations A through H, as shown in Figure 4 and Photograph 4. The following sections present our field observations for each creek area, including photographs showing pertinent features of the August 18, 2015, debris flow. Because of dense vegetation, features we observed in Channels B through H were not conducive to viewing in photographs.

Photograph 4. Sawmill Creek Road view looking west.

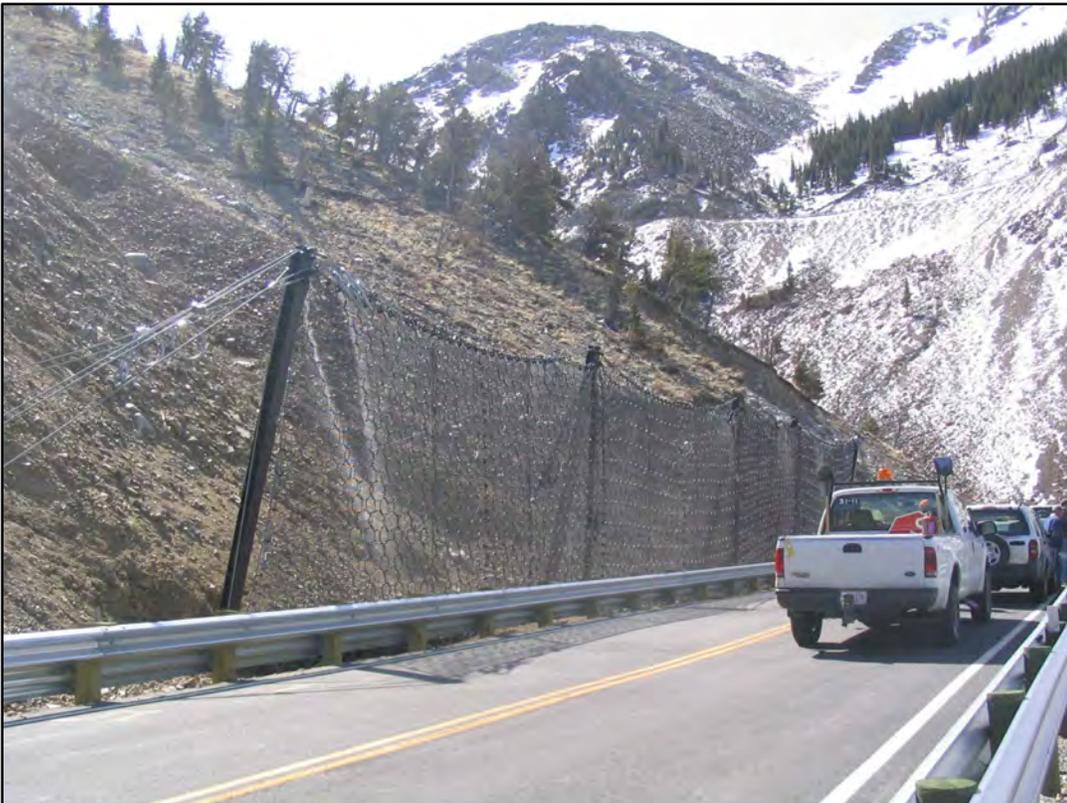
Photograph 16. Typical flexible debris flow barrier that was installed along the Beartooth Highway, MT, in 2005.

A flexible debris flow barrier consists of high-tensile steel wire netting and mesh that are supported by a steel cable on top. The top cable can be anchored to sides of a channel or supported on steel posts. The steel posts typically have anchor cables or bars to resist impact forces. Because the system is flexible, large deformation during debris flow impact and energy absorbing elements in the ropes substantially reduce peak loads during impact. Photographs 16 and 17 show a typical debris flow barrier, which was constructed on a slope along the Beartooth Highway near Red Lodge, Montana.

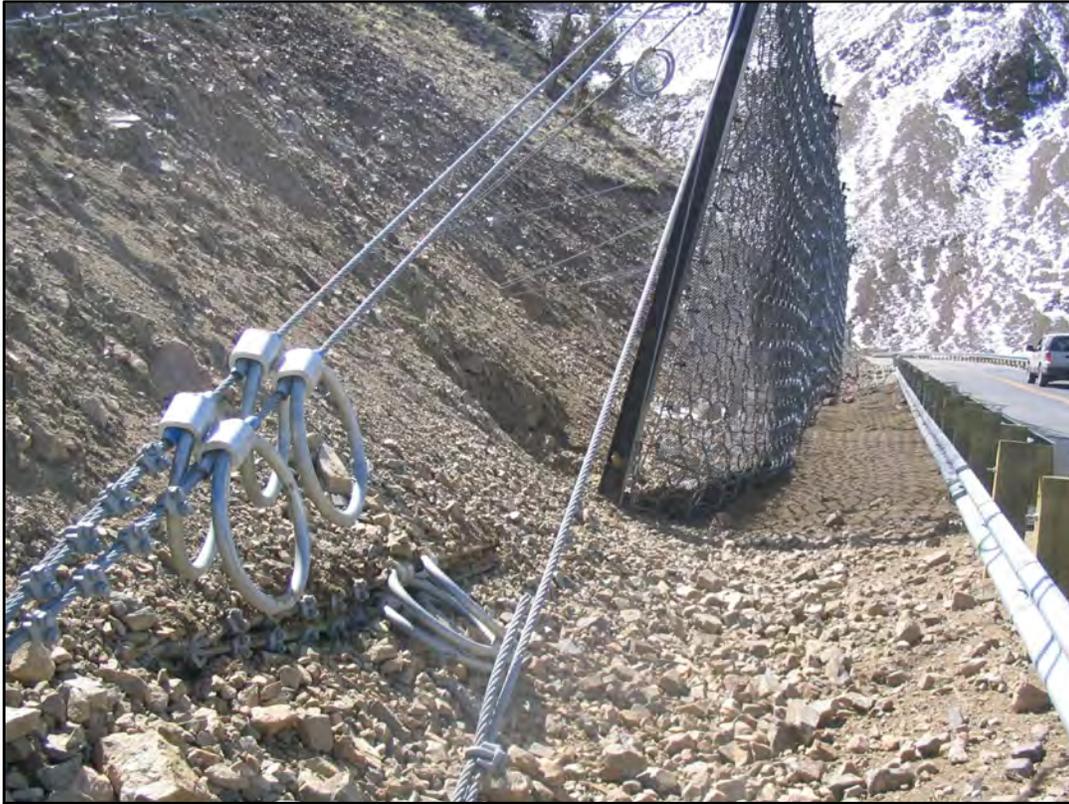
Photograph 17. Typical flexible debris flow barrier profile view.
Beartooth Highway, 2005.

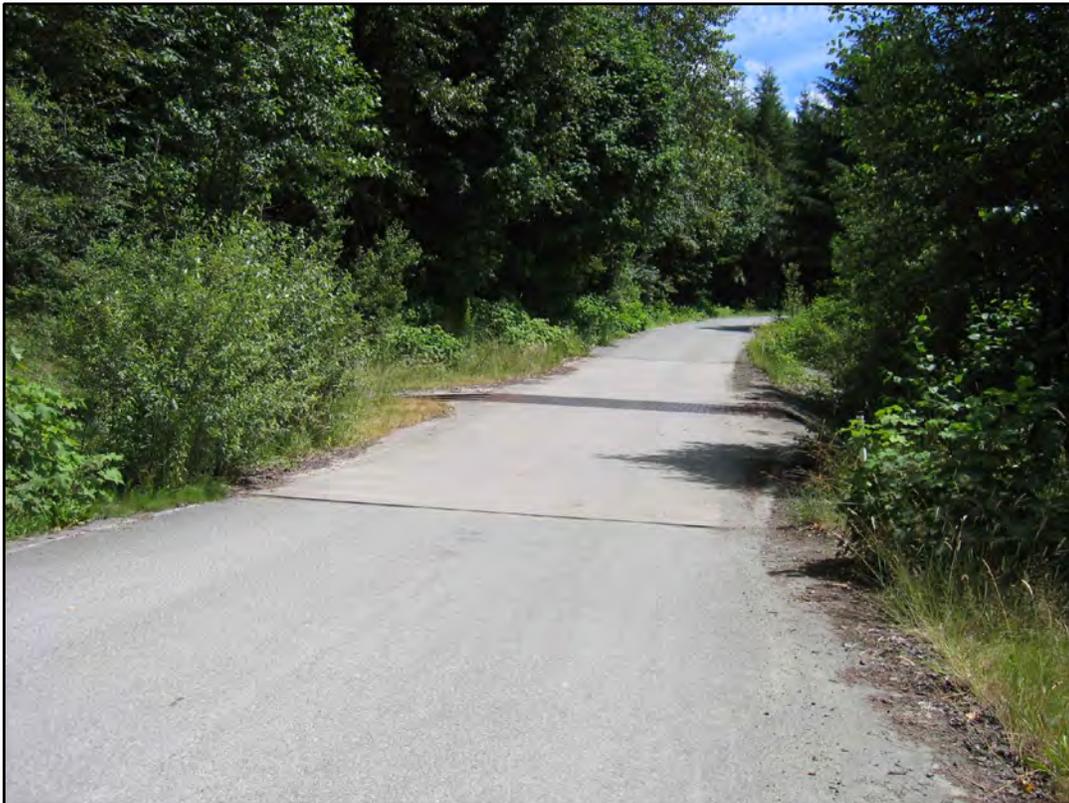
Photograph 18. Vented ford with steel grate cover over box culvert. Note concrete armor for flood flow.

Photographs 18 through 23 show concrete box vented fords with culverts that have removable steel or concrete decks. The roadway has a dip that is designed to pass the creek flow if the culvert becomes plugged or if the discharge exceeds the culvert capacity. Photographs 18 through 21 show low water crossings where the dip is armored with concrete to prevent erosion. Photographs 22 and 23 show a low water crossing armored with articulated concrete panels and riprap. The culvert can be sized for fish passage and other environmental considerations. We recommend constructing a trash rack at the inlet to reduce potential for large sediment entering the culvert to reduce cleaning.

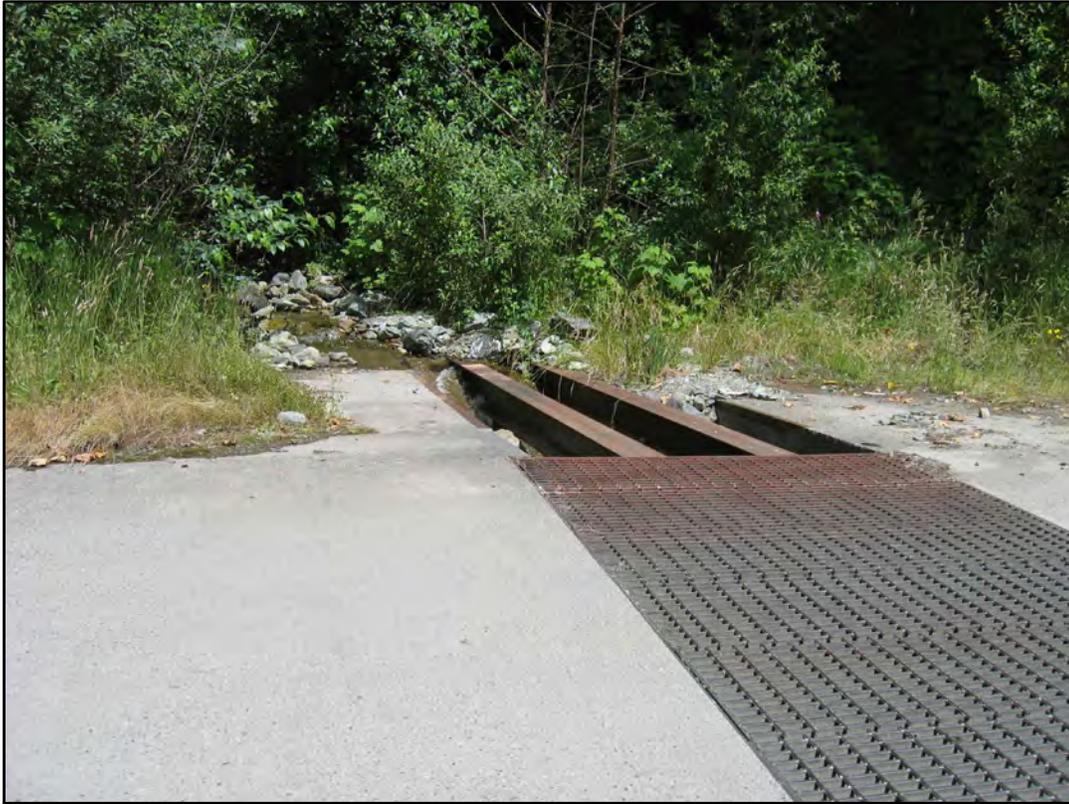
Photograph 19. Vented ford: close up of steel grate cover and trash rock.

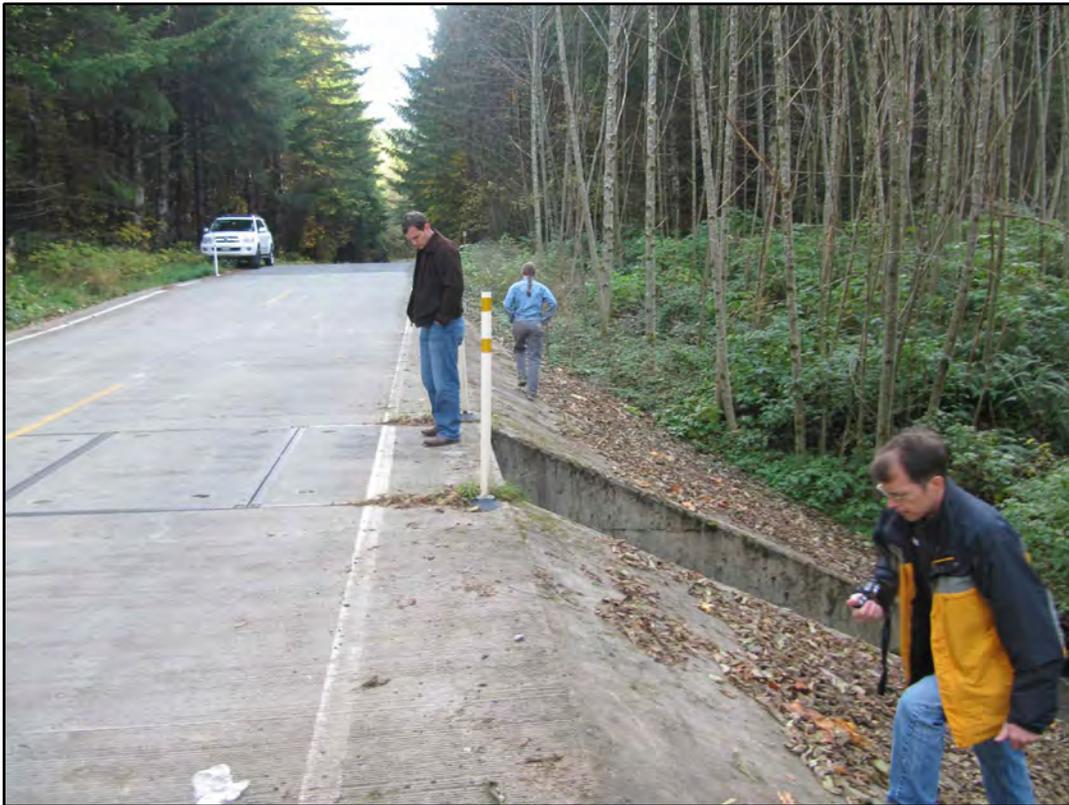
Photograph 20. Vented ford with removable concrete cover over box culvert.

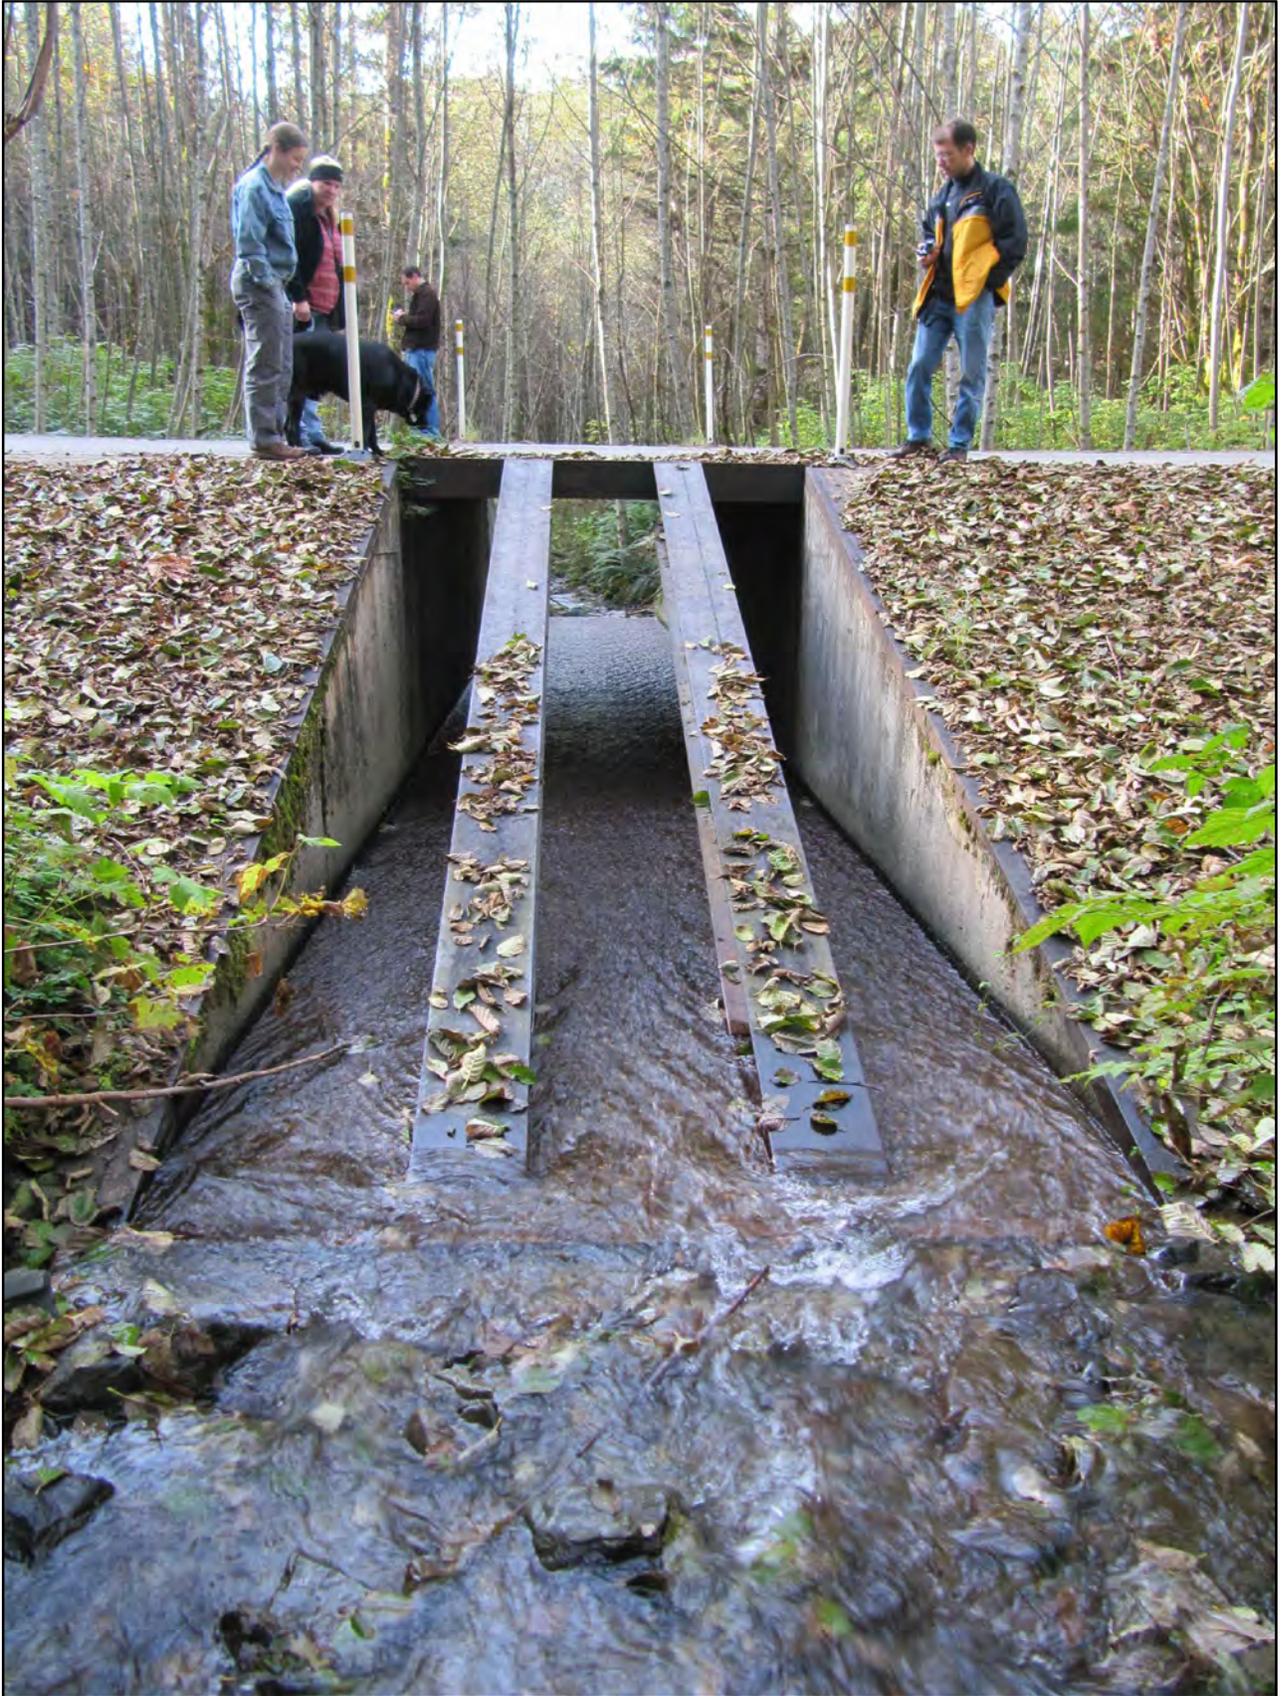
Photograph 21. Vented ford looking downstream through box culvert.

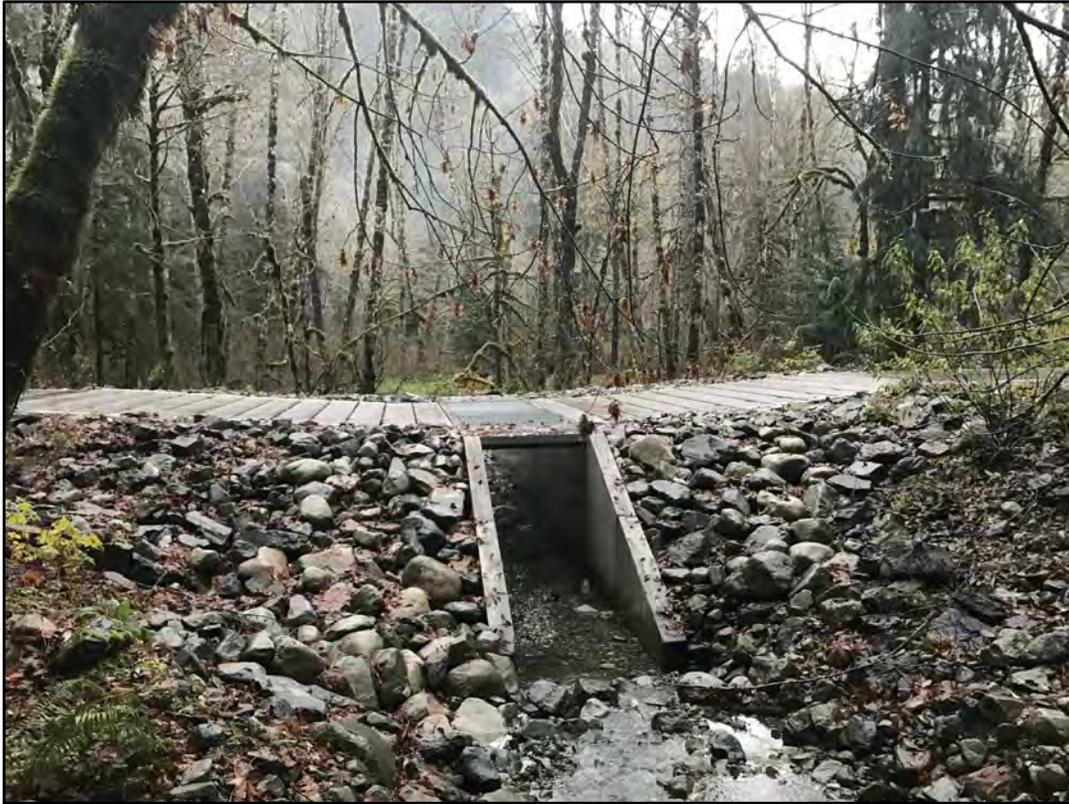
Photograph 22. Vented ford looking downstream through box culvert.
Note articulated concrete mat and riprap erosion protection.

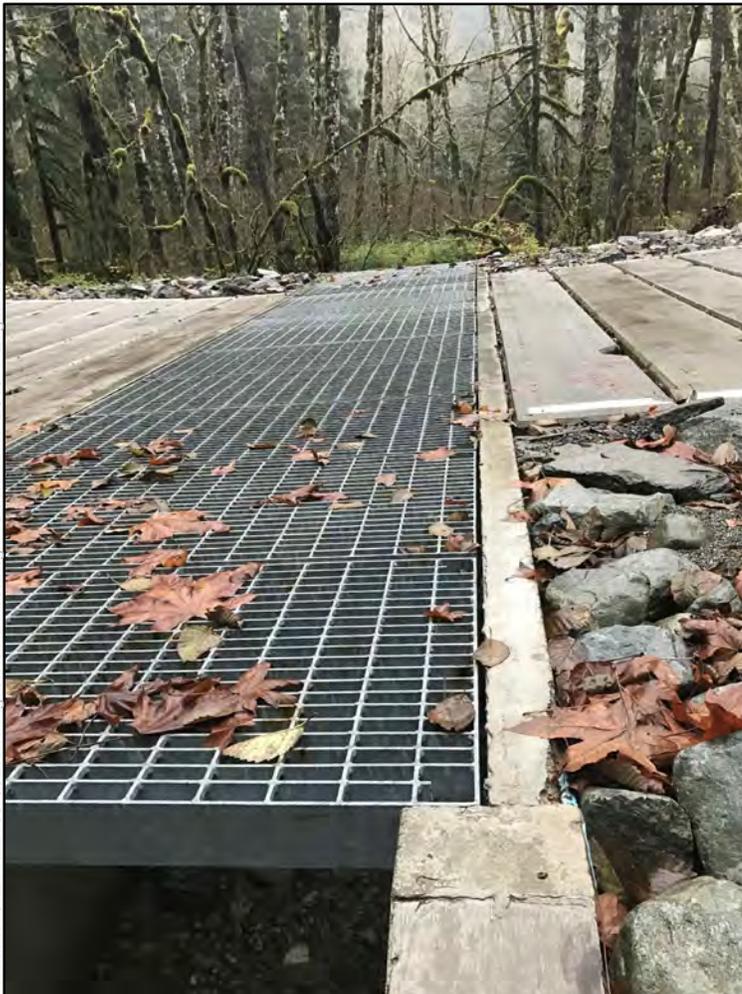
Photograph 23.
Close up of vented
ford in Photograph 22
showing removable
metal grate over box
culvert and articulated
concrete mat.
